**TECHNICAL INSTRUCTIONS**

**SPECIAL SERVICE CAMPAIGN 22TC06**

**INCORRECT MODEL YEAR LABELS**

**CERTAIN 2022 MODEL YEAR C-HR**

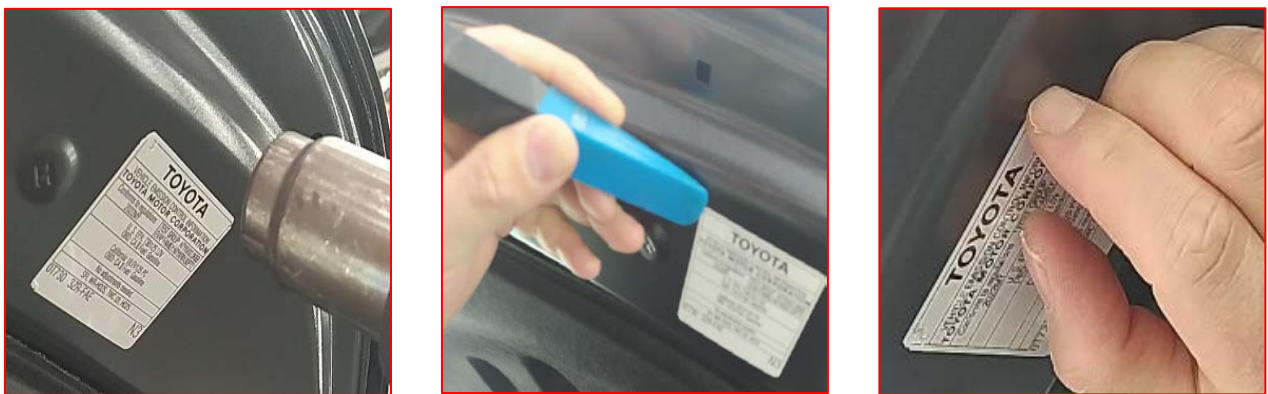
- b. Remove the emission label from under the hood which has the “9Q” printed on it.
- i. Heat the label with a heating device for 15-20 seconds.
  - ii. Remove the label from the hood by scraping with a plastic scraper.

**Caution: Hold the heating device 10cm away from the label. Be careful to not burn your fingers or damage the paint from applying too much heat.**

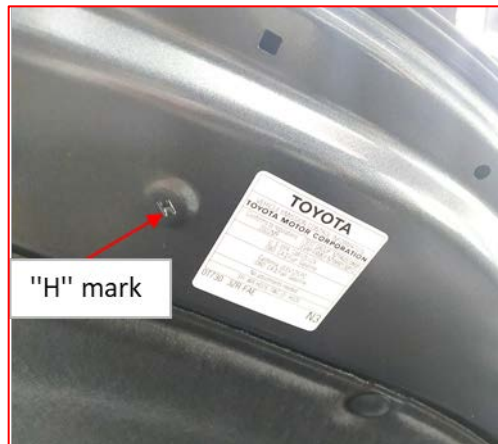
- ii. Confirm the label orientation.
- iii. Use the Toyota "H" Mark in the picture below to confirm the sticker location is correct.

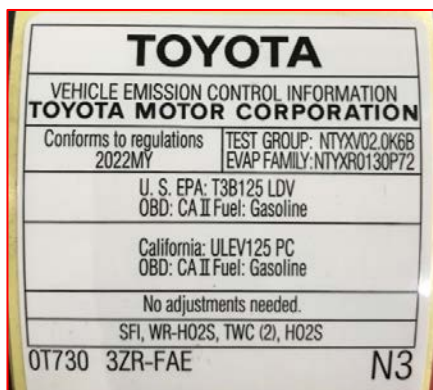
- e. Confirm the quality of the repair.
  - i. Use hand pressure to prevent bubbles from forming and ensure proper adhesion to the underside of the hood.

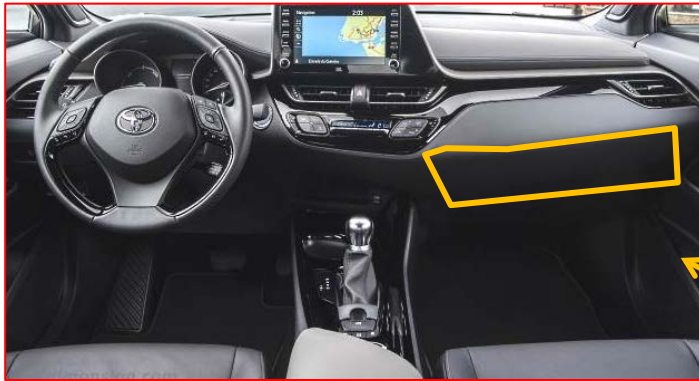
Manuals located in the vehicle glove box

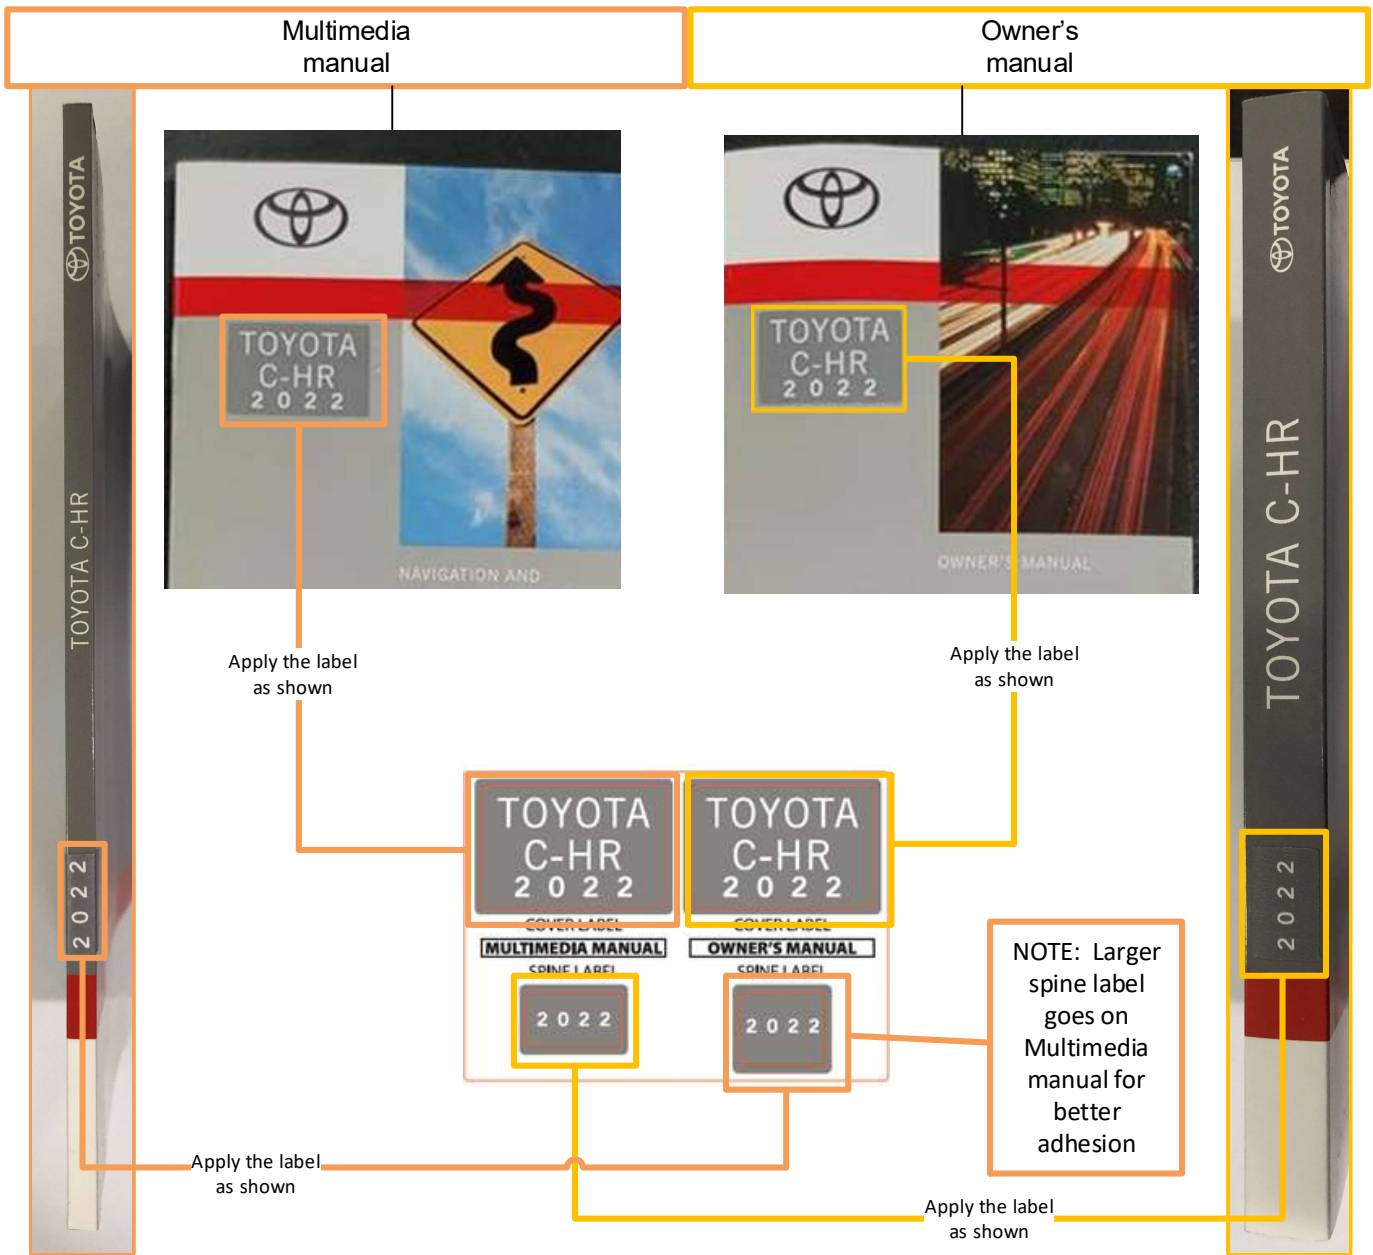
- e. Locate the manual sticker sheet from 22TC06 C-HR Label kit. Both stickers that say "Toyota C-HR 2022" are the same shape and size. Apply one label on the front cover per the image below.

- f. Apply the larger of the two spine labels which say "2022" to the Multimedia spine. The larger sticker is intended for the thinner book for improved adhesion to the book providing a long-lasting repair. Ignore the "MULTIMEDIA MANUAL" "OWNER'S MANUAL" text printed on the stickers as this was a printer error.
- g. Remove any bubbles by smoothing out using a flat plastic scraper tool to smooth out the sticker application.
- h. Return the completed manuals to the vehicle glove box.
