Service Bulletin

Bulletin No.: 21-NA-264

Subject: Liftgate Actuator Showing a Leaking Residue on Strut

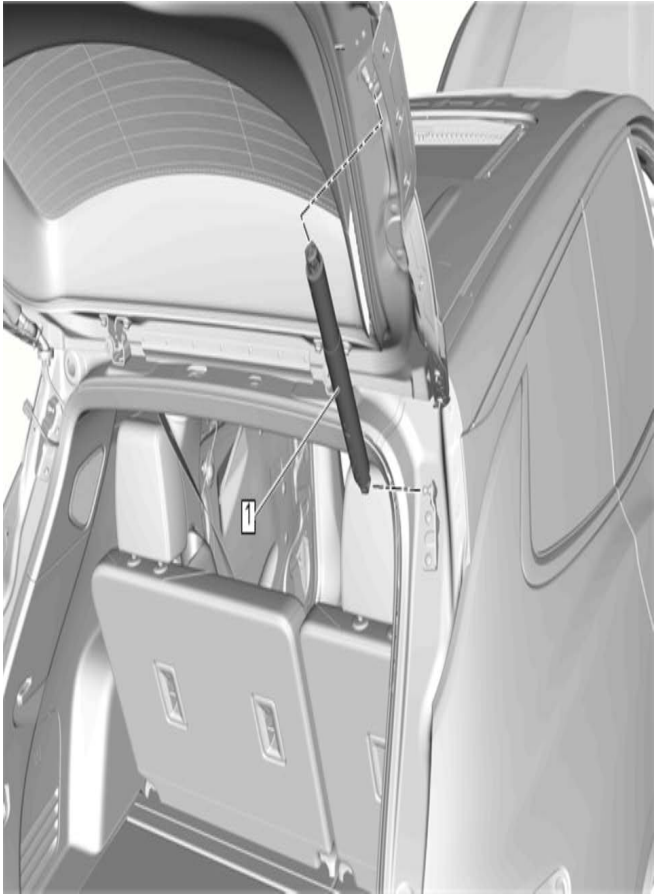
| | <p>5924501</p> <p>Some customers may comment on seeing a leak, or residue on the rear liftgate strut.</p> |

| <p>Cause</p> | <p>The cause of the condition may be a specific issue in which typically extra padded grease is used for the boot, to reduce noise from movement. This in some cases can be confused with a leak from a type of hydraulic fluid that assists with the pressure of the actuator. This is not the case. The struts do not contain any fluid for its mechanical functionality. There are no concerns with the part functionality from this residue of grease. This is extra grease that has found its way out from added pressure on the boot.</p> |

| <p>Correction</p> | <div style="text-align: right;">4808160</div> <p>Open the liftgate to access the strut (1), then grease can be wiped away with a damp cloth and dried appropriately.</p> |
