### Applicable Vehicles

87-22-01TT – Rear Evaporator Diagnosis

Release date: 9/8/2022

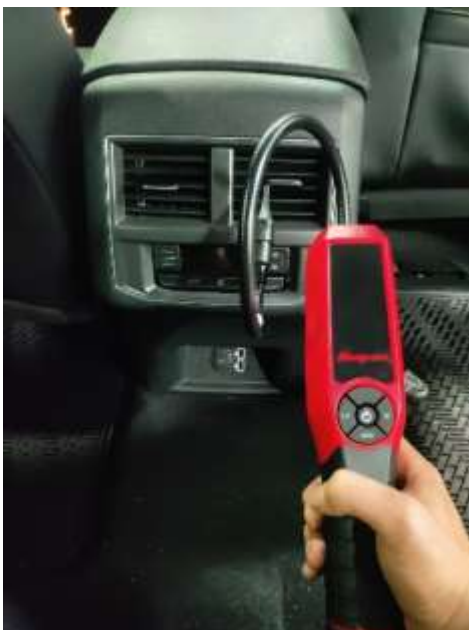
Figure 1

- Adjust the rear A/C to cool and set the rear distribution to the rear vent.
- Set the A/C to OFF to turn off the blower.
- Carefully analyze the rear evaporator using tool MRT Refrigerant Leak Detector ACT925.

To aid in diagnosis of the rear evaporator refrigerant system use the MRT Refrigerant Leak Detector ACT925.

To check the system, it is important to have the A/C blower OFF during testing.
