## ServiceNews Article

September 2022 A22090A Version 1

## **Clarity FCV Sub Tank Harness Rodent Damage**

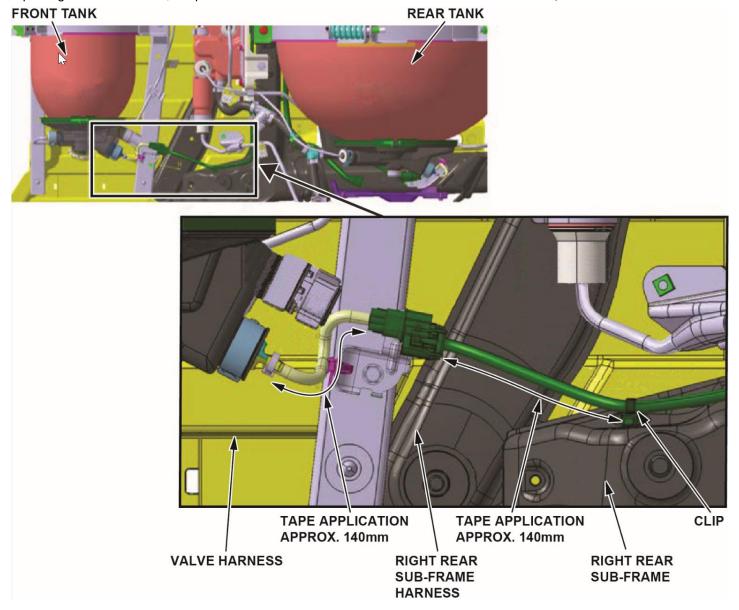
In the event you experience a sub tank wire harness rodent damage on the 2017–2020 Clarity FCV, after repairing / replacing the wire harness, wrap the areas shown below with **RODENT DETERRENT TAPE, P/N 4019-2317.**

After repairing or replacing the harness, wrap some of that tape around the affected area. It has **capsaicin**. This should keep any critters from causing future problems.
