## STAR ONLINE PUBLICATION

**Case Number:** S2213000001

**Symptom/Vehicle Issue:** Frame Bracket Attached To Right Front Frame Rail Behind Front Tire.

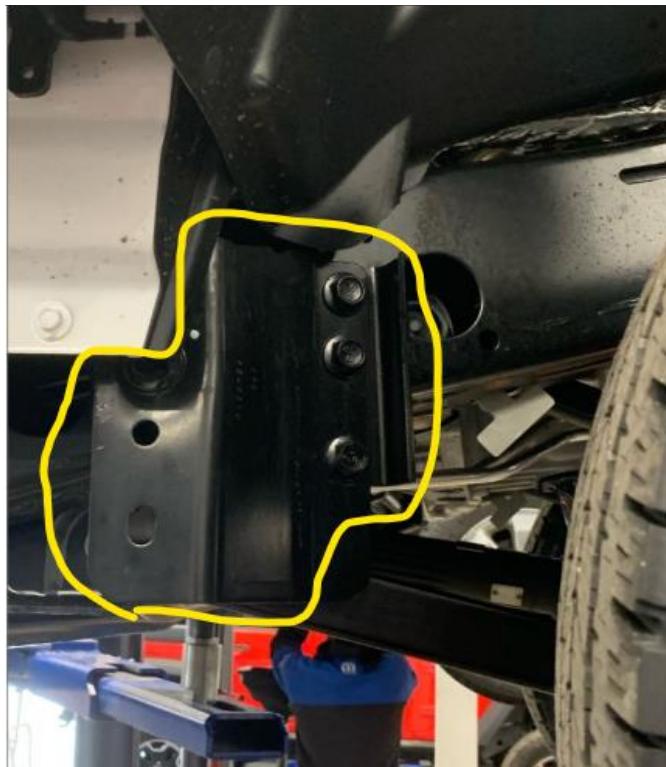
Bracket on right front frame behind front tire.

The bracket shown above is only on the right front. There will be no bracket on the left front. This bracket is for side impact offset ridged barrier performance or also known as a SORB bracket. It is not to be removed and is part of the crash safety system of the vehicles frame.
