STAR ONLINE PUBLICATION

Case Number: S1823000056 Rev E

Symptom/Vehicle Issue: Tailgate Ajar Indicator Light Is On And Or High Effort Required To Close And Latch The Tailgate

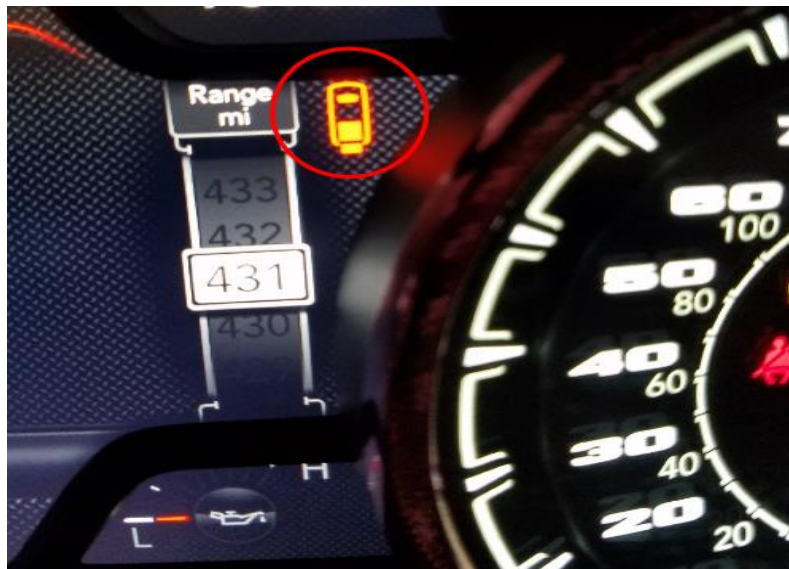
High or difficult closing effort can be caused by a striker setting or flush mismatch between the Tailgate and the Tailgate opening of the pickup box when the striker / latch is improperly adjusted. The striker / latch may require adjustment to optimize flush appearance and closing effort. Improperly adjusted latches may cause one latch to not fully engage unless the Tailgate is slammed shut. The ajar switch is on the right-side tail gate latch only. Verify the customers concern by using the following procedure.

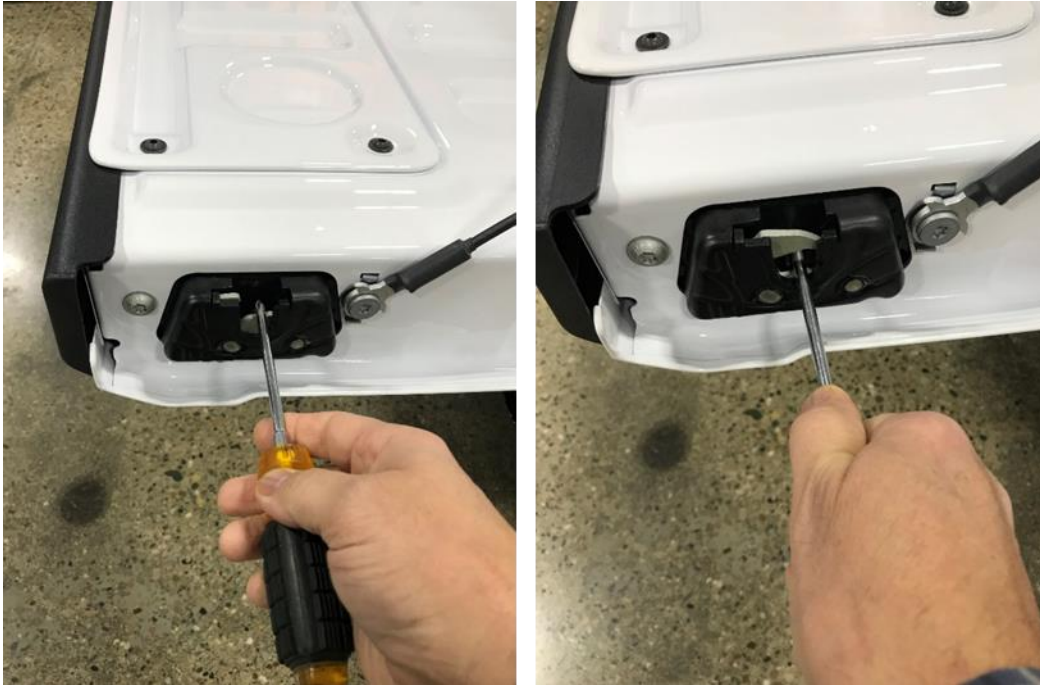
Fig 2 closing latch

1 - Confirm latch function -

- With tailgate open, using screwdriver actuate the latch(s) (Figures 2).
- If tail gate ajar light on dash turns off DO NOT replace latch.
- If the ajar light does not turn off check electrical connection and re-test.
- If electrical connection is good and latch ajar still does not turn off, then replace right side latch.

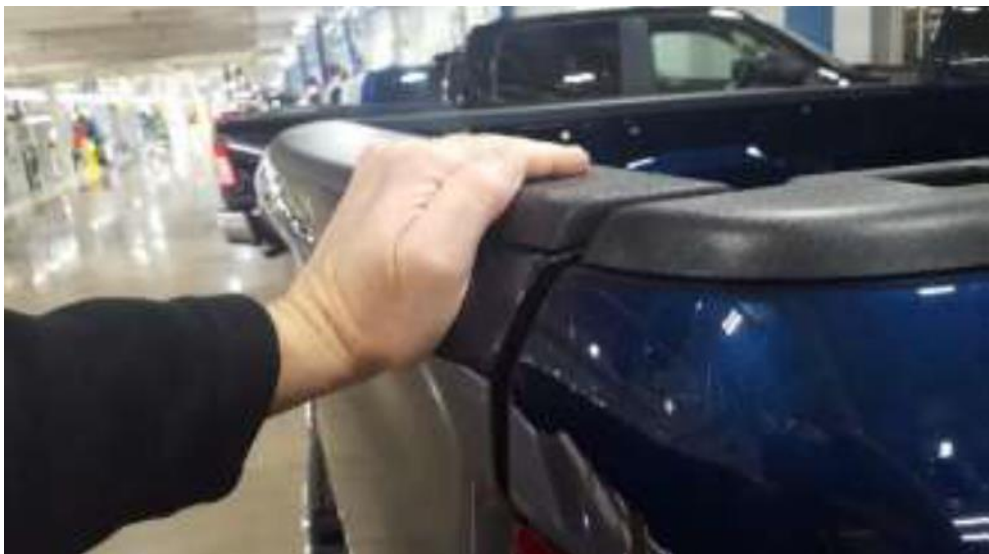
Fig 4. Over flush tail gate

1. Actuate the tailgate handle to open the latches before closing the tailgate.
2. Adjustment of strikers
 - Assess flush condition of tailgate to box on both sides. (Figure 4)

- Make sure up / down position of both strikers hits the center of the latch opening. This can be seen visually by bringing the tailgate up to the striker on each side. A striker binding on the top or bottom latch opening can bind and prevent it from opening. Adjust each striker up/down if required to center it to the latch.
- With a China marker or grease pen mark striker location.
- Adjust right side striker aft such that both latches engage when pushing on tailgate from the center.
- If the latches are not latching simultaneously then the left side striker may need to be moved forward to reduce the closing effort.
- Secure the striker to the torque specified in Tech Connect. 35NM 26FtLbs.

<<<Note>>> The goal of this repair is to minimize the force required to fully latch the tailgate. One side of the tailgate may be slightly under flush relative to the other side but within specification.
