## STAR ONLINE PUBLICATION

**Case Number:** S2224000008

**Symptom/Vehicle Issue:** Customer Indicates AC Blows Warm Air

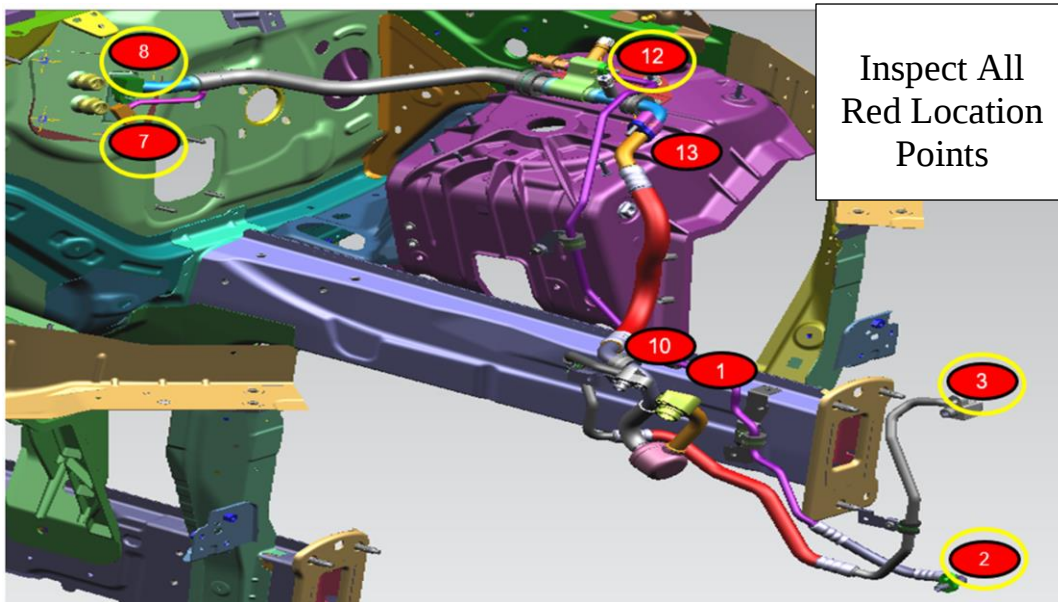
**Discussion:** Using an UV light inspect AC lines for leaks at TXV valve port, AC charge ports and condenser fittings. (See image below for reference). If a leak is detected replace the O-ring only.
