NUMBER: 14-009-22

Fuel Line Buzz Vibration Noise

This bulletin involves isolating the fuel lines from the chassis.

2021 (WK) Jeep Grand Cherokee

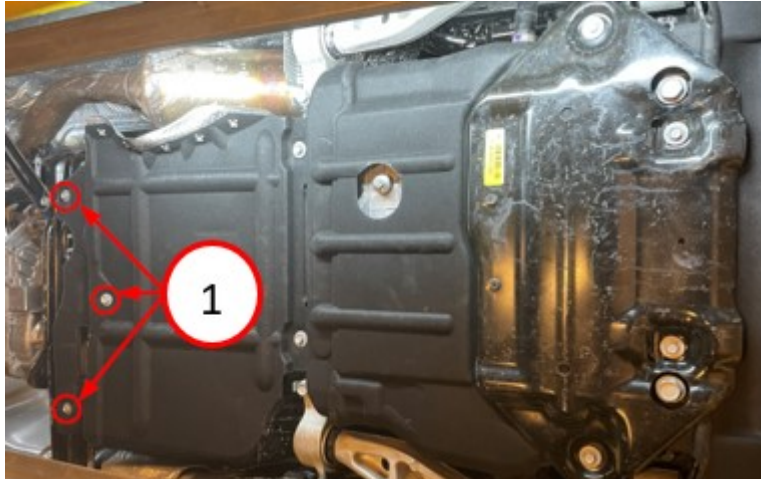
Fig. 1
Rear Close Out Panel Bolts

1 - Rear Close Out Panel Bolts

1. Raise the vehicle on a hoist. Refer to the detailed service procedures available in DealerCONNECT> under: Service Info>04 Vehicle Quick Reference/Hoisting/ Standard Procedure.
2. Remove three 13 mm bolts securing the rear close out panel from the transmission cross member support. (Fig. 1)
