NUMBER: 23-021-22

GROUP: 23 - Body

Front Seat Will Not Unfold and Lock Into Position

2019 - ****2022**** (JL) Jeep Wrangler

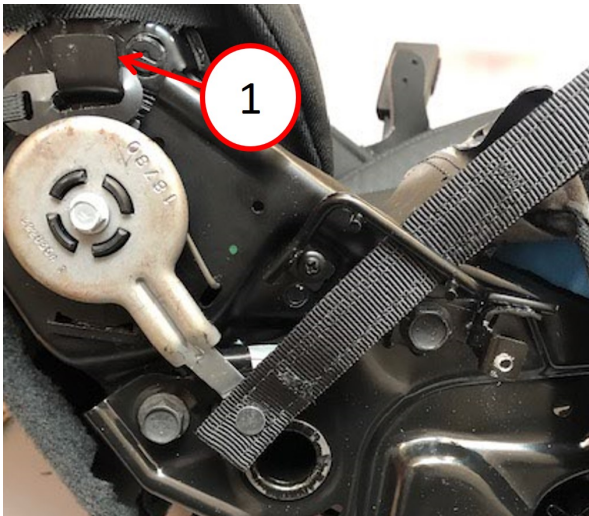
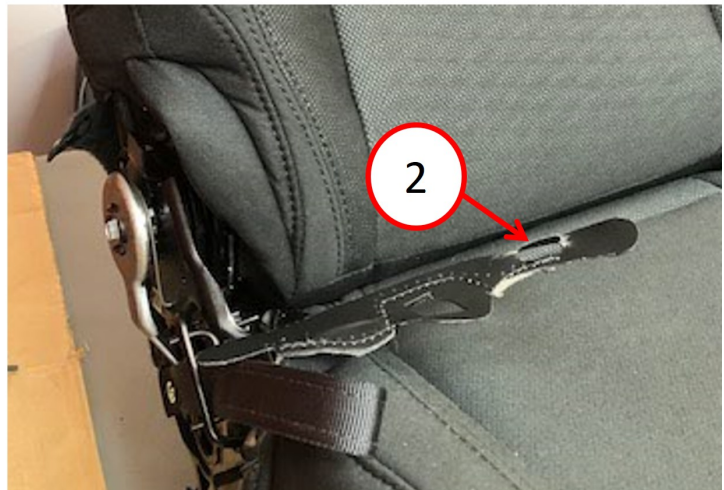
Fig. 1

Cushion Trim Stiffener And Metal Tab

- 1 - Metal Tab
2 - Trim Stiffener

1. Remove the seat cushion side shield. Refer to the detailed service procedures available in DealerCONNECT/Service Library under: Service Info> 23 - Body / Seats, First Row / Side Shields, Seat Cushion, Front / Removal.
2. Recline the seatback to the full rear position.
3. Disengage the cushion trim stiffener from the metal tab (Fig. 1) , to expose the interlock mechanism (Fig. 2) through the biteline in the front of the seatback.

18. Connect the two cushion trim j-retainers from the cushion suspension (Fig. 3) .
19. Install the cushion trim stiffener on the metal tab (Fig. 1) and (Fig. 2) .
20. Move the seatback to the full forward position.
21. Install the seat cushion side shield. Refer to the detailed service procedures available in DealerCONNECT/Service Library under: Service Info> 23 - Body / Seats, First Row / Side Shields, Seat Cushion, Front / Installation.**

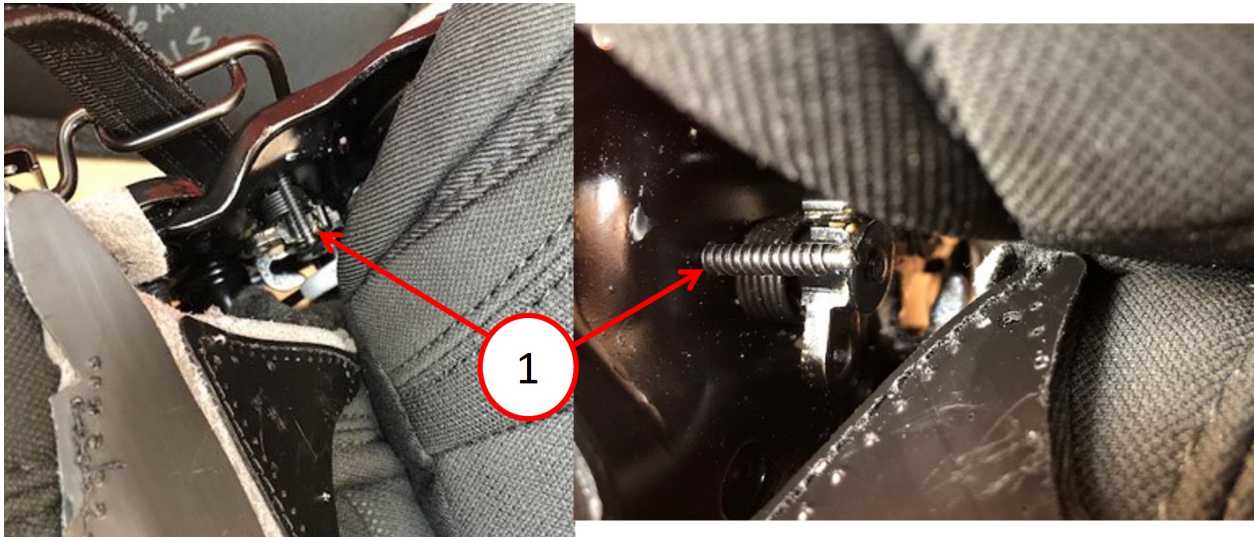
Fig. 2
Interlock Mechanism

1 - Interlock Mechanism

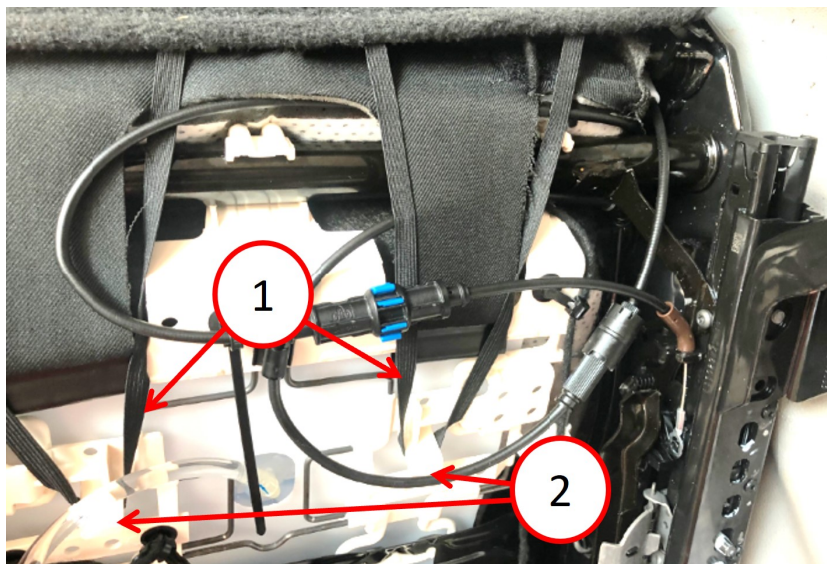
Fig. 3
J-Retainers And Bungees

1 - Bungees
2 - J-Retainers

4. Remove the two bungees from the suspension mat hooks (Fig. 3) .

5. From the rear/bottom of the cushion, remove the two cushion trim j-retainers from the cushion suspension (Fig. 3) .

11. Feed the new communication cable through the rear of the cushion, up into the biteline of the seatback.
12. Install the cable z-fitting to the interlock bracket hole (Fig. 6) .
13. Install the communication cable conduit end-fitting on the u-bracket on backframe a-bracket (Fig. 5) .
14. Install the cable clip on the track-pin (Fig. 4) .
15. Install the communication cable conduit end-fitting on the u-bracket to the track (Fig. 4) .
16. Connect the two bungees from the suspension mat hooks (Fig. 3) .

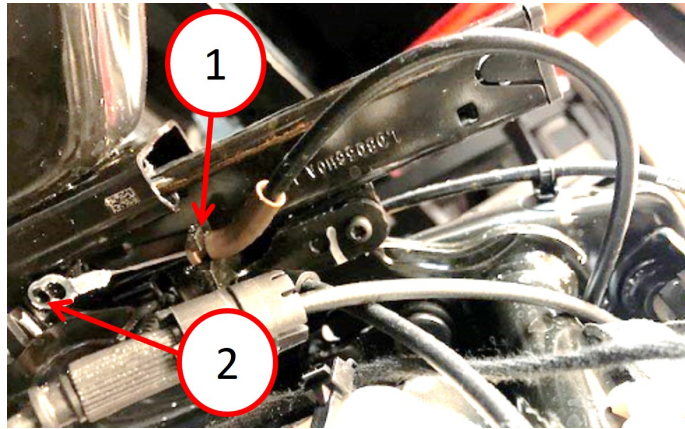
Fig. 4

Communication Cable Conduit And Track Pin

- Communication Cable Conduit End-Fitting
- Track-Pin

- Using a flat blade screwdriver and from underneath the rear of the cushion, pop the communication cable conduit end-fitting out of the u-bracket on the track (Fig. 4) .

- Remove the cable clip from the track-pin (Fig. 4) .
- Using the cable (Fig. 4) just disconnected in Step 7, pull on it to manually release the seat and fold it backwards.
- From the front biteline of the seat. Using a flat blade screwdriver and from the rear of the cushion, pop the communication cable conduit end-fitting out of u-bracket on backframe a-bracket (Fig. 5) .

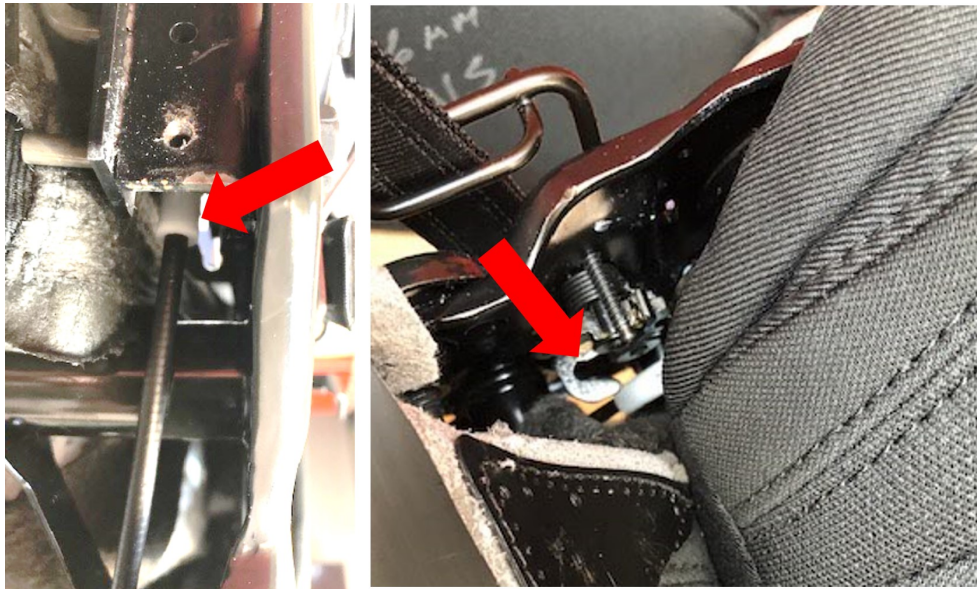
Fig. 5

Cable Conduit End-Fitting And U-Bracket

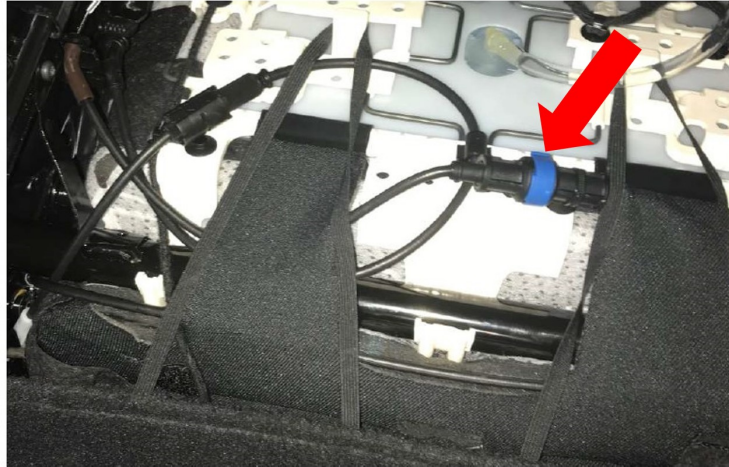
Fig. 7

Communication Cable Routing With Heated Seats

17. Route the new longer compensator communication cable (**with or without heated seats**) as required underneath the cushion suspension, with heated seats (Fig. 7) and without heated seats (Fig. 8) .

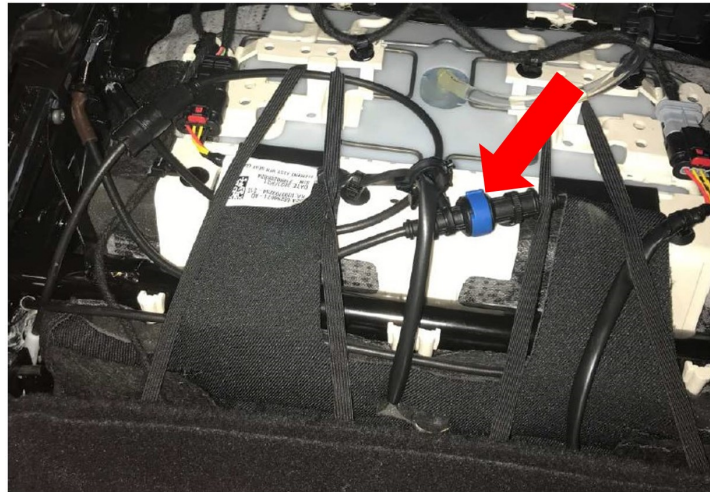
Fig. 8

Communication Cable Routing Without Heated Seats

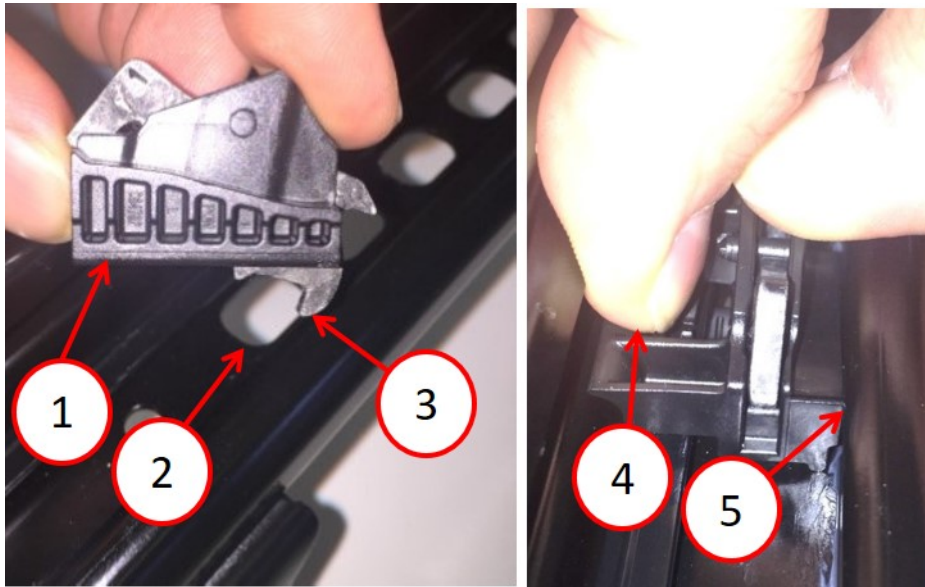
Fig. 10
Seat Position Return Installation

- 1 - Corrugated Side
- 2 - Seat Track Slot
- 3 - Claw
- 4 - Push This Side Of The Seat Position Return
- 5 - Side Of The Seat Position Return To Insert Into The Track First

23. Insert the new seat position return corrugated side first, into the seat track (Fig. 10) .
24. Install the new seat position return by placing one finger on the peak and a second finger on the open cavity side, pushing the seat position return straight down into the seat track with the claw inserted into the last locking slot on the track (Fig. 10) .
