## MIL Is ON with DTC P0455

Supersedes 21-007, dated September 2, 2022, to revise information highlighted in **yellow**.

### AFFECTED VEHICLES

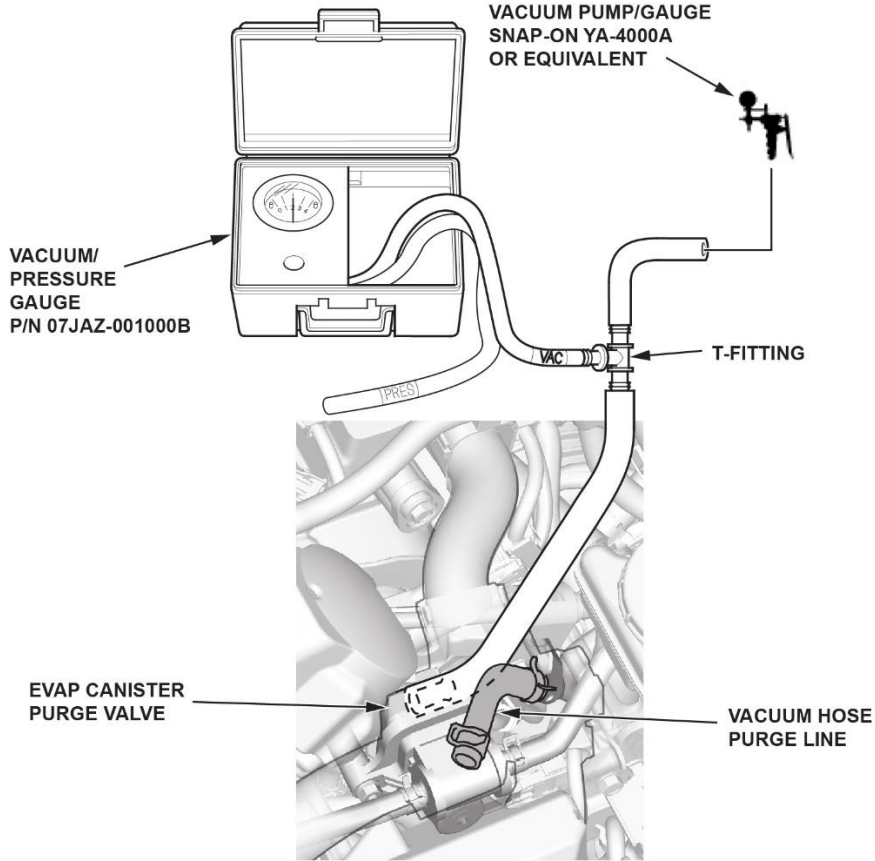
1. Connect the i-HDS to the vehicle and confirm DTC P0455 is present.
  - If DTC P0455 is present, go to step 2.
  - If DTC P0455 is not present, this bulletin does not apply. Continue with normal troubleshooting.
2. Check the vacuum at the EVAP canister purge valve using the vacuum pump. Apply about **2 kPa** (0.6 inHg, 15 mmHg) of vacuum to the hose using the vacuum tool.

- If the vacuum holds for **1 minute**, continue to step 3.  
NOTE: Leave the vacuum hose purge line disconnected.
- If it does not hold for **1 minute**, this bulletin does not apply. Continue with normal system troubleshooting.

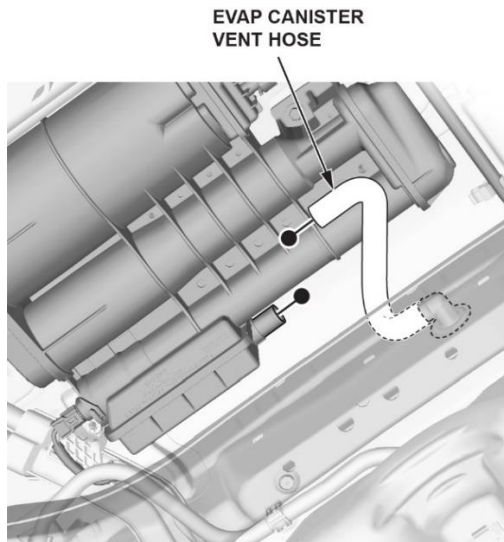
4. Disconnect and check the EVAP canister vent hose for a blockage or restriction.

- If there isn't a blockage or restriction, the system is normal. Continue to step 5.

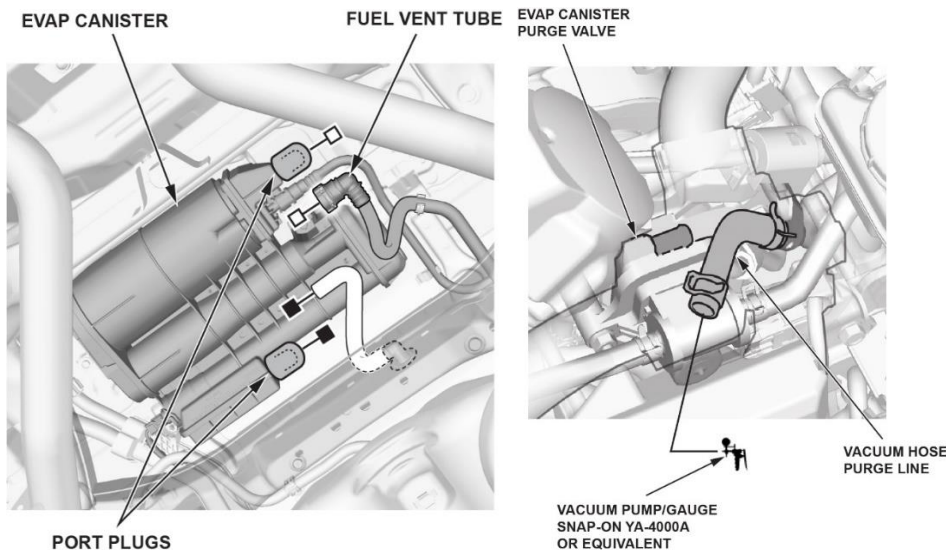
5. Disconnect the fuel vent tube and plug the fuel vent tube and canister vent hose ports with plugs. Then, connect a vacuum pump to the vacuum hose purge line at the EVAP canister purge valve, located in the engine bay.

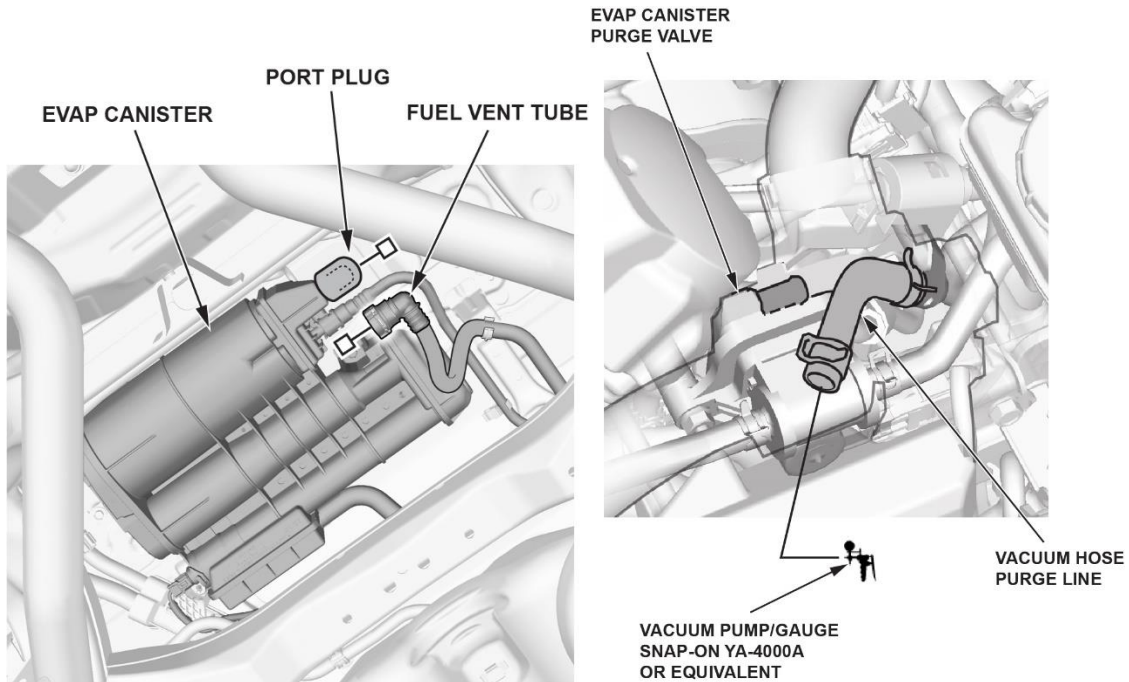
11. Check for a poor connection or damage on the fuel fill pipe and the fuel tank vapor recirculation tube.

- If the connections are ok and there are no damages, the system is normal. Reconnect the fuel vent tube and the vacuum hose purge line. Go to REPAIR PROCEDURE.
- If there are any damages or loose connections, this bulletin does not apply. Continue with normal system troubleshooting.

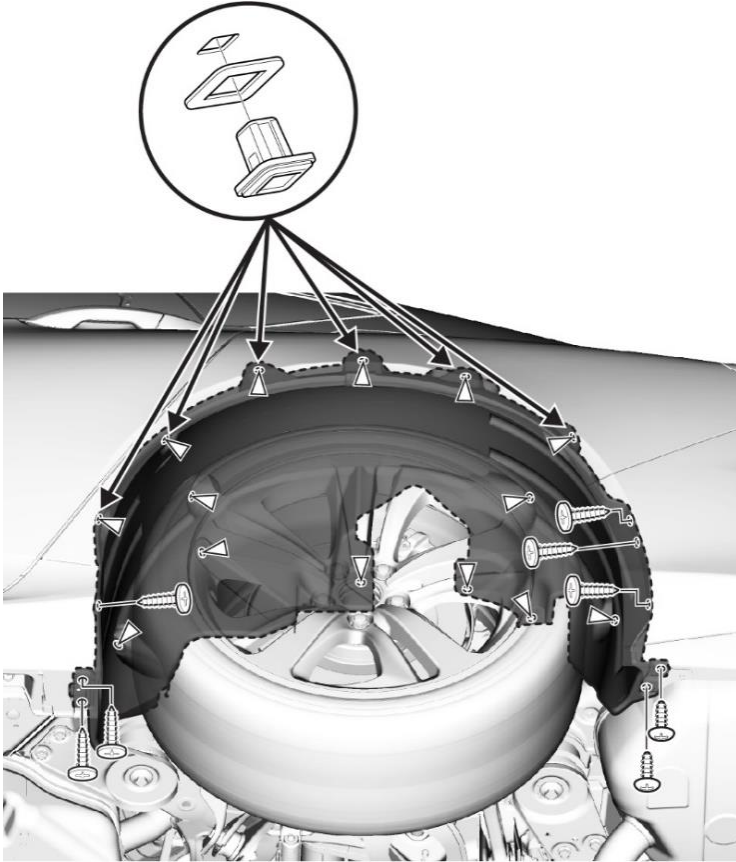
1. Relieve the fuel pressure.
2. Disconnect the battery.
3. If the fuel tank level is above  $\frac{3}{4}$ , drain the fuel until the fuel tank is at or below  $\frac{3}{4}$ .
4. Remove the left rear wheel and inner fender.

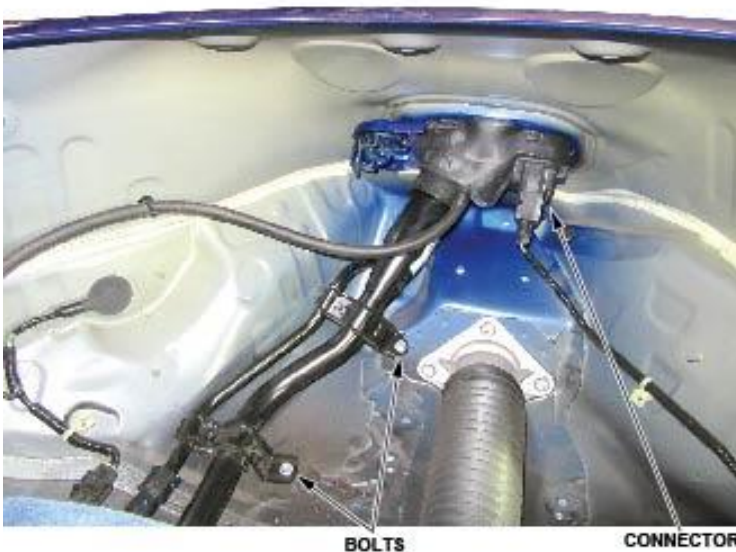
5. Disconnect the connector and remove the two fuel filler neck bolts.

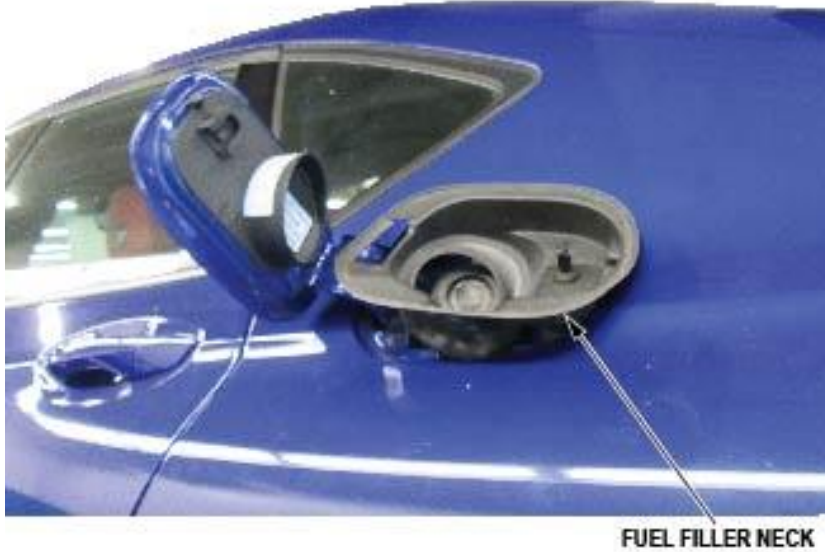
- Unclip the fuel filler adapter assembly from around the filler door hinge.

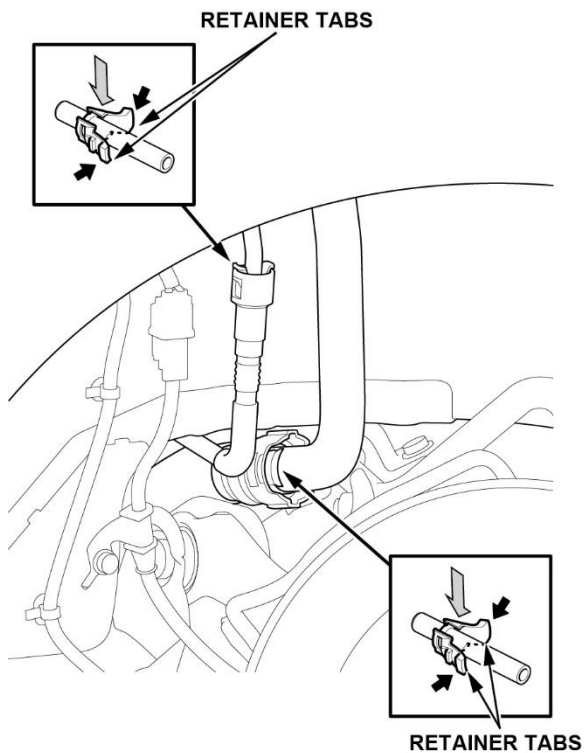
- Pull away the filler neck adapter assembly (no need to fully remove).
- Remove the fuel filler pipe assembly by releasing the retainer tabs on the clips that release them from the locking tabs.

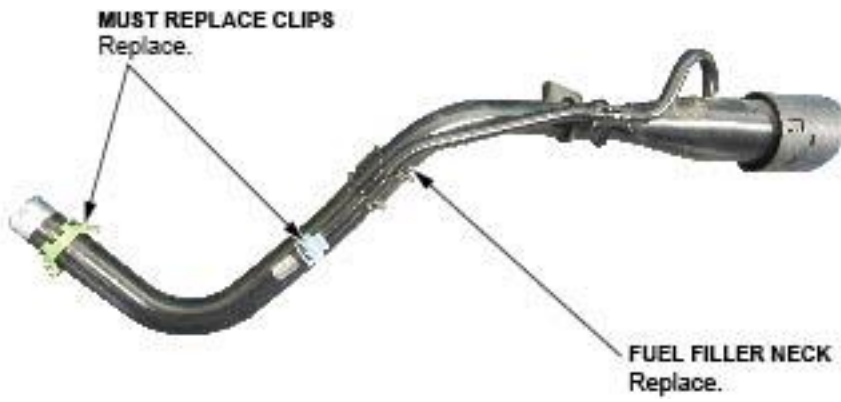
- Install the new fuel filler pipe assembly with the two new must replace clips into the fuel line until a click sound is heard. Then, torque the bolts to **9.5 N.m (7 lb-ft)**.
