HYUNDAI

Technical Service Bulletin

GROUP	NUMBER
CAMPAIGN	22-01-074H
DATE	MODEL(S)
SEPTEMBER 2022	Veloster N (JSN)

SUBJECT: BRAKE PEDAL ASSEMBLY REPLACEMENT
(SERVICE CAMPAIGN T8R)

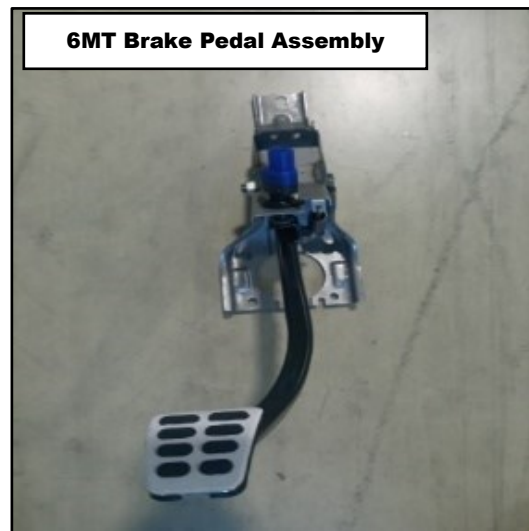
Description: This bulletin describes the procedure to replace the brake pedal assembly on certain 2022 MY Veloster N (JSN) models. The brake pedal in certain vehicles may have been produced with an insufficient weld that may cause noise during operation. This bulletin provides instruction to inspect the brake pedal to determine if a replacement brake pedal assembly is needed and, if so, instruction to replace the assembly.

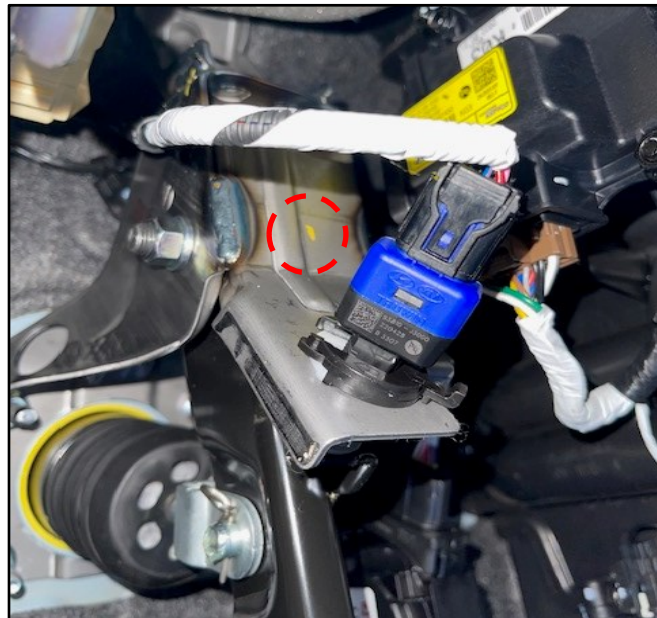
3. Check the brake pedal marking area to determine the color of the dot. Then perform the action as described below that relates to that color.

- **Yellow, White, or Black** – brake pedal assembly replacement is not necessary.

Yellow, White, Black dot – replacement is not necessary

The service procedure is now complete.

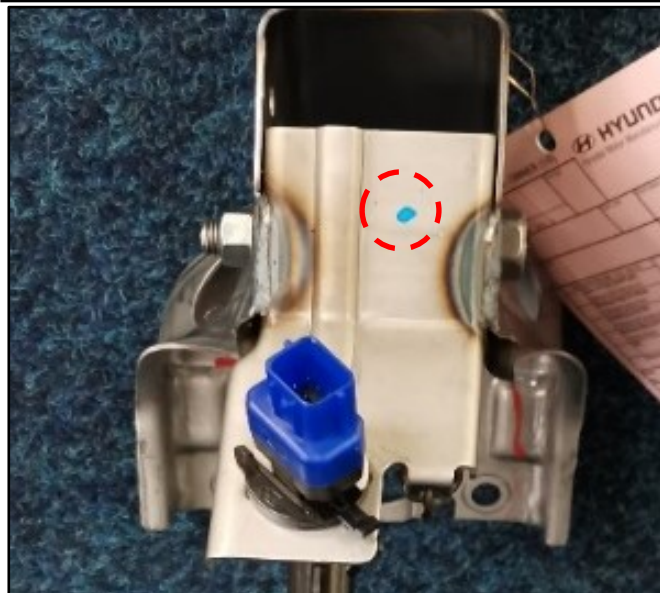
- **Blue** or the dot is not visible – brake pedal assembly replacement is necessary.

Blue dot – replacement necessary

Follow the instructions in the Service Manual and replace the brake pedal assembly with the new part.

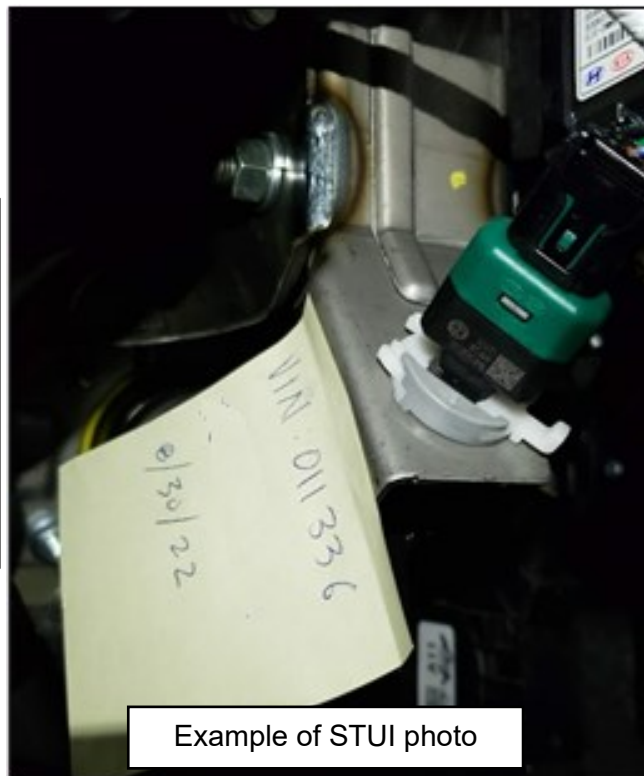
4. After installation of the new brake pedal assembly, use STUI to take a photo of the brake pedal marking area.

Using STUI, take a photo of the brake pedal marking area dot color with the last 6 digits of the VIN and the date of repair on a piece of paper. See example shown to the right.

Example of STUI photo

Upload the photo to STUI.
