## Technical Service Bulletin

<b>GROUP</b> <b>CAMPAIGN</b>	<b>NUMBER</b> 22-01-071G
<b>DATE</b> SEPTEMBER, 2022	<b>MODEL(S)</b> G70 (IK) G80 (RG3) GV70 (JK1) GV80 (JX1)

**SUBJECT:** TORQUE CONVERTER REPLACEMENT (SERVICE CAMPAIGN T27G)

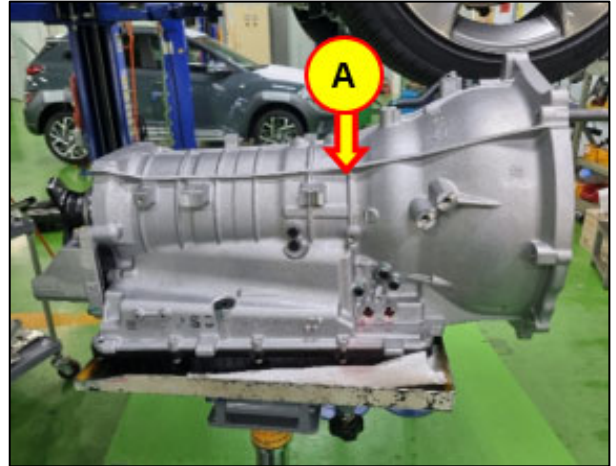
2. Remove the transmission (A).

Refer to the applicable shop manual, **Automatic Transmission System > Automatic Transmission System > Automatic Transmission > Repair procedures.**

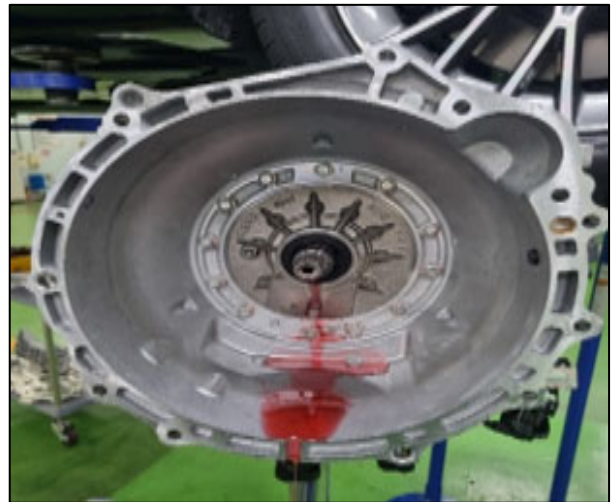
3. Remove the torque converter.

Use a paper towel or shop rag to wipe off the residual ATF.
