Technical Service Bulletin

66 Front radiator grille trim incorrect for vehicle

66 22 92 2068096/1 September 28, 2022.

Model(s)	Year	VIN Range	Vehicle-Specific Equipment
Q8	2023	000001 – 003082	Not Applicable

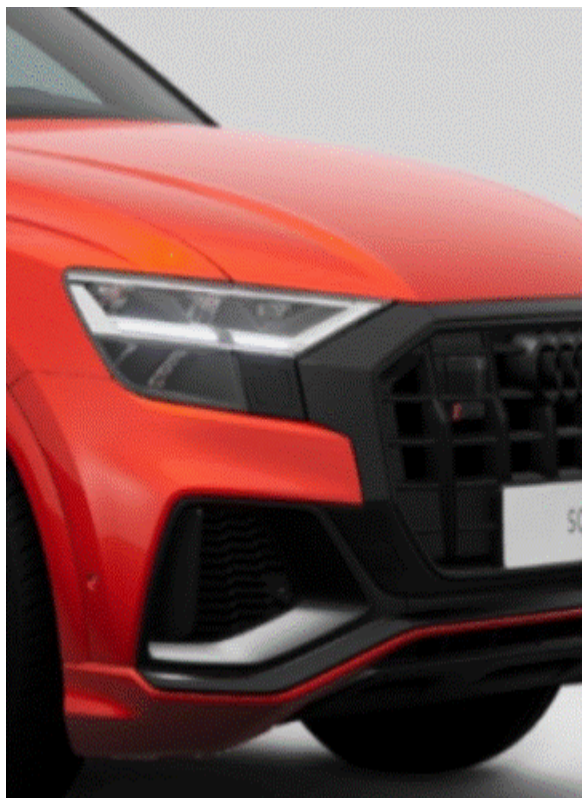
Figure 2 shows the correct configuration with a black radiator trim.

Figure 2. Correctly configured radiator grille trim in black.
