## Firefly Terminator G4 Tap Connector

<b>Bulletin Type:</b>	TSB	<b>Publication Date:</b>	September 2022
<b>Bulletin #(s):</b>	22-076	<b>Make(s):</b>	Jayco & Entegra Coach
<b>Job Code(s):</b>	9803580	<b>Model(s):</b>	Ethos LI (20AL, 20TL) Launch (19Y) Launch LE (19Y) Swift LI (20AL, 20TL) Terrain (19Y) Terrain LE (19L)
<b>Flat Rate(s):</b>	9803580 - .10 Repair	<b>Model Year(s):</b>	2022

## FIREFLY TERMINATOR G4 CONNECTOR REPAIR INSTRUCTIONS

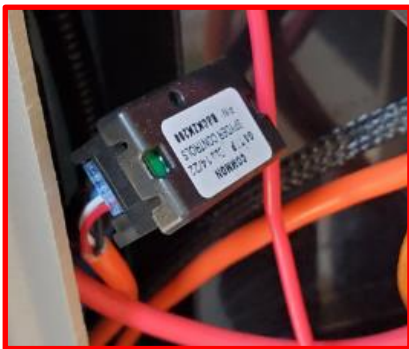
1. Locate G4 Tap Connector at the end of the Lithium Battery:
  - A. Mercedes Sprinter (Launch, Launch LE, Terrain, Terrain LE, VY): Rear Access Cover (Fig. 1)
  - B. Dodge Promaster 20AL (Ethos LI, Swift LI): Battery (Forward Bed) Access Cover (Fig. 2)
  - C. Dodge Promaster 20TL (Ethos LI, Swift LI): Timberline Tank (Forward Bed) Access Cover (Fig. 3)

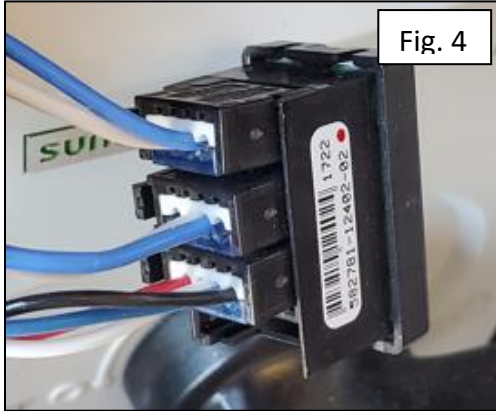
Fig. 4

2. Remove the three plugs from the Common G4 Tap (Figure 4) and place them into the new Terminator G4 Tap from the parts list. (Figure 5)
  - A. **NOTE:** With the Terminator G4 Tap installed, ensure that the Firefly and Renogy Battery screens are providing accurate information and/or are not showing faults.
