TECHNICAL SERVICE BULLETIN

Various Electrical Concerns - Wiring Harness Contacting Coolant Reservoir Bracket - Built On Or Before 20-Nov-2020

21-2219

Ford
2021 F-650/F-750

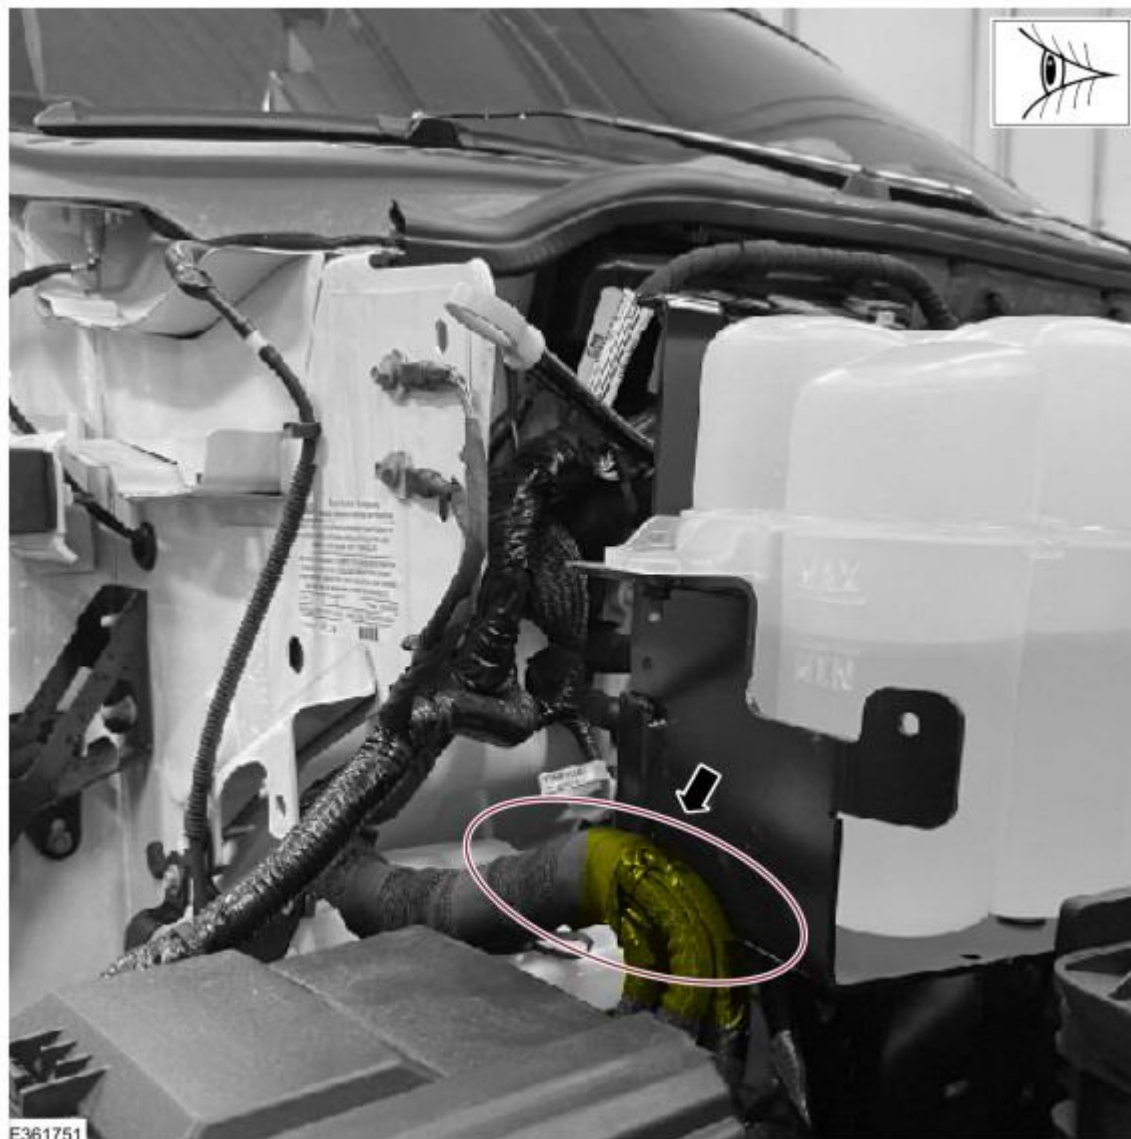
Figure 1

1. Closely inspect the wiring harness for contact with the coolant reservoir bracket. (Figure 1)

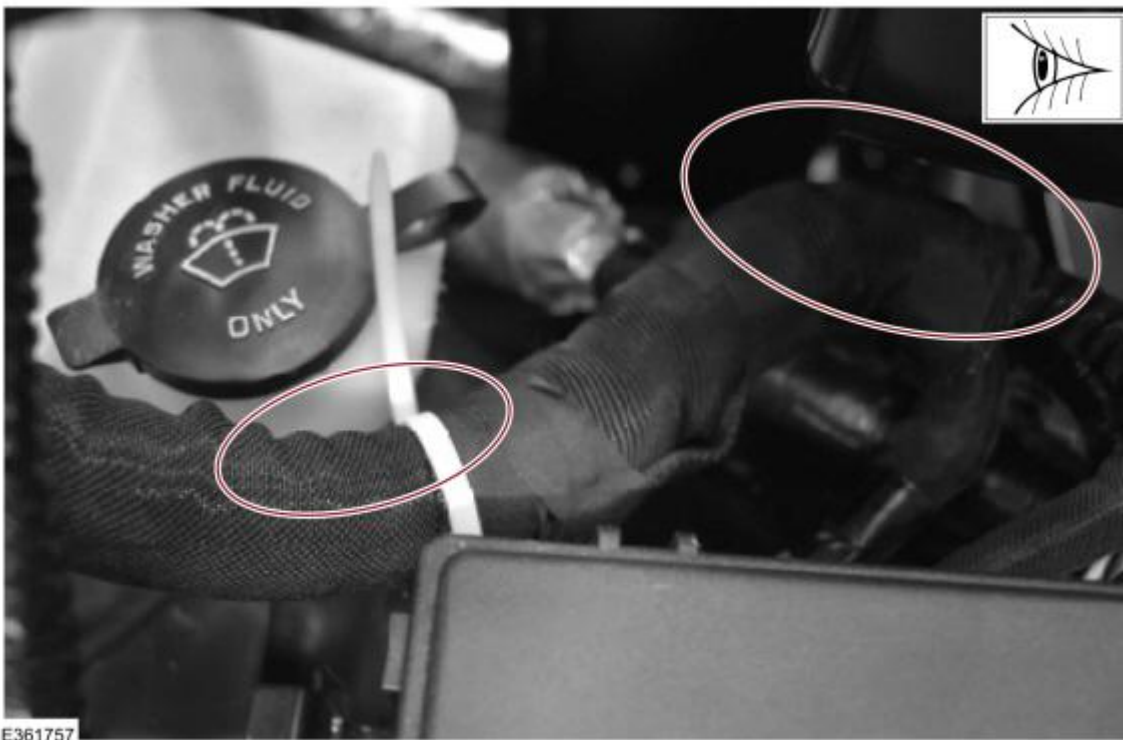
Figure 7

8. Inspect and make sure adequate clearance is present around the wiring harness near the washer fluid reservoir and the coolant reservoir bracket. (Figure 7)
