## TAG AXLE HUB NUT TORQUE VERIFICATION

Prevost vehicles

On the vehicles affected by this bulletin, inspect the hub nut for proper torque.

## SP22-302B

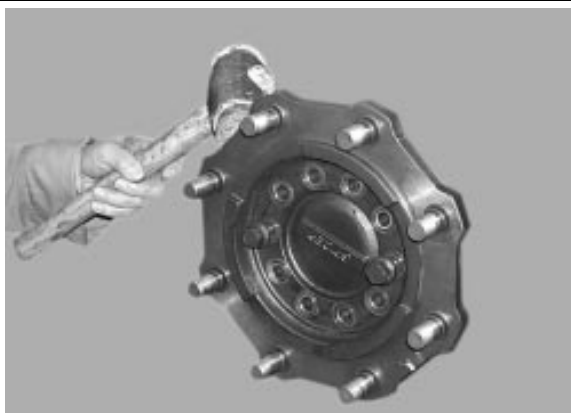
FIGURE 6

8. Gently tap hub flange outwards using a soft faced hammer.

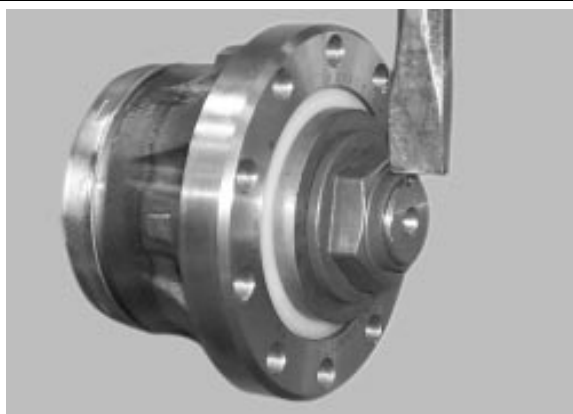
FIGURE 11

2. Install new hub nut then torque hub nut.

**TORQUE: 563-687 lb-ft (763-931 Nm)**

3. Stake the hub nut by deforming with a *round nosed chisel*. Refer to the proper staking criteria below.

*Do not use a chisel with a sharp edge.*

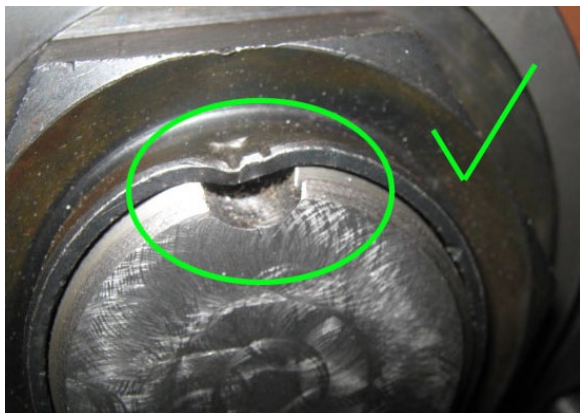
FIGURE 12: **CORRECT** - PREVENTS THE NUT FROM GETTING LOOSE

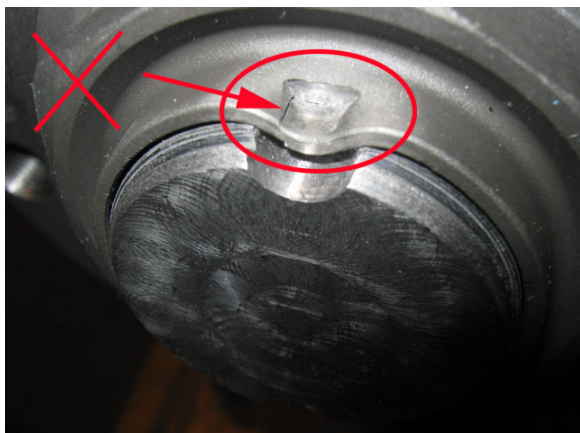
FIGURE 14: BROKEN OR TORN LIP – **REJECTED**

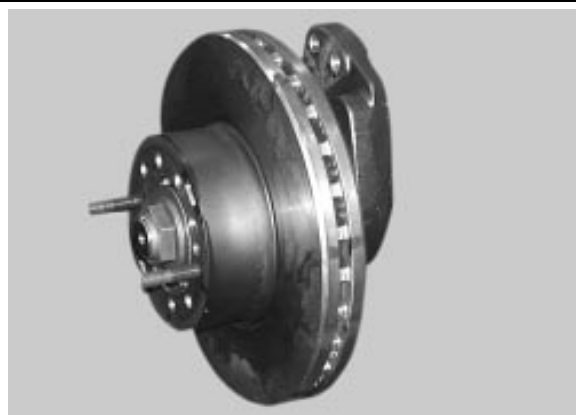
FIGURE 23

4. With the hub flange already removed in PART 1, insert two guide studs in the disc.

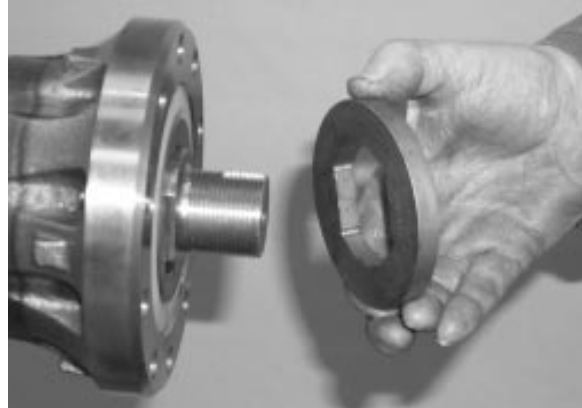
FIGURE 27

12. Remove the thrust washer.  
Keep for re-use.

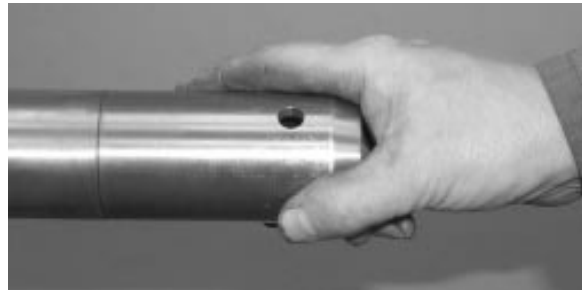
13. Screw insertion tool onto spindle.

| Insertion tool, tag axle | G32950 |

FIGURE 28: INSERTION TOOL

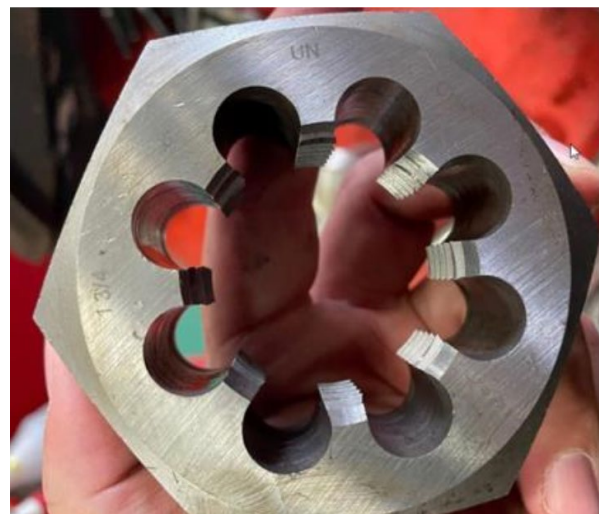
14. Carefully pull unitized bearing assembly and remove.  
15. **Discard** unitized bearing.

16. **If damaged**, repair the first spindle threads using appropriate thread cutting die.

Tag axle spindle thread: 1 3/4-8 UNR 3A

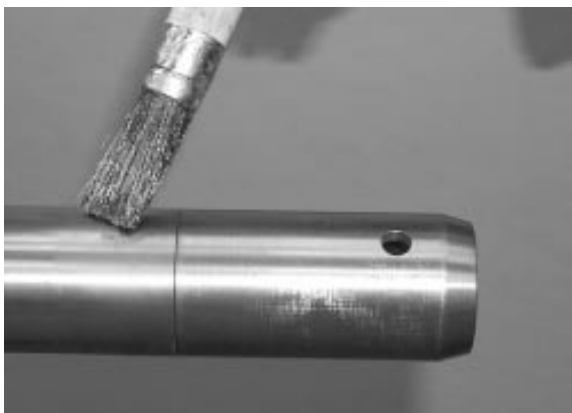
2. Apply a thin layer of antifriction/antifretting lubricant on spindle where bearing will be located (Gleitmo 805 grease is recommended, Prevost #685274).

FIGURE 32: APPLY GLEITMO 805 GREASE

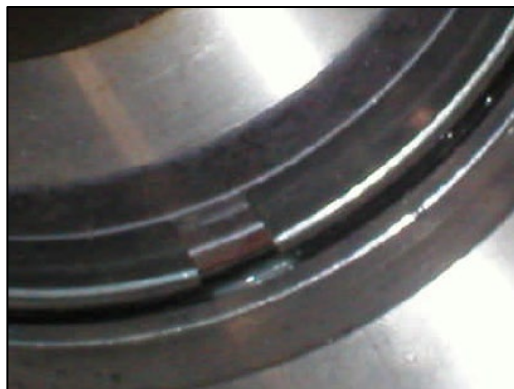
*If the inner rings are not properly guided (i.e. not in line to spindle) there may occur a seizing between inner ring and spindle before the assembly be completed. By pushing abruptly the hub unit back, there is a risk of separation of inner rings. The clip can be dislodged as per the two pictures below.*

*Always use an insertion tool*

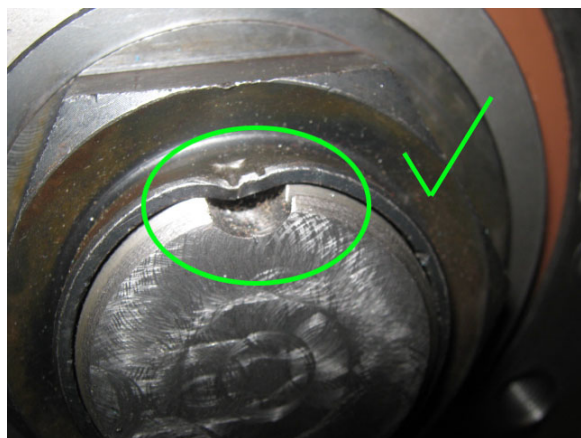
- Stake the hub nut by deforming with a *round nosed chisel*.

FIGURE 36: CORRECT - PREVENTS THE NUT FROM GETTING LOOSE

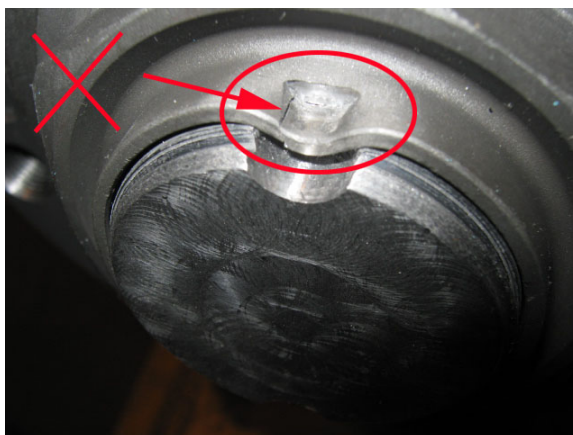
FIGURE 39: BROKEN OR TORN LIP – REJECTED
