Special Bulletin

SP22-305B

TAG AXLE HUB NUT APPROPRIATE STAKING

Prevost vehicles

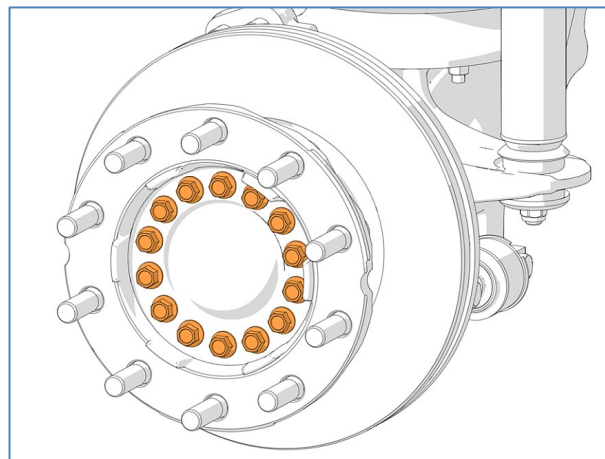
Figure 4

3. Loosen but do not remove the hub flange bolts.

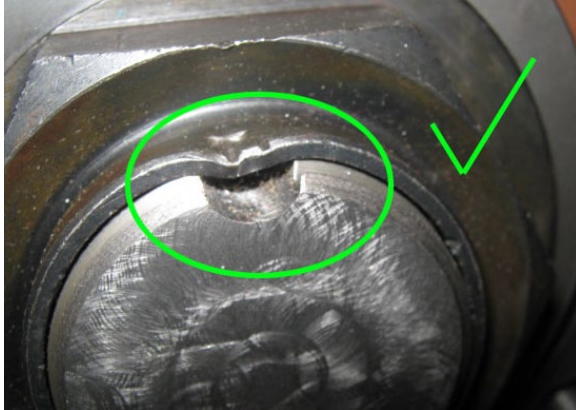
1. Inspect the hub nut staking quality. Refer to figures below for acceptance criteria.

FIGURE 8: **CORRECT** - PREVENTS THE NUT FROM GETTING LOOSE

- If staking is **CORRECT**, proceed to **1.3 HUB NUT STAKING CORRECT** below to complete this bulletin.

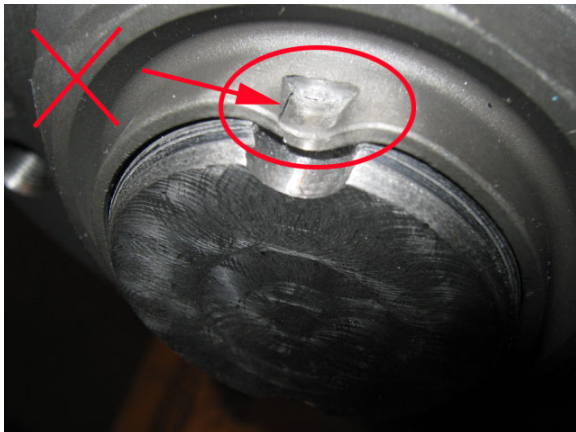
FIGURE 10: BROKEN OR TORN LIP – **REJECTED**

- If staking is **REJECTED**, inform Prevest CSR team (Customer Support Representative). CSR must request relevant notification to be opened by TechPubs. The corrective measures are found on a different Special Bulletin.

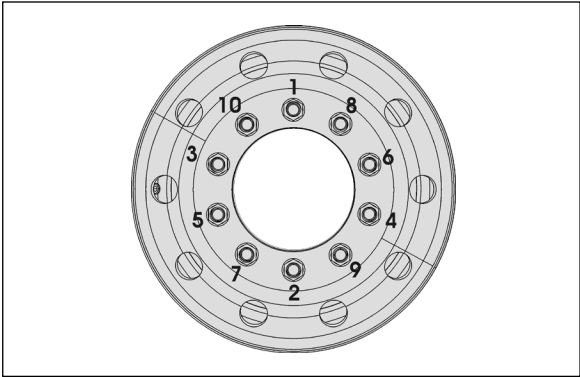
8. Tighten stud nuts progressively as shown in FIGURE 17.

The final tightening should be done with a truck lug nut torque wrench. Tighten stud nuts.

TORQUE: 450-500 lb-ft (610-678 Nm)

FIGURE 17: TIGHTENING SEQUENCE
