Outside Door Handle Cracks/Breaks

Vehicles Affected

Model	Model Year	Model Type	VIN Range	Vehicle-Specific Equipment
Cayenne	2019-2021	9YA/ 9YB	N/A	M Number 4F2, 4F6 Keyless Entry

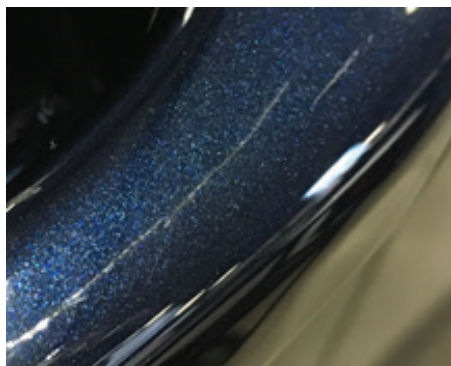
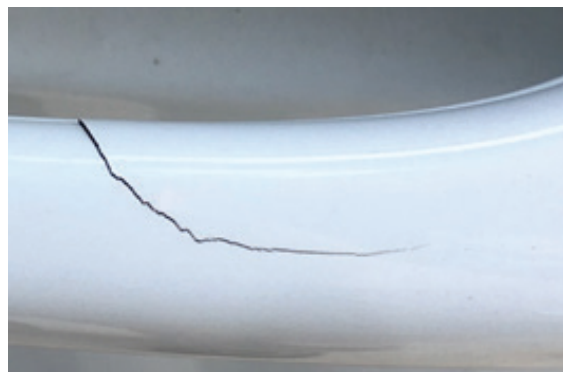
The outside door handle may crack and break. It initially looks like the paint is cracking, but will grow to larger size cracks.

A material incompatibility in the handle itself has been found to cause this issue.

The door handle should only be replaced, if the crack has become more than a hairline crack like the photo on the right.

9Y0.837.205.E G2X

9Y0.837.206.E G2X
