Outside Door Handle Cracks/Breaks

Vehicles Affected

Model	Model Year	Model Type	VIN Range	Vehicle-Specific Equipment
Cayenne	2019-2021	9YA/ 9YB	N/A	M Number 4F2, 4F6 Keyless Entry

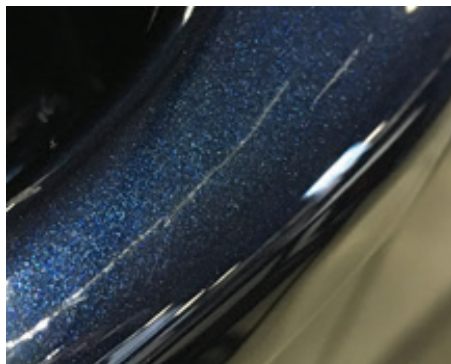
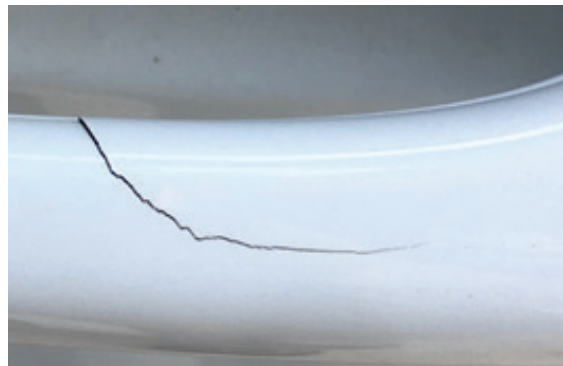
The outside door handle may crack and break. It initially looks like the paint is cracking, but will grow to larger size cracks.

A material incompatibility in the handle itself has been found to cause this issue.

Replace the door handle with the applicable part numbers listed below:

9Y0.837.205.E	G2X
9Y0.837.206.E	G2X
