Service Bulletin

Bulletin No.: 18-NA-361

Subject: Diagnostic Tip for Diesel Fuel System Contamination, Malfunction Indicator Lamp (MIL) Illuminated - DTC P026D, P2A00, P0171, P0172 and/or P0300 Set

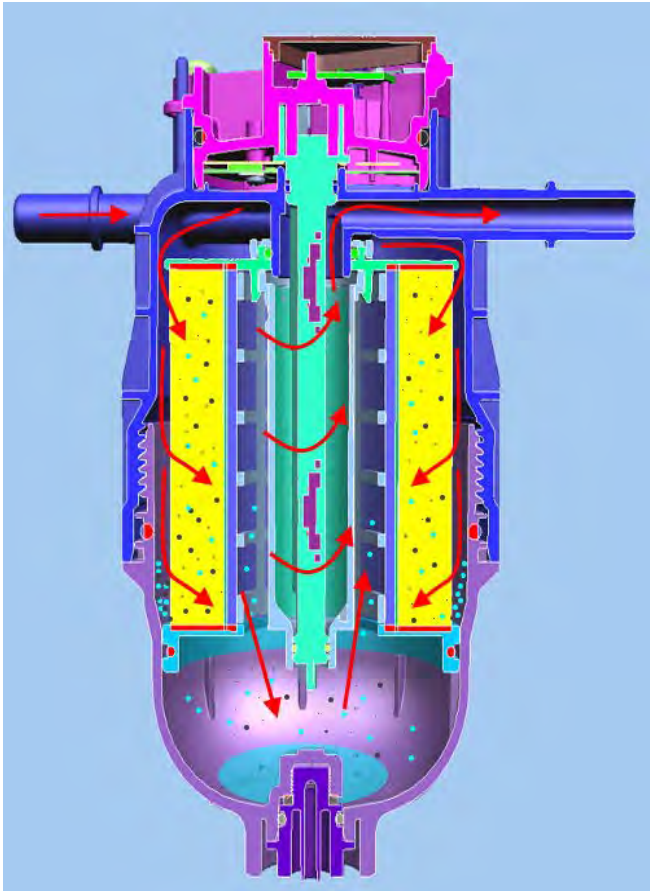
5417311

Water or other like contaminants in the fuel will create driveability concerns and loss of engine power. If water and/or debris is present in the fuel system, the fuel cannot cool and lubricate the components properly, causing overheating, rust and corrosion. This can result in component failure. Water and debris can enter the fuel system in several ways, either through a contaminated refueling source, plugged venting or through long term condensation in the vehicle fuel tanks.

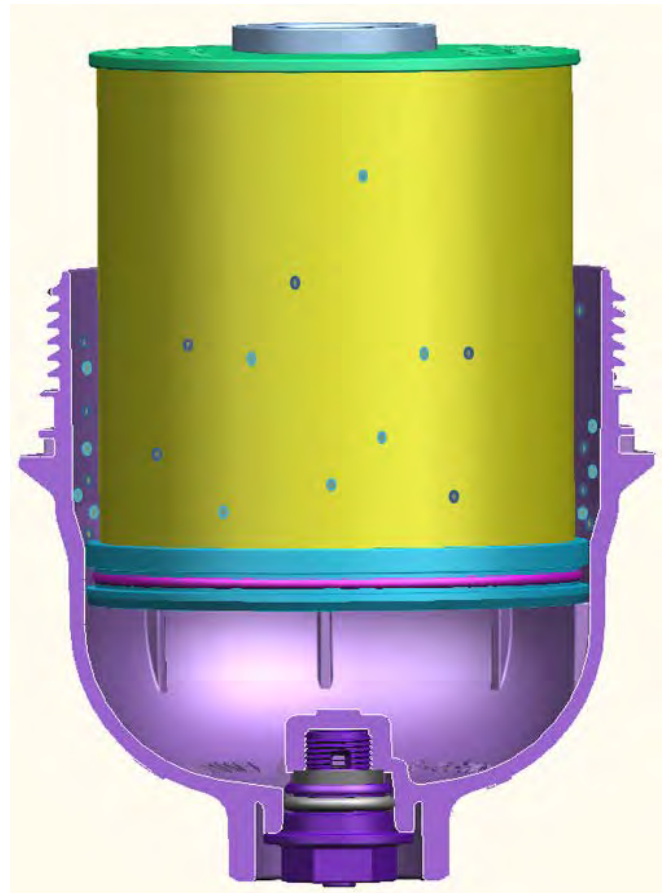
5417281

1. Remove the fuel/water filter from the housing using care not to separate the filter from the fuel/water separator reservoir.

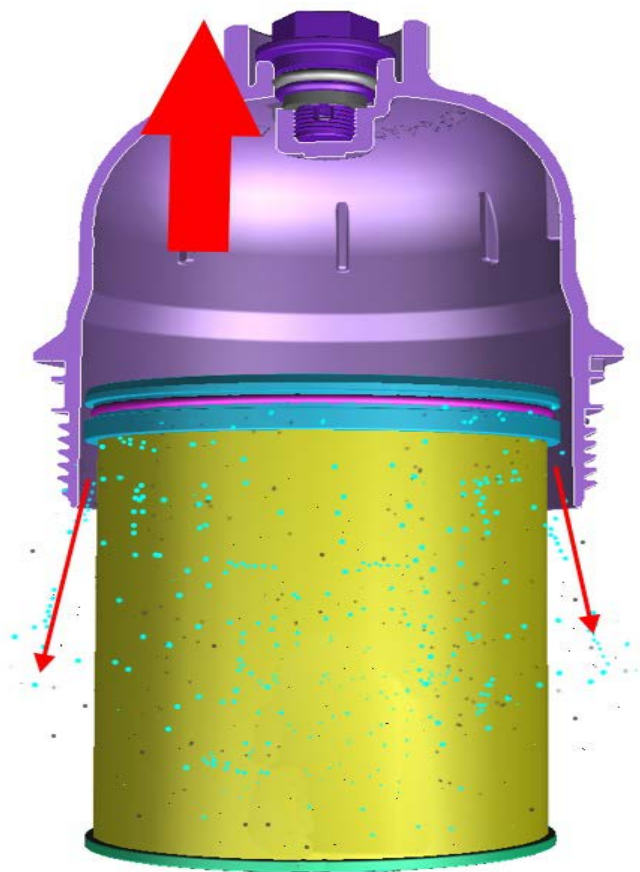
5417298

2. Using care, separate the filter from the fuel/water separator reservoir by placing the filter downwards in a clean/dry drain pan.

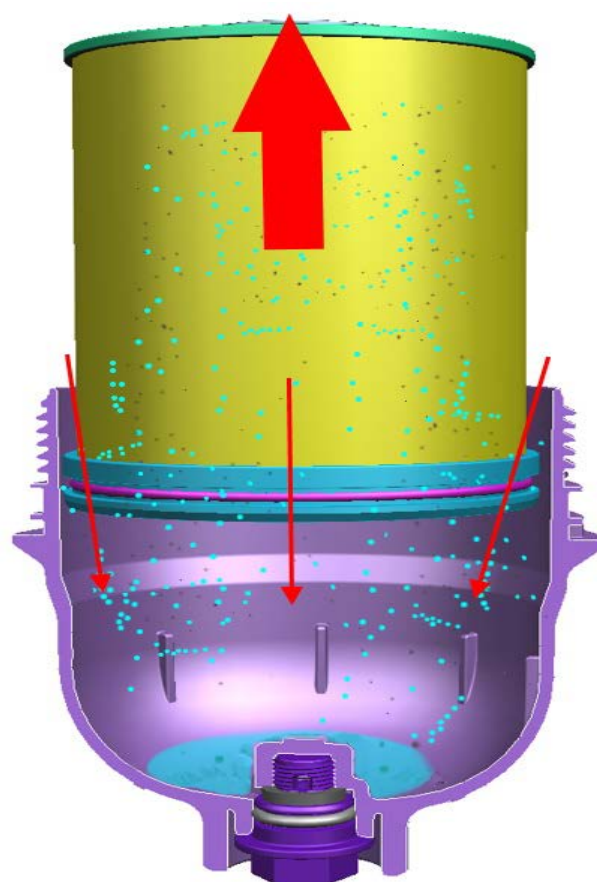
5417283

- If the filter is facing upwards, debris left on the sides of the filter may escape past the O-ring seal during removal and settle in the fuel/water separator reservoir.

- Water and/or debris left in the fuel/water separator reservoir will flow past the filter, directly into the fuel system when re-started.
 - Debris that is allowed past the filter and into the fuel system can cause fuel injection issues that may set DTCs P2A00, P026D, P0300, P0172. Replacement of fuel injectors without a complete cleaning of the fuel system will only be a temporary fix until the debris gets into the new injectors.

3. Inspect the fuel/water separator reservoir and filter for heavy debris.
 - If heavy debris is found in the filter, clean the fuel/water separator reservoir and continue to the Fuel System Flushing Procedure below.

- If no signs of debris are found, clean the fuel/water separator reservoir, install a new filter and refer to SI for further diagnostics.

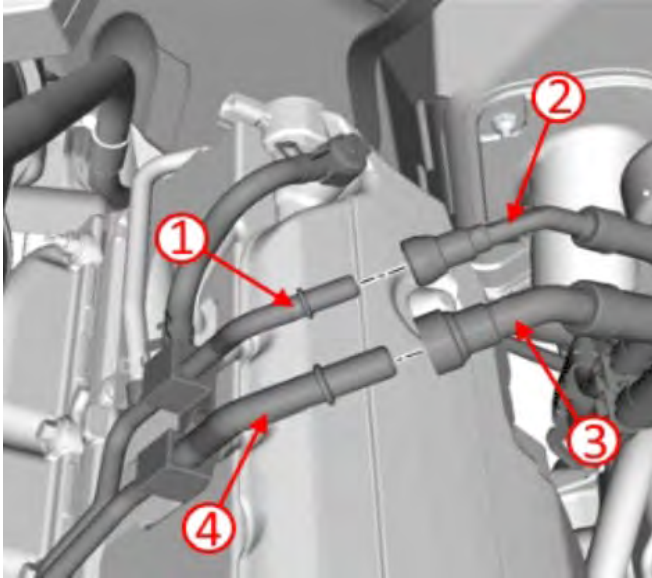
5167517

2. Disconnect the chassis side fuel feed hose (3) from the engine side fuel feed pipe (4).
3. Place the end of the chassis side fuel feed hose into a clean container and run the fuel pump to clean any debris left in the fuel lines, approximately 2-3 gallons (7.6-11.4L).
4. Clean the fuel/water separator reservoir.
5. Install a new fuel filter.
6. Disconnect the chassis side fuel return hose (2) from the engine side return pipe (1).

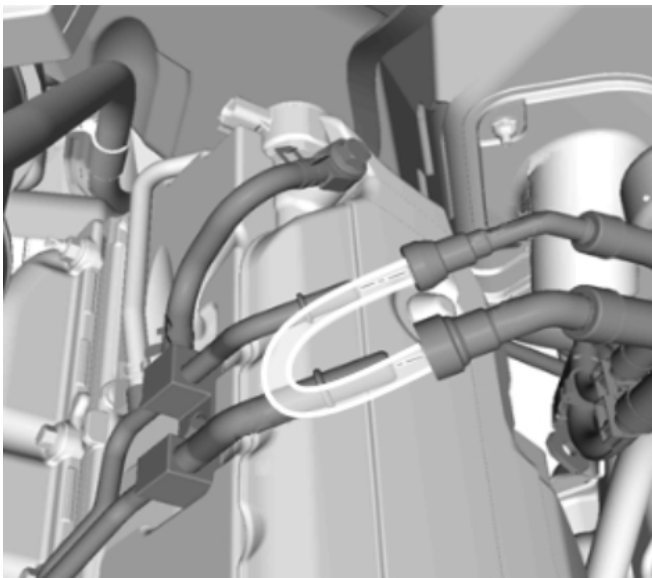
5168476

Note: The white "Tubing" shown in the graphics below depict the route of the clear line, not the length.

7. Install a clear line between the fuel supply hose and the fuel return hose.
8. Run the fuel pump until the fuel runs clear in the line.

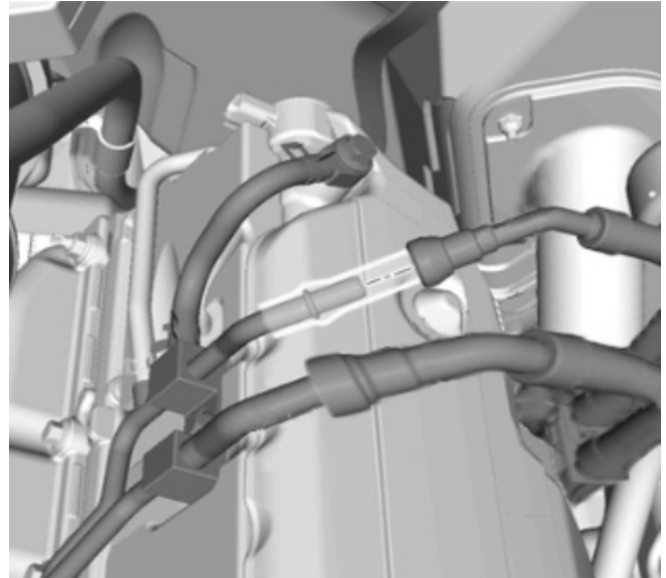
5168447

9. Connect the fuel supply hose to the engine supply pipe.
10. Install a clear line in series at the fuel return hose to the engine return pipe.
11. Run the fuel pump until the fuel runs clear in the line.

Reconnect all fuel lines and retest for any codes or symptoms in the vehicle.
