Airstream Service Bulletin

Bulletin Number: 192

Product Line: 2021 & 2022 Basecamp 20

Subject: 2021 & 2022 Basecamp Battery Box Lid Gasket

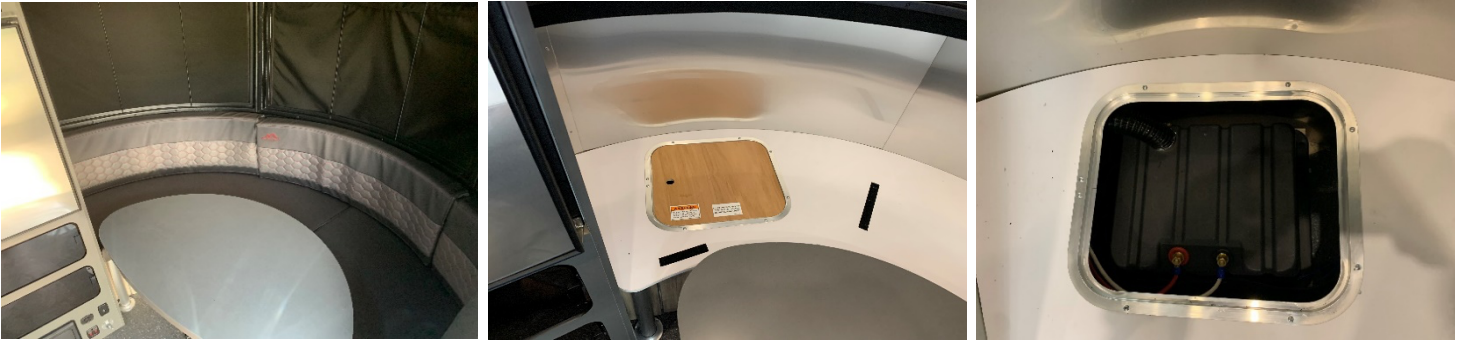
On the Basecamp 20, the battery box is located under the dinette seat, next to the refrigerator cabinet.
