**NUMBER:** 02-001-22

Air Suspension Inoperable

This bulletin involves inspecting the vehicle for multiple air suspension failures.

2022 (WS) Grand Wagoneer/Wagoneer

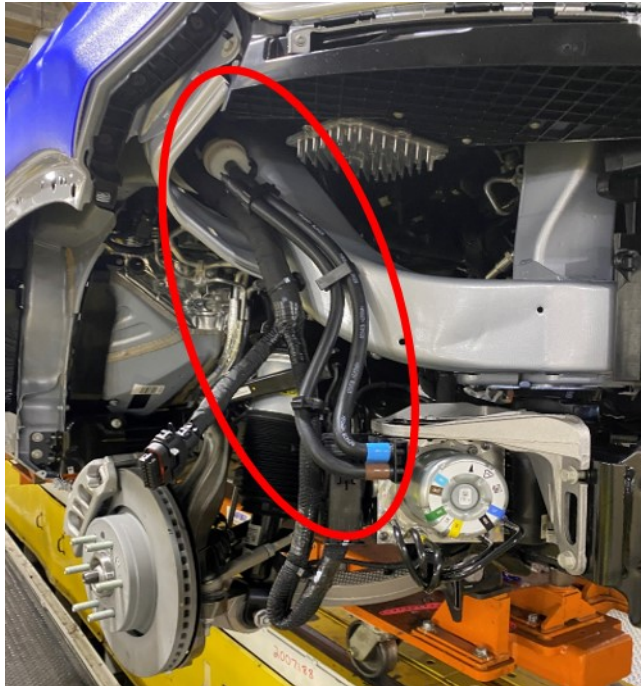
**Fig. 1**  
**Vent Hose and (ASCM) Connection**

1. Electrical connection for the Air Suspension Control Module is not fully seated.
2. Vent hose inlet/outlet for air compressor for being properly connected (Fig. 1) .

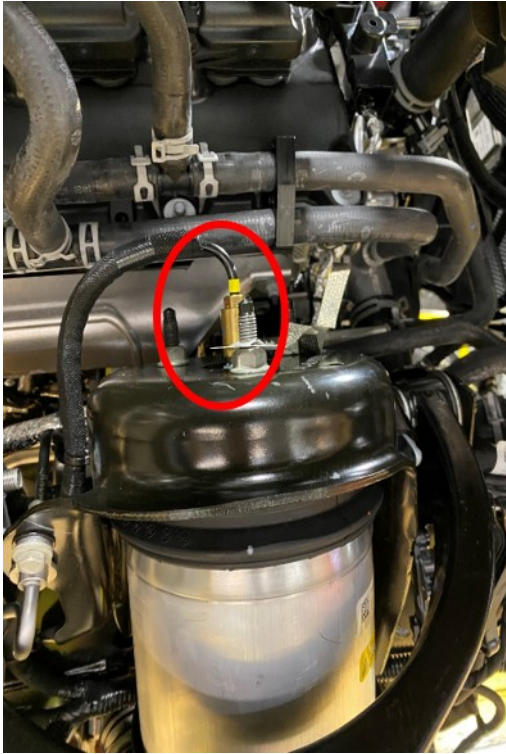
Fig. 2  
Air Lines Not Fully Seated

3. Air lines not fully seated either front or rear suspension (Fig. 2) .

8. Inspect and if necessary reconnect the front air suspension electrical connectors at the front ride height sensors (both sides) (Fig. 3) .
9. Inspect and if necessary properly reconnect the front air suspension lines to the suspension air bag (both sides) (Fig. 2) .

**NOTE: Air line should be inserted up to the tape, allowable up to 1 mm clearance.**

10. Inspect and if necessary reconnect the front air suspension linkage rods at the front ride height sensors (both sides).
11. Install the front inner wheel liners. Refer to the detailed service procedures available in DealerCONNECT> Service Library under: 23 - Body / Exterior / Shield / Installation > Front Wheelhouse Splash Shield.
12. Remove the rear inner wheel liners. Refer to the detailed service procedures available in DealerCONNECT> Service Library under: 23 - Body / Exterior / Shield / Removal > Rear Wheelhouse Splash Shield.
13. Inspect and if necessary reconnect the rear air suspension electrical connectors at the front ride height sensors (both sides) (Fig. 4) .
14. Inspect and if necessary properly reconnect the rear air suspension lines to the suspension air bag (both sides) (Fig. 2) .

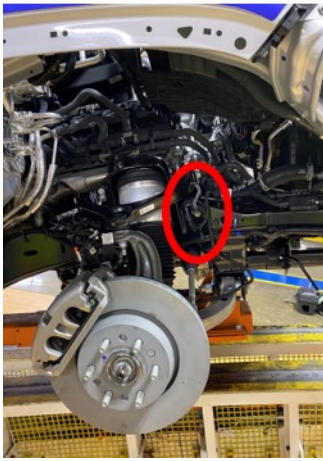
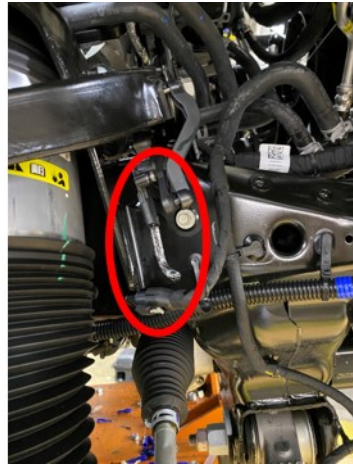
**Fig. 3**  
**Front Electrical Connector**

4. Front or rear ride height sensor not connected to the control arm (Fig. 3) or (Fig. 4) .

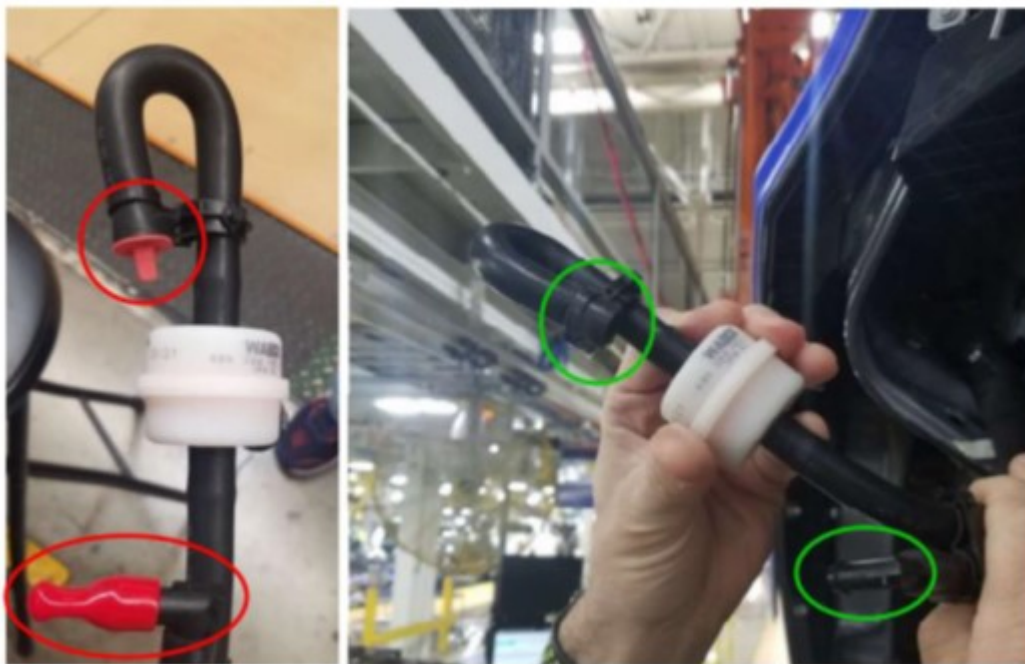
Fig. 5  
Shipping Caps Left On Hose

5. Shipping caps not removed from vent hose (Fig. 5) .

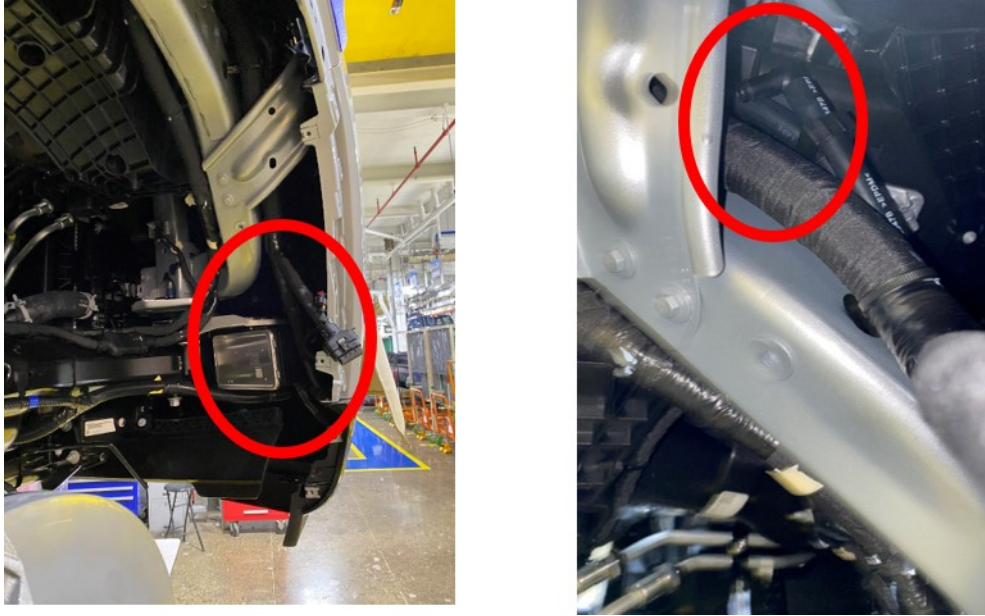
Fig. 6

### ASCM and Vent Hose Connections

4. Verify the front air springs are partially deflated by going into “Component Air Mass > Pressure > Ride Height Readings” ensure pressure readings are lower than previously recorded values.
5. Raise and support the vehicle. Refer to the detailed service procedures available in DealerCONNECT> Service Library under: 04 - Vehicle Quick Reference / Hoisting / Standard Procedure.
6. Remove the front inner wheel liners. Refer to the detailed service procedures available in DealerCONNECT> Service Library under: 23 - Body / Exterior / Shield / Removal > Front Wheelhouse Splash Shield.
7. Inspect and if necessary remove the red caps (Fig. 5) from the hose and reconnect the front vent hose and electrical connector to the Air Suspension Control Module (ASCM) (Fig. 6) .
