Rattle Noise When the Sliding Roof Is Tilted Open

Service Category Vehicle Exterior

Section Sliding Roof/Convertible **Market** USA

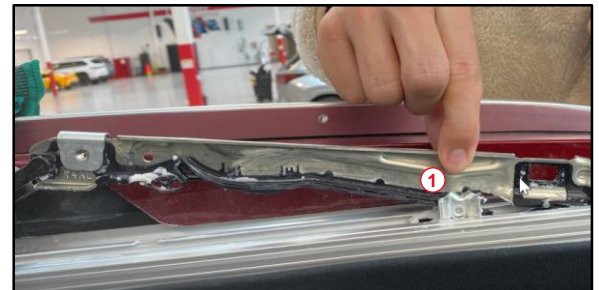
Figure 1.

3. Inspect the sliding roof drive cable sub-assembly for looseness and a rattle noise with a wiggle check as shown. Can rattle noise be confirmed at the mating part of the mechanical bracket and rear shoe?

1	Inspect for Looseness
----------	------------------------------

- **YES** — Replace the sliding roof drive cable sub-assembly according to the applicable model and model year Repair Manual.
- **NO** — Continue to step 4.

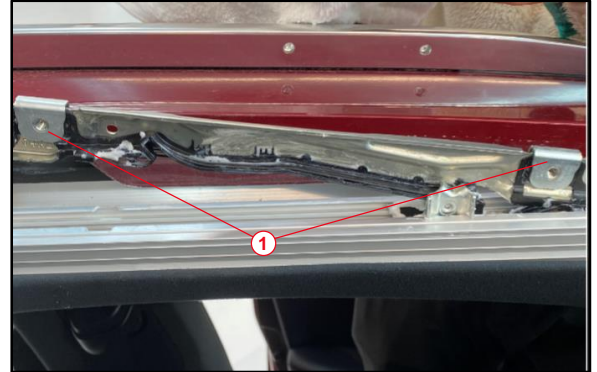
Figure 2.

4. Remove the adjustment nuts.
 - A. Remove the nut covers by gently inserting the removal tool and twisting.

1	Nut Cover
----------	------------------

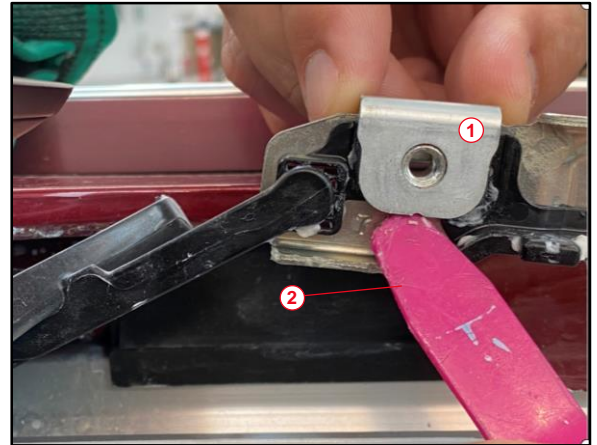
Figure 3.

1	Nut Cover
2	Removal Tool

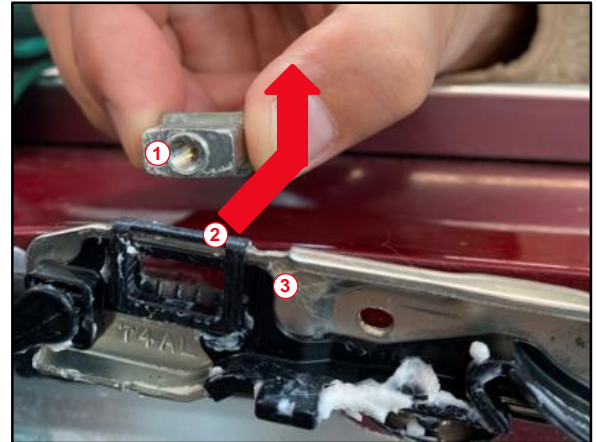
Figure 4.

- B. Remove the adjustment nuts by pulling them out of the mechanical bracket.

1	Adjustment Nut
2	Pull Out in This Direction
3	Mechanical Bracket

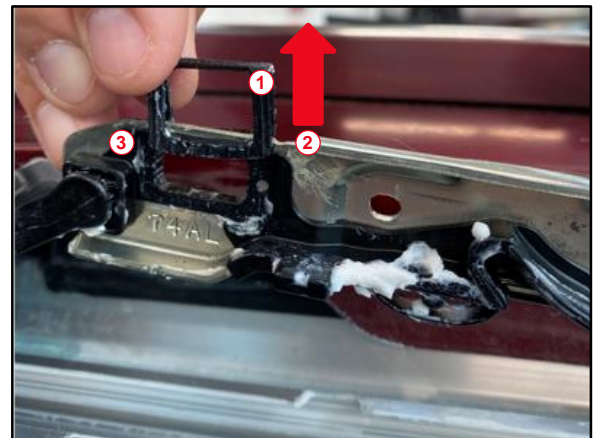
Figure 5.

- 5. Remove the rubber pads by pulling them up from the mechanical bracket.

1	Rubber Pad
2	Remove in This Direction
3	Mechanical Bracket

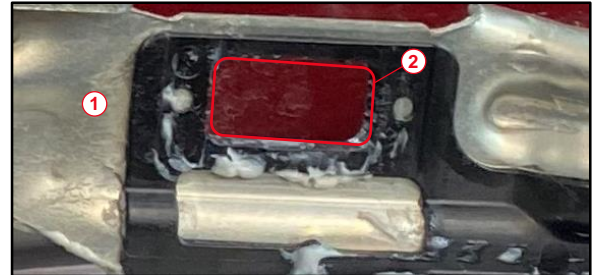
Figure 6.

6. Clean and apply NEW grease to the contact areas of the mechanical bracket.

1	Mechanical Bracket
2	Apply Grease

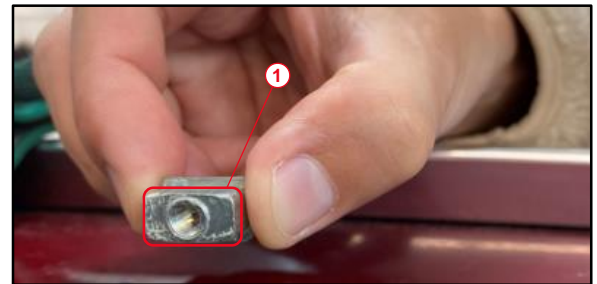
Figure 7.

7. Apply grease to the outer circumference area of the NEW adjustment nut.

1	Apply Grease
---	--------------

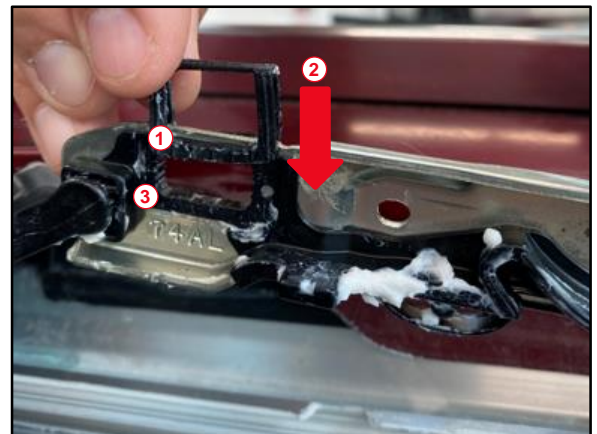
Figure 8.

8. Reinstall the rubber pad to the mechanical bracket.

1	Rubber Pad
2	Install in This Direction
3	Mechanical Bracket

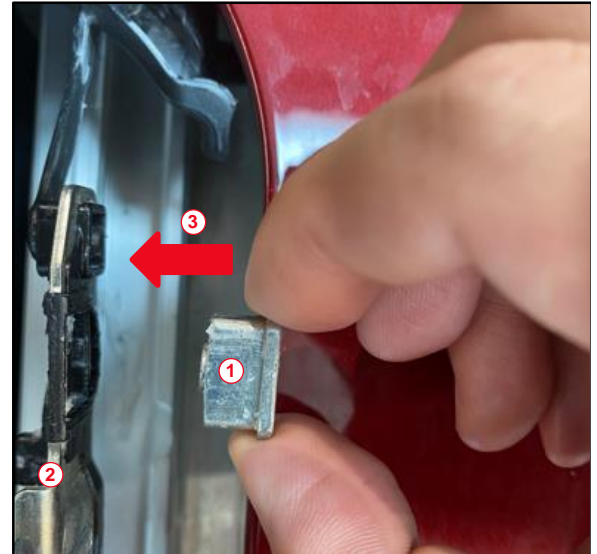
Figure 9.

9. Reinstall the adjustment nut to the mechanical bracket.

Insert the adjustment nut from outside the vehicle toward the interior.

1	Adjustment Nut
2	Mechanical Bracket
3	Install in This Direction

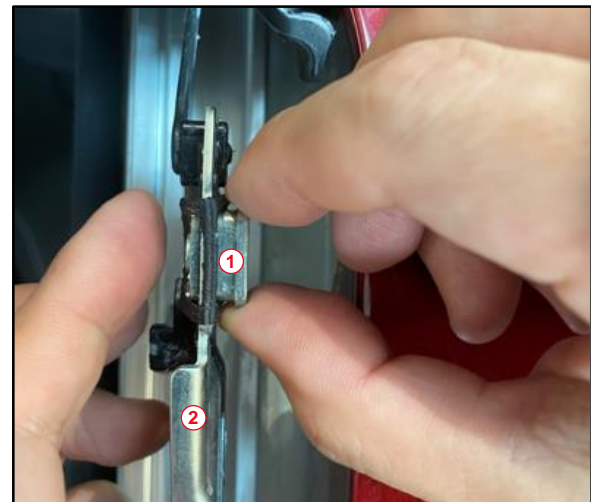
Figure 10.

1	Adjustment Nut
2	Mechanical Bracket

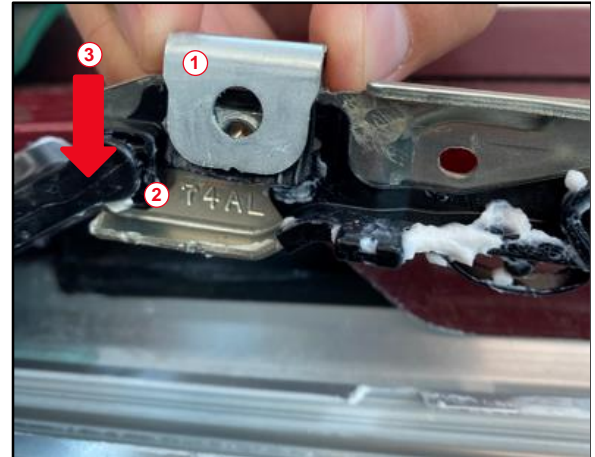
Figure 11.

10. Push down the nut cover from the top of the mechanical bracket and insert it firmly.

When installing the nut cover, do NOT interfere with the rubber pad.

1	Nut Cover
2	Mechanical Bracket
3	Install in This Direction
