Technical product information

Topic	New Continental GT and GTC - Window drop glass concerns
Market area	Russische Föderation (5RU),Australia E04 Bentley rest Asia and Australia (6E04),China 796 VW Import Comp. Ltd (Vico), Beijing (6796),Germany E02 Bentley rest Europe (6E02),Japan E03 Bentley Japan (6E03),Korea, (South) E08 Bentley South Korea (6E08),United Arab Emirates E06 Bentley Middle East and Africa (6E06),United Kingdom E01 Bentley UK (6E01),United States E05 Bentley USA and rest America (6E05)
Brand	Bentley
Transaction No.	2067436/4
Level	EH
Status	Approval
Release date

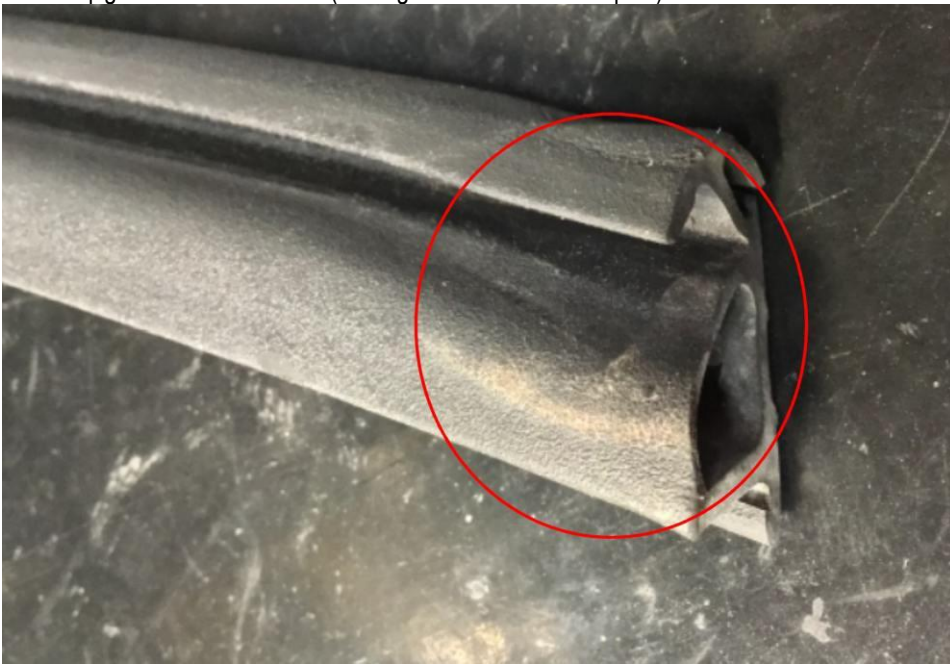
Figure 4

- Damage
- Splits
- Tears
- Misalignment
- Incorrectly fitted/located
- Drop glass seal deformation (see Figures 4 and 5 as examples)

NOTE: Any issues found with the window seals must be rectified before conducting the remaining steps
