**SIB 64 09 21**

AC TEMPERATURE FLUCTUATION OR LOSS OF COOLING PHEV

This Service Information Bulletin (Revision 4) replaces SI B64 09 21 **dated June 2022**.

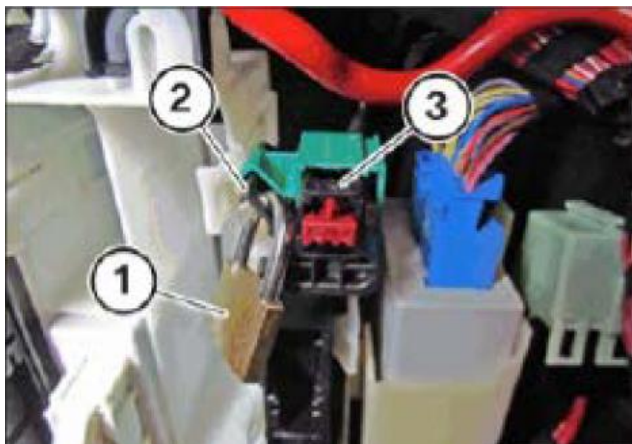
Caution: High-voltage system.

When working near high-voltage components (labelled accordingly by signs and/or orange coating), disconnect the high-voltage system and protect it from damage.

Use a padlock on the high voltage safety connector / interlock loop disconnect to prevent the high voltage system from being turned on during repairs.

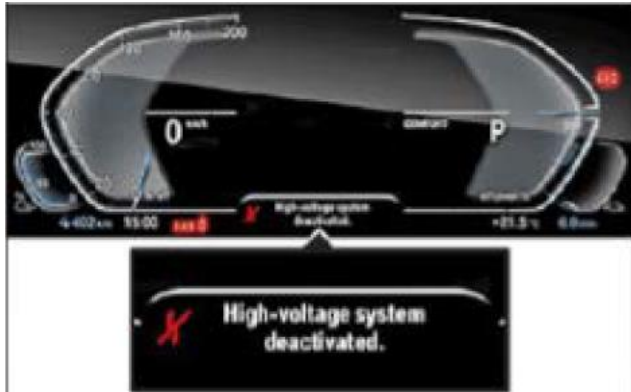
Ensure that the check control message “High voltage system deactivated” appears in the instrument cluster (vehicle ignition in PAD mode) before you start work.

If the instrument cluster does not clearly show that the electrical system has been deactivated, do not start any work. Danger of death.

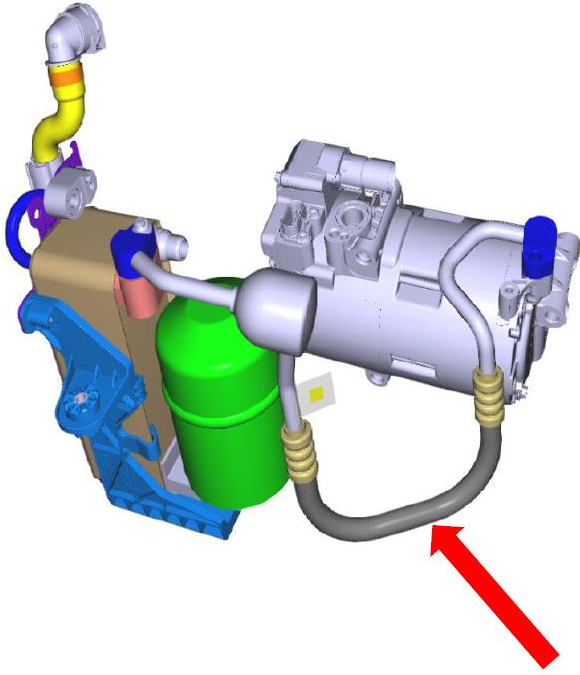
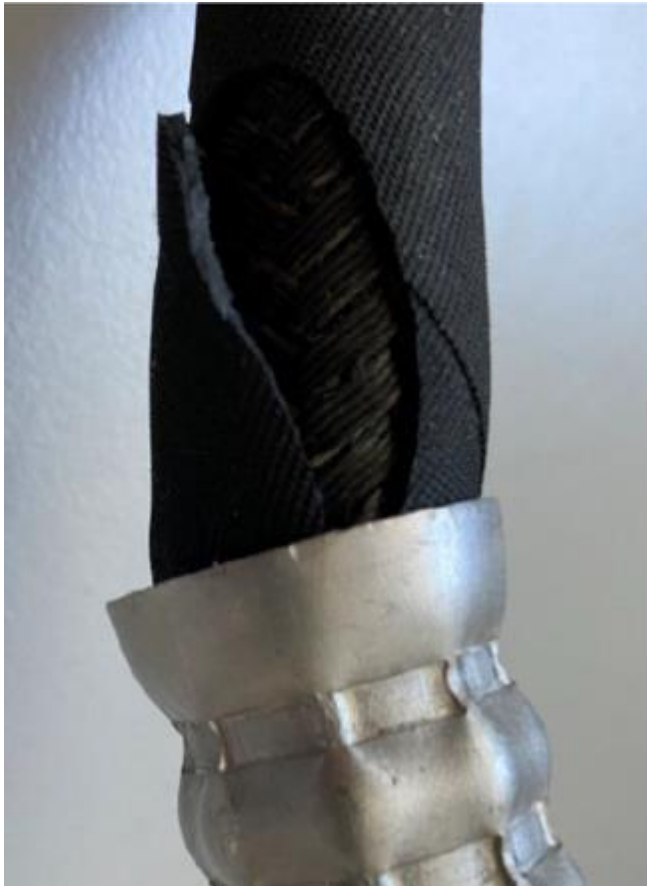
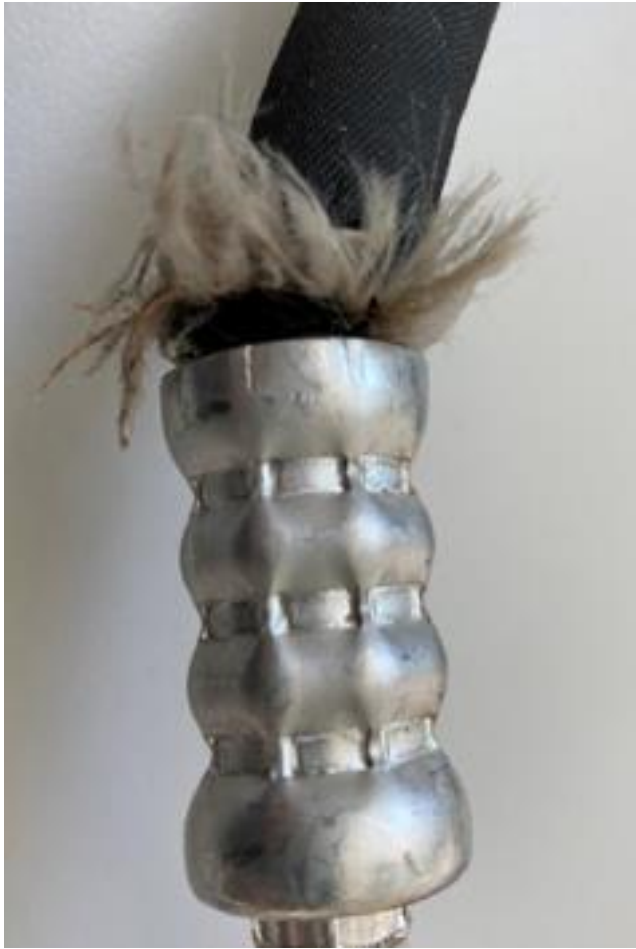
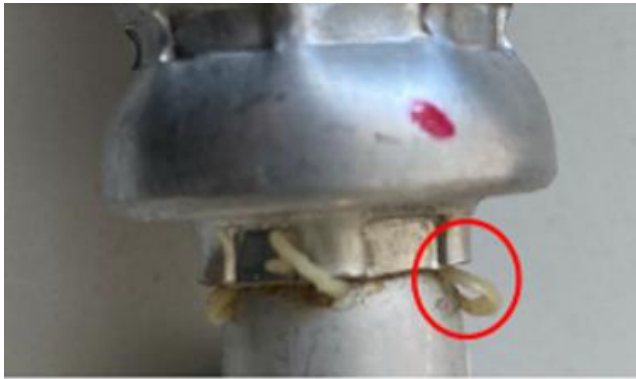
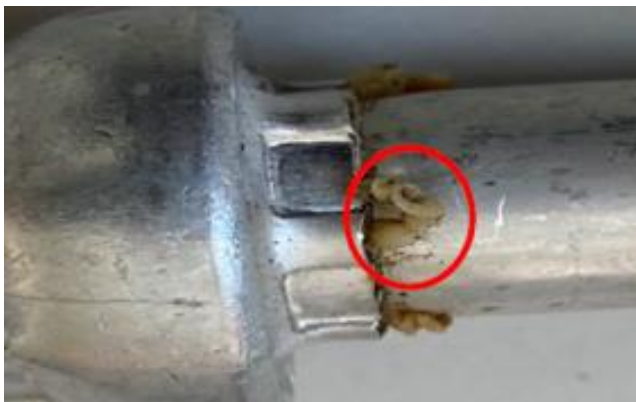
4. Check the high-pressure side hose between the AC compressor (EKMV) and the condenser (WCC) for damage or signs of leakage as seen in these pictures.

5. Important: If the leaking components include the eKMV and/or the pressure line between compressor and condenser the following components must be replaced together:
- EKK

- Condensator with desiccant
 - High Side Pressure line between the compressor and the condenser
6. If the tests under step 2 are not passed and there is no leakage, the following components are to be replaced together:
- EKK
 - Condensator with desiccant
 - High Side Pressure line between the compressor and the condenser
7. Proceed with
- step 8 **Procedure if flushing equipment is available for the refrigerant circuit**
- or
- step 30 **Procedure if NO flushing equipment is available for the refrigerant circuit**

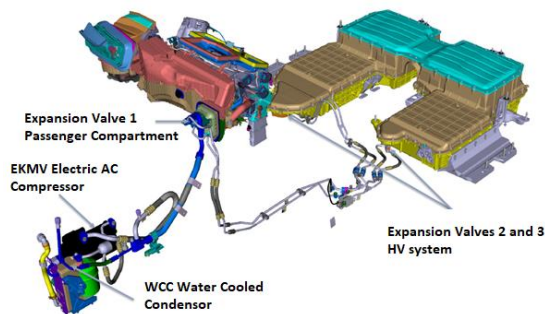
8. Procedure if flushing equipment is available for the refrigerant circuit

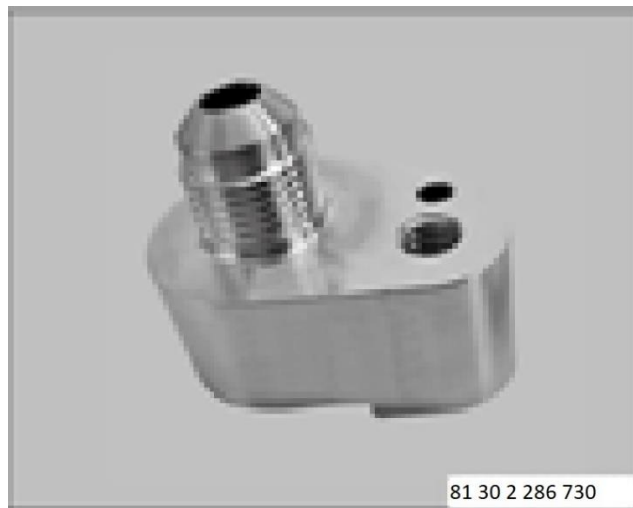
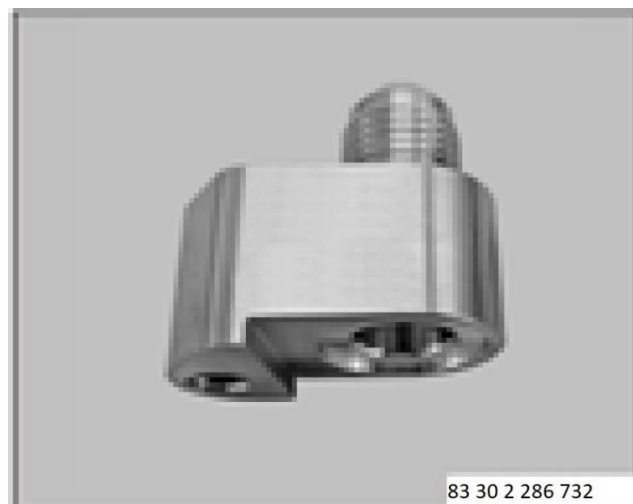
9. Remove and then bypass the air conditioning compressor with two flushing adapters.

- Mount the special tool **83 30 2 286 732** onto the high-pressure line (2) of the air conditioning compressor and secure with the M8 screw (1) that is on the vehicle
- Mount the special tool **83 30 2 286 730** onto the low-pressure line (4) of the air conditioning compressor and secure with the M8 screw (5) that is on the vehicle
- **M8 Bolts Torque 19 Nm.** Two persons, one holding the adapter and the other tightening to torque simplifies the process
- These adapters are connected via a jumper hose such as **83 30 2 285 575**

These two special tools are part of the BMW i basic adapter set **83 30 2 413 236**.

When servicing a **G05 hybrid vehicle a second special tool 83 30 2 286 732 is also required** so you will need two 83 30 2 413 236 kits. Refer to Repair Instructions

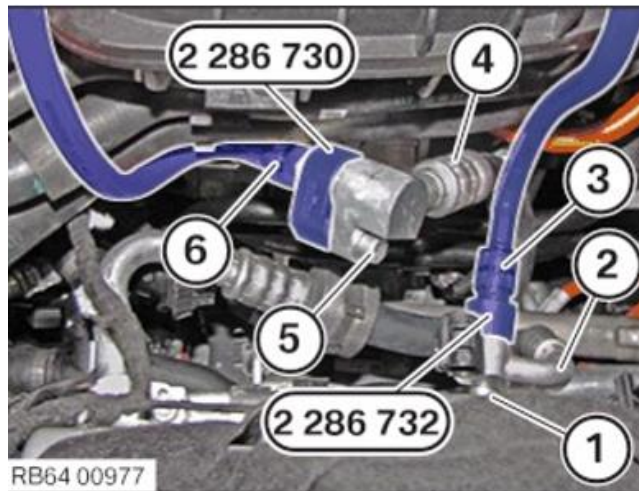
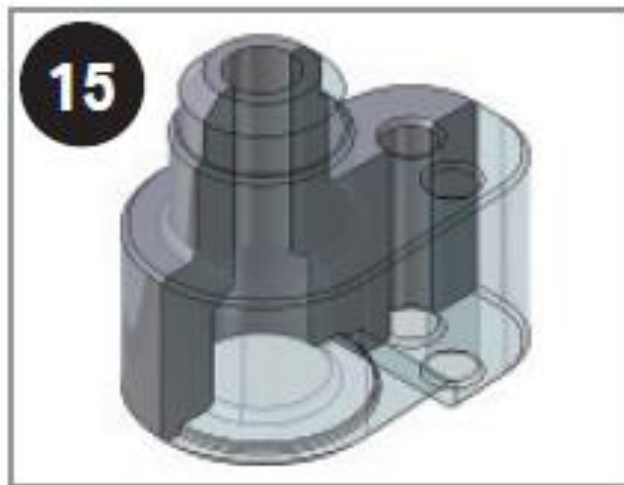
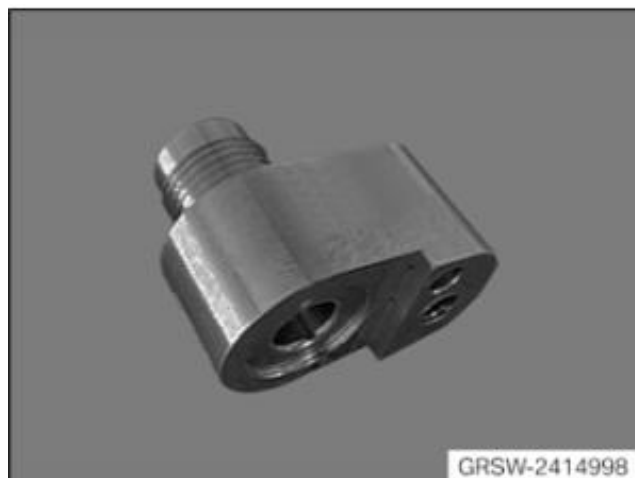
83 30 2 412 932

10. The condenser must be bypassed and replaced since it is a non-flushable component.

- Disconnect condenser hoses and bypass with flushing adapter **83 30 2 412 932** and **83 30 2 414 998**
- **M6 Bolts Torque 13 Nm.**
- Connect the two adapters with connecting hose **83 30 2 285 575**

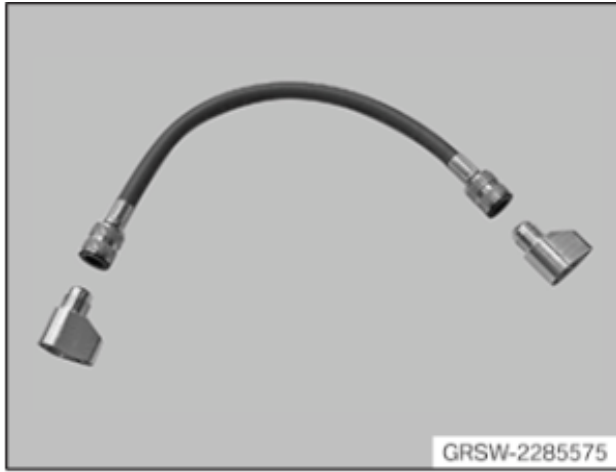
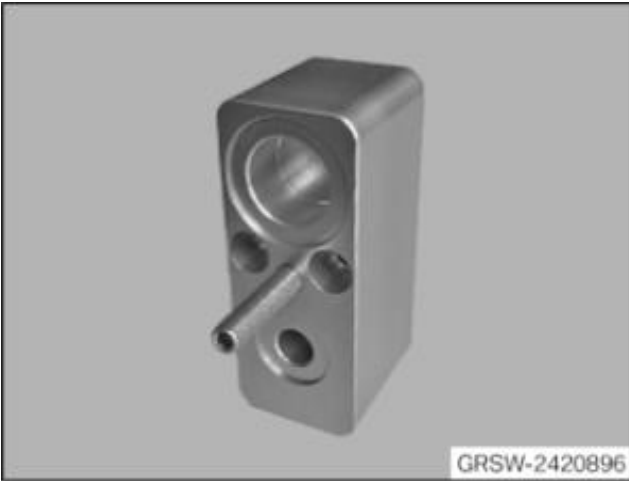
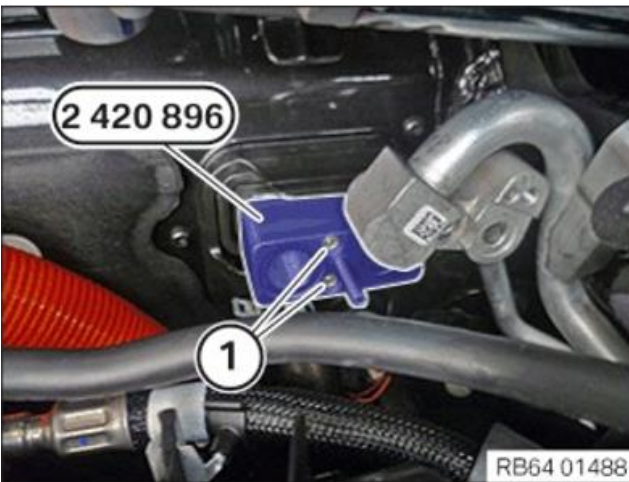
11. Remove and then block off **EXPANSION VALVE #1** at the passenger compartment, with adapter **83 30 2 420 896**. This adapter is solid and blocks off flushing of the evaporator for the first flush cycle.

- Fasten with the M5 screws (1) of the expansion valve that has been previously removed
- **M5 Bolts Torque 5.5 Nm**

When mounting the refrigerant lines (3) onto the block off plate 1, secure them with the nut previously removed.

- **M6 nut Torque 13 Nm**

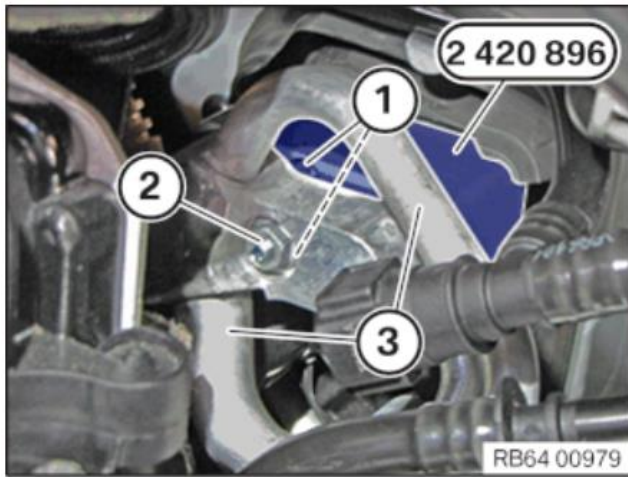
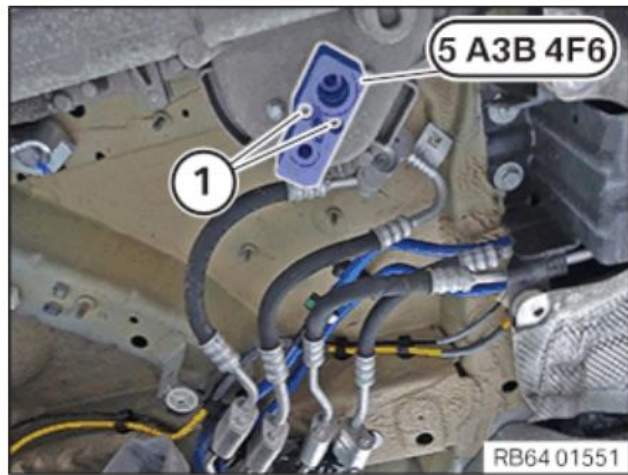
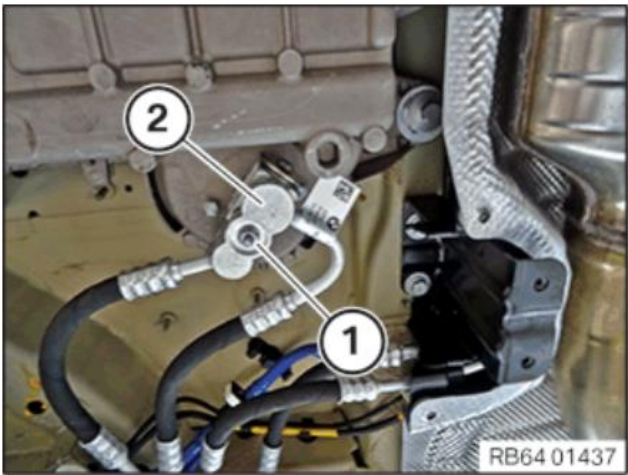
12. Remove and install flushing adapter **83 30 5 A3B 4F6** instead of **EXPANSION VALVE #2** at the high voltage battery.

- Fasten with the M5 screws (1) of the expansion valve that has been previously removed
- **M5 Bolts Torque 5.5 Nm**

When mounting the refrigerant lines (2) onto the adapter secure them with the nut previously removed.

- **M6 nut Torque 13 Nm**

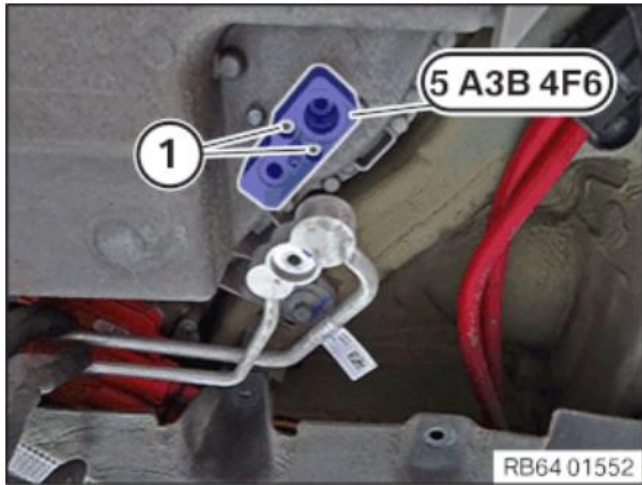
13. Remove and install flushing adapter **83 30 5 A3B 4F6** instead of **EXPANSION VALVE #3** at the high voltage battery.

- Fasten with the M5 screws (1) of the expansion valve that has been previously removed
- **M5 Bolts Torque 5.5 Nm**

When mounting the refrigerant lines (2) onto the adapter secure them with the nut previously removed.

- **M6 nut Torque 13 Nm**

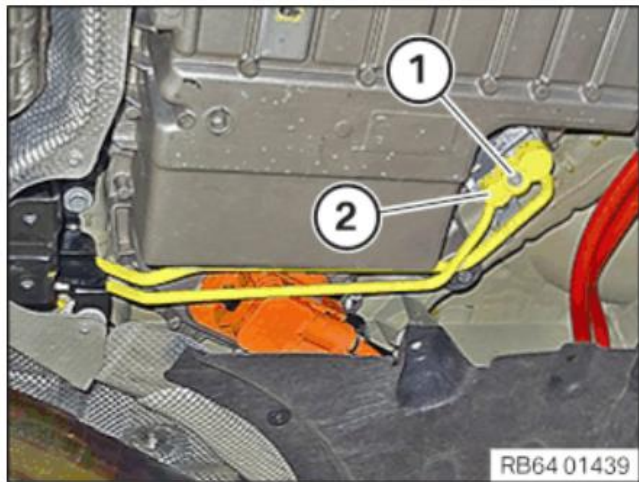
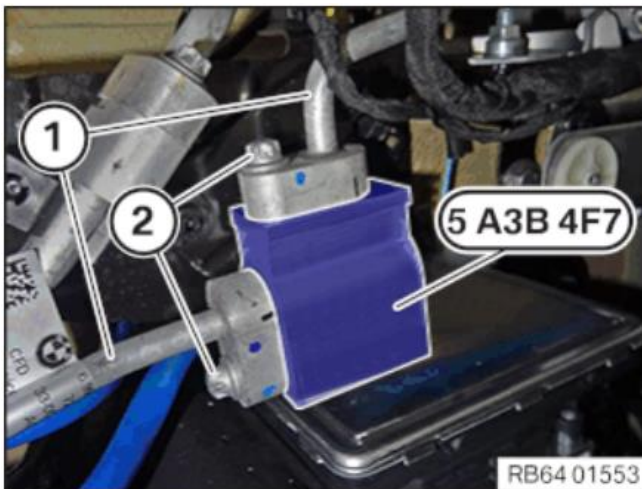
14. Remove and install special tool **83 30 5 A3B 4F7** instead of the **refrigerant shutoff valve**.

When mounting the refrigerant lines onto the special tool, secure them with the bolts previously removed.

- **M6 Bolts Torque 13 Nm**

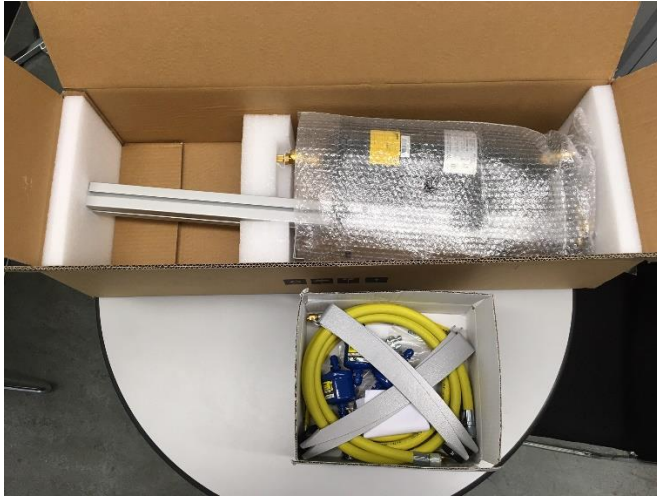
15. The flush machine (Robinair or Mahle manufactured) will come with hoses, filter, and hardware. Pictures are of the Mahle flush kit as received.

The adapters to connect to the AC machine come with the flushing machine.

There are adapters for both R134a and Y1234a.

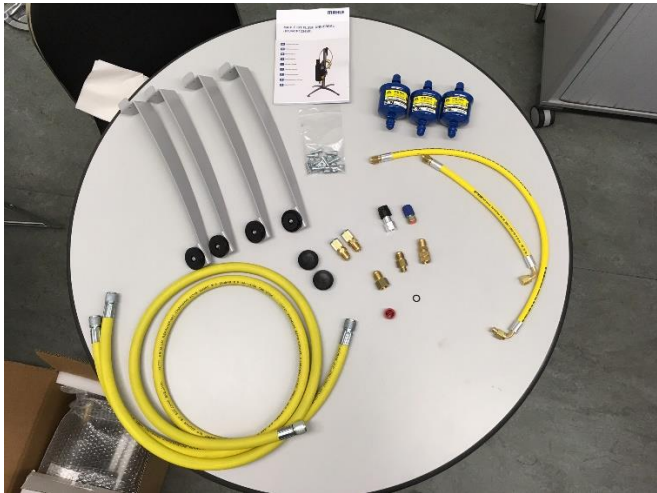
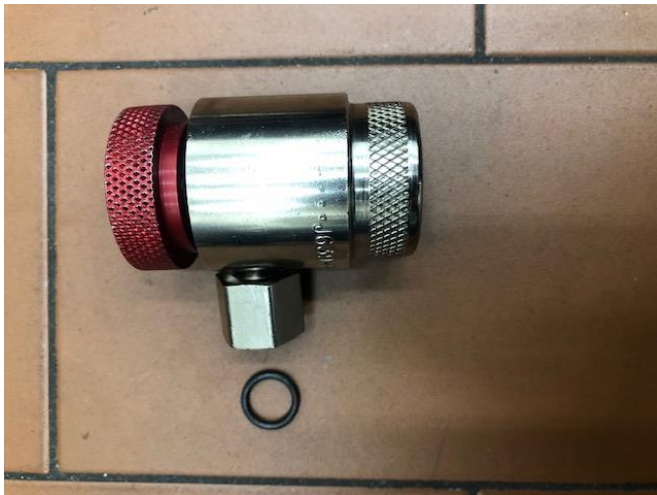
16. Only the R134a adapters fit the quick disconnects of the AC machine.

The **Y1234a** adapter fits the low side quick disconnect of the AC machine. However, **the high side must have the quick disconnect fitting removed (left) to install the brass adapter** for connection.

The O-ring seen in the picture, removed from the high side quick disconnect, must not be installed onto the brass adapter. This additional O-ring will not allow for full compression of the fittings when tightening resulting in a leak from the brass adapter.

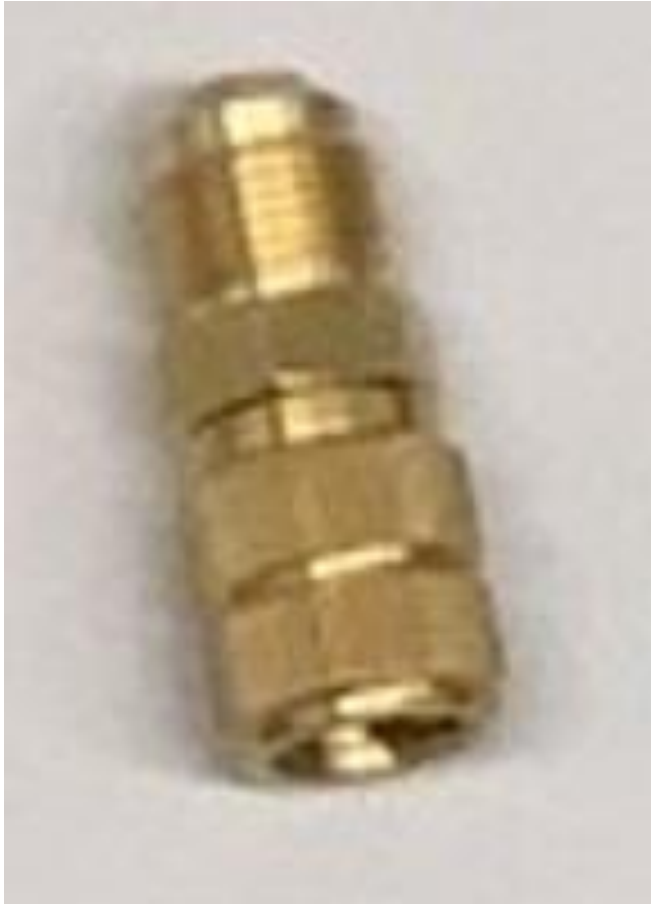
17. High side brass swivel fitting adapter for Y1234a high side connection.

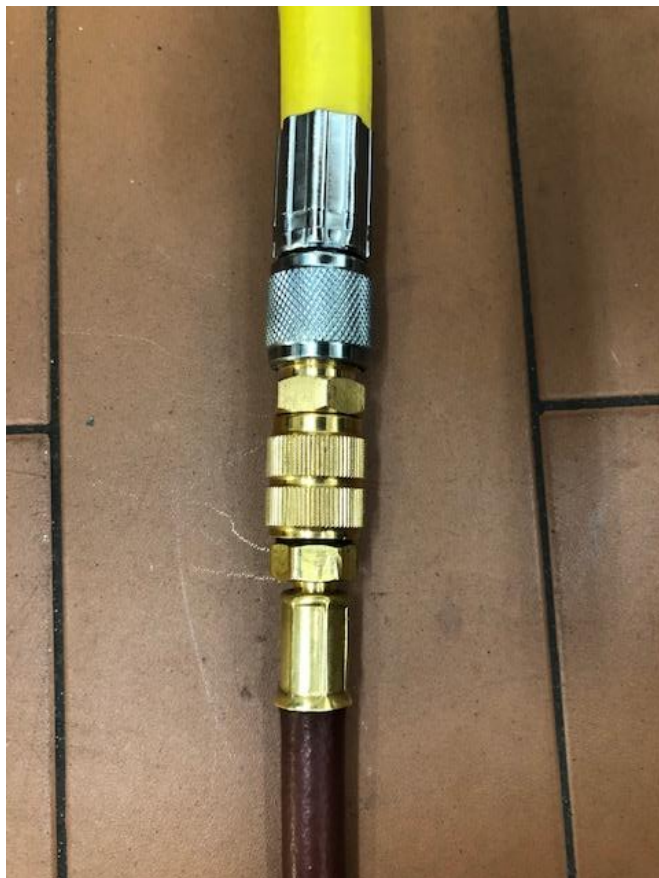
18. **Y1234a high side adapter installed** in place of the quick disconnect

AC Flush circuit yellow hose (top), brass swivel adapter, and AC Flush machine high side red hose (bottom).

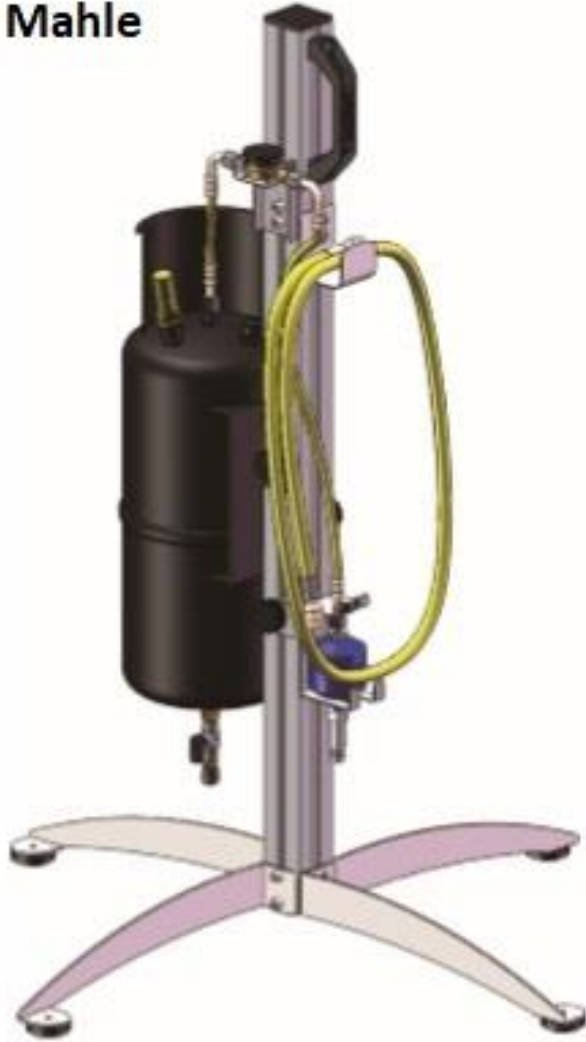
Mahle

19. Connect the air conditioning service device (AC Recycling machine and flushing adapter) to the cable connections. Follow instructions from the flushing adapter instruction manual on proper hose connections to the vehicle.

It is best to leave the yellow hose loose at the flush machine, make your connection to the vehicle, then tighten the hose at the flush machine.

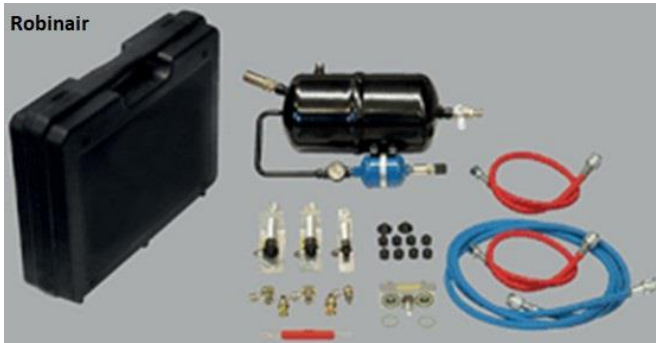
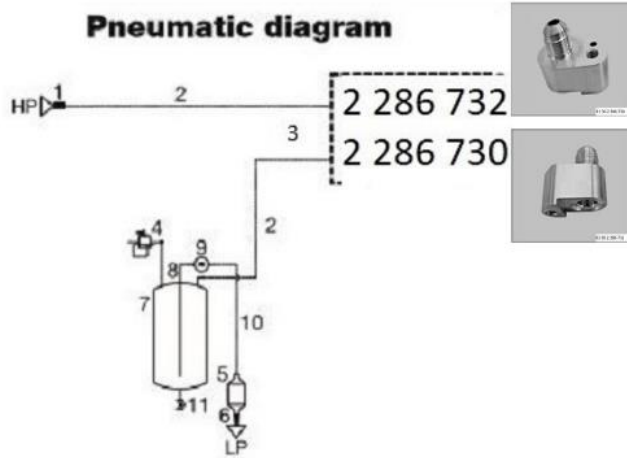
Robinair

20. Once all hoses are connected, mark one, or both hoses, to ensure proper connection of the flushing equipment (i.e. Red high side, Blue low side).

You cannot flush the system backwards due to the orifice sizes on inlet/outlet of the expansion valve bypass.

1	HP outlet adapter fitting
2	High-flow connection hoses
3	Item to be flushed
4	Safety valve 18 bar / 261 psi
5	Filter 15 µm
6	LP fitting
7	6 liter fluid vessel
8	Connection hose between vessel and sight glass
9	Fluid indicator sight glass with cap
10	Connection hose between sight glass and filter
11	Auxiliary valve with cap

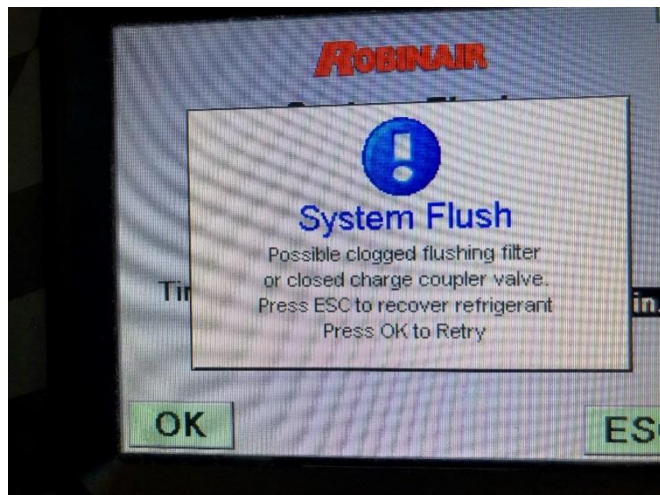
21. The filter on the flushing cannister must be replaced on a regular basis to ensure no contamination entering the AC machine.

- This filter should be replaced after flushing 5 vehicles maximum
- **TIP:** To track filter usage a permanent marker or a paint line can be placed on the filter every flush. After 5 lines it's time to replace.

If the filter is plugged, some AC machines (Robinair) will display an error message "System Flush not possible clogged flush filter".

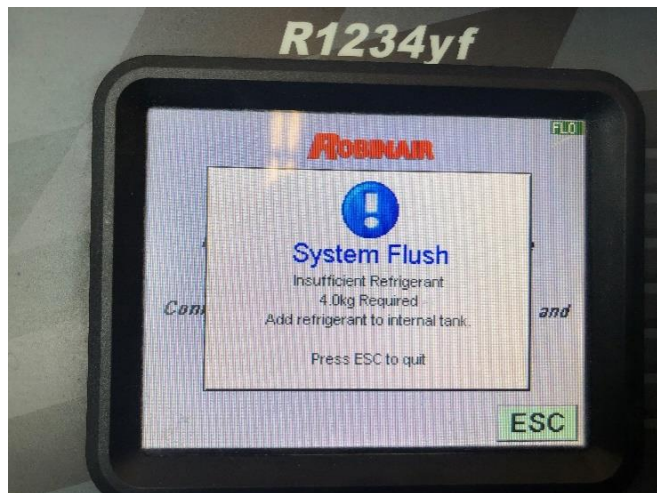
22. The flush procedure requires 4+ kg of refrigerant in the Internal Storage Vessel (ISV) tank within the AC flush machine.

If there is an insufficient amount of refrigerant in the ISV, the flush procedure will not start and will prompt an error message “Insufficient Refrigerant”. The amount of refrigerant allowed in the ISV when the AC flush machine transfers from the external tank is set in the machine’s “Settings” menu. You may have to go into the menu of the AC machine to set the ISV amount. Follow instructions of the AC flush machine manufacturer.

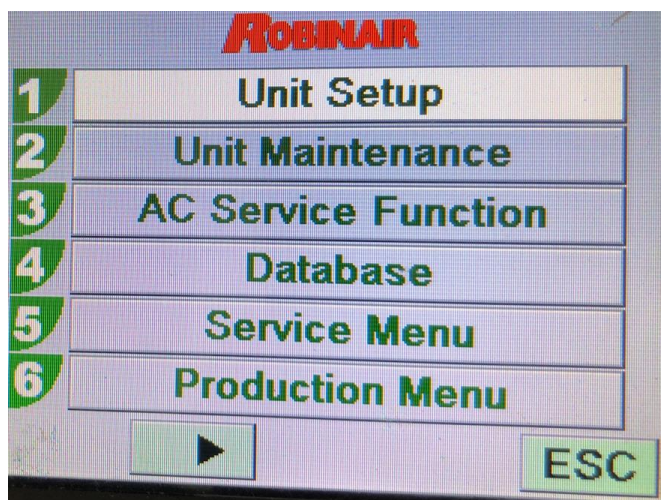
23. **For example-** on the Robinair AC1234-6 machine to change the amount of stored refrigerant in the ISV, go to-
UNIT SETUP
TANK FILL ADJUSTMENT
enter the amount required.

NOTE: On this Robinair AC machine there is 0.9 kg of refrigerant within the system that is not displayed in the ISV tank level. So, to get an actual 4 kg of refrigerant you would need to set the tank level to at least 4.9 kg for the flush procedure to run.

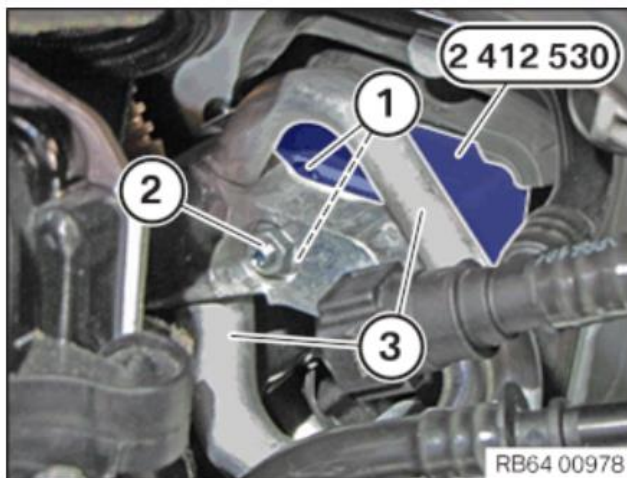
25. After first flush the block off adapter 83 30 2 420 896 must be removed from **EXPANSION VALVE #1**.

Then install flushing adapter **83 30 2 412 530** in place of expansion valve #1. The flushing adapter will have a hole on both inlet and outlet.

- Fasten with the M5 screws (1) of the expansion valve that has been previously removed
- **M5 Bolts Torque 5.5 Nm**

When mounting the refrigerant lines (3) onto the block off plate 1, secure them with the nut previously removed.

- **M6 nut Torque 13 Nm**
