NUMBER: 23-032-22

Door Outer Appliques Delaminating

2022 (WK) Jeep Grand Cherokee

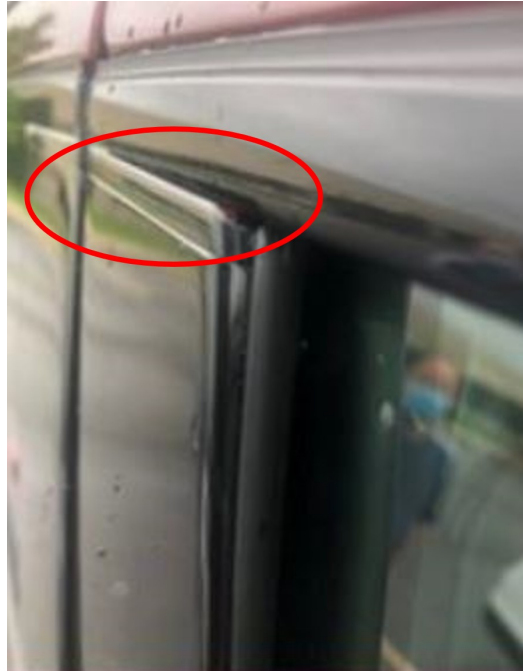
- Using a feeler gauge, inspect all six B and C-pillar door appliques by grasping the top of the applique with finger tips and pull the applique away from door (Fig. 1) .

Fig. 1
Separating, Warped Or Lifting Applique

- Were any of the front or rear B or C-pillar door appliques not firmly attached and pulled away 1.5 mm (.15 cm) or more at the top of the doors (Fig. 1) ?
 - YES>>> Proceed to [Step 1](#) of the Repair Procedure for front door applique replacement **and/or** proceed to [Step 2](#) of the Repair Procedure for rear door applique replacement.
 - NO>>> This bulletin does not apply, use inspect LOP (23-05-11-97) to close the active RSU.

NOTE: Only replace the B and C-pillar door appliques that are separating, warped or lifting. This Repair Procedure does not cover replacement of all B and C-pillar door appliques.

1. Replace the front door B-pillar applique(s). Refer to the detailed procedures available in DealerCONNECT > Service Library> under: 23 - Body / Doors - Front / Applique, B-Pillar, Front / Removal / Installation.
2. Replace the rear door B or C-pillar applique(s). Refer to the detailed procedures available in DealerCONNECT > Service Library> under: 23 - Body / Doors - Rear / Applique, B-Pillar, Rear / Removal/ Installation **and/or** 23 - Body / Doors - Rear / Applique, C-Pillar / Removal / Installation.
