NUMBER: 23-035-22

Front Row Seat Back Panel Loose

2022 (WS) Grand Wagoneer/Wagoneer

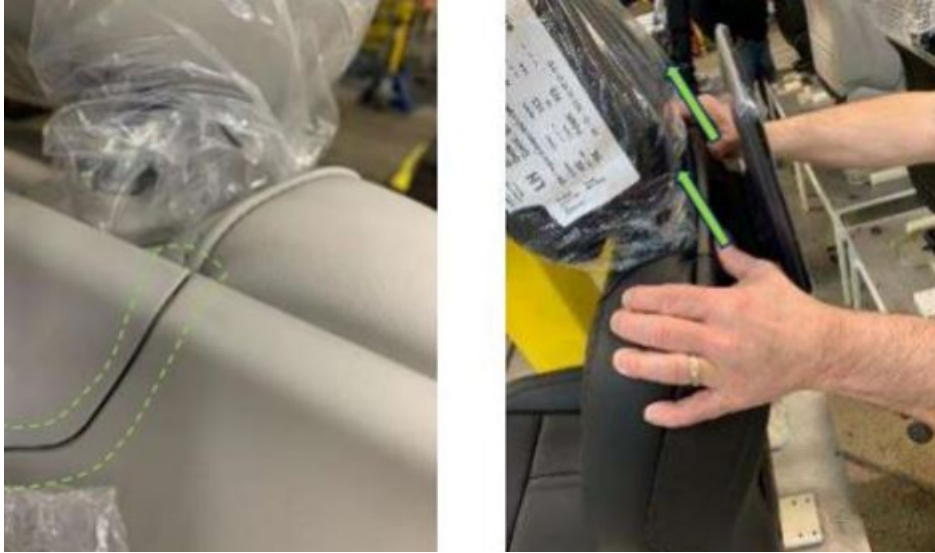
Fig. 1
Upper Seat Back (Bezel)

1. Check the seat back and upper screen bezel for large gaps and loose panels
 - a. Verify the Rear Seat Entertainment (RSE) screen bezel installation by checking visually and running hand over the seam checking gap and flushness. Gap should not exceed 1.5mm. Verify with feeler gage if necessary. Cap (bezel) should be flush to back panel. With both thumbs positioned on cap (bezel), simultaneously push upwards to verify engagement. Cap (bezel) should stay engaged (Fig. 1) .

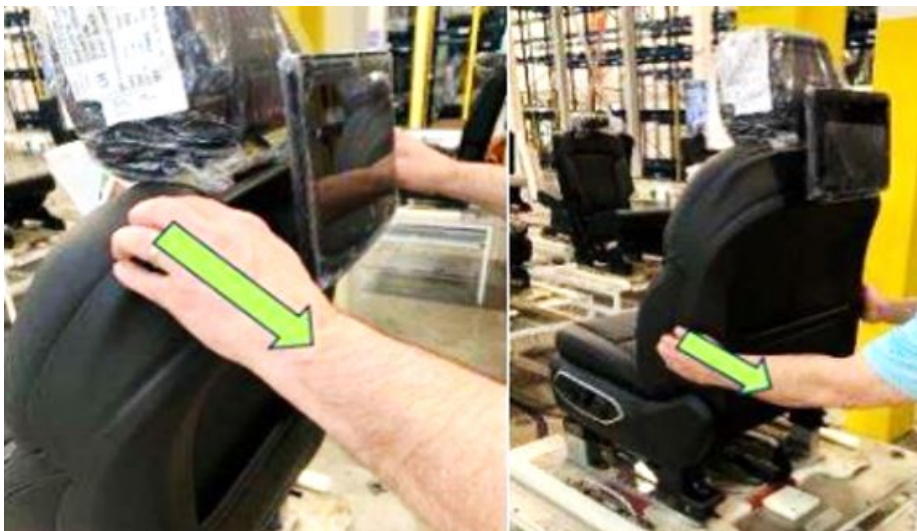
Fig. 2
Seat Back Inspection

Verify the front seat back panel installation is correct. From the rear seat area place both hands near top of back panel and with fingers slightly engaged into back panel gently pull to verify back panel is correctly installed. There should be no movement in the back panel from this direction. To verify engagement of lower part of back panel, grab rear lower sides and gently pull at same time. Back panel should not show any signs of movement (Fig. 2) .

- YES>>> Proceed to [Step 1](#) of the Repair Procedure.
- NO>>> This bulletin has been completed. Use inspection LOP (23-20-34-96) to close the active RSU.

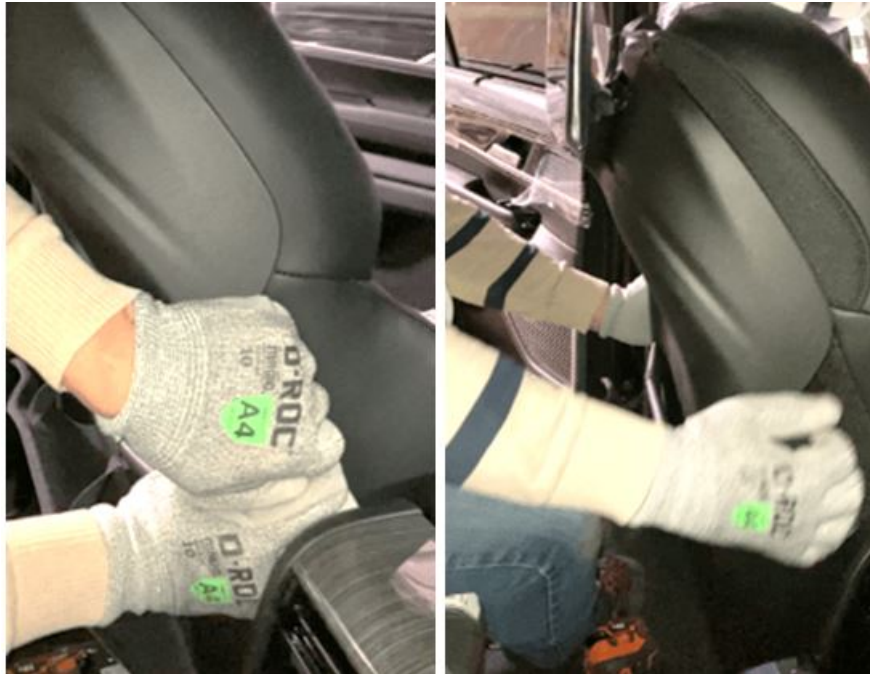
Fig. 4

Removing Lower Seat Back

3. Unhook the J-straps from under the seat frame and fold the carpet upwards uncovering the two hidden screws.
4. Remove the two hidden screws.
5. Grab inboard side lower bolster edge of the back panel with two hands and pull toward you.

- Grab the inboard side and outboard side of the back panel and push down with rotation clockwise on the inboard side and counterclockwise on the out-board side to disengage the four Snaps (Fig. 4) .

- With the panel removed, inspect the clips and attachments points for damage. Replace the panel if damaged.

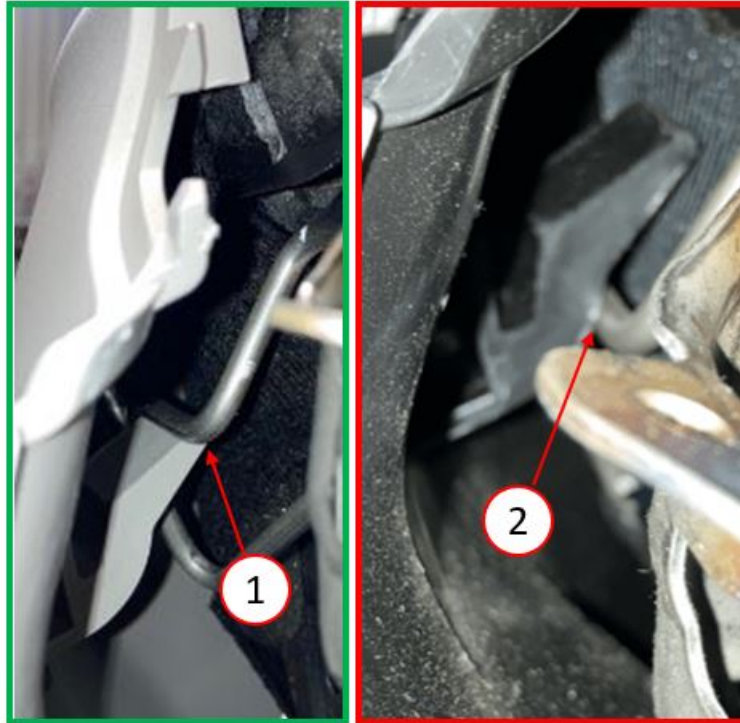
Fig. 5
Seat Back Panel Hook Points

- 1 - Correctly Installed
- 2 - Not Installed Properly

- Place the back panel under the screen and gradually push it up until the upper back panel hooks (2) will start to engage with the RSE bracket wires. Ensure the back panel hooks are in the correct position using the opening in the back panel under the screen and ensure the hooks are under the bracket wires (Fig. 5) .

- With the back panel hooks in place, push one side of the upper area of the back panel up with one hand and at the same time push away the upper corner of the seat trim with the second hand. Perform the same step on another side of the seat.
- Verify both upper back panel hooks are properly installed and engaged with the RSE bracket wires.
