# HYUNDAI

## Technical Service Bulletin

GROUP <b>AUTOMATIC TRANSMISSION</b>	NUMBER <b>22-AT-011H</b>
DATE <b>OCTOBER 2022</b>	MODEL(S) <b>VELOSTER N (JSN) SANTA FE (TMA PE) SONATA (DN8a) SANTA CRUZ (NXT) KONA N (OSN) ELANTRA N (CN7N)</b>

**SUBJECT:** 8-SPEED WET DCT REPLACEMENT INSTRUCTIONS

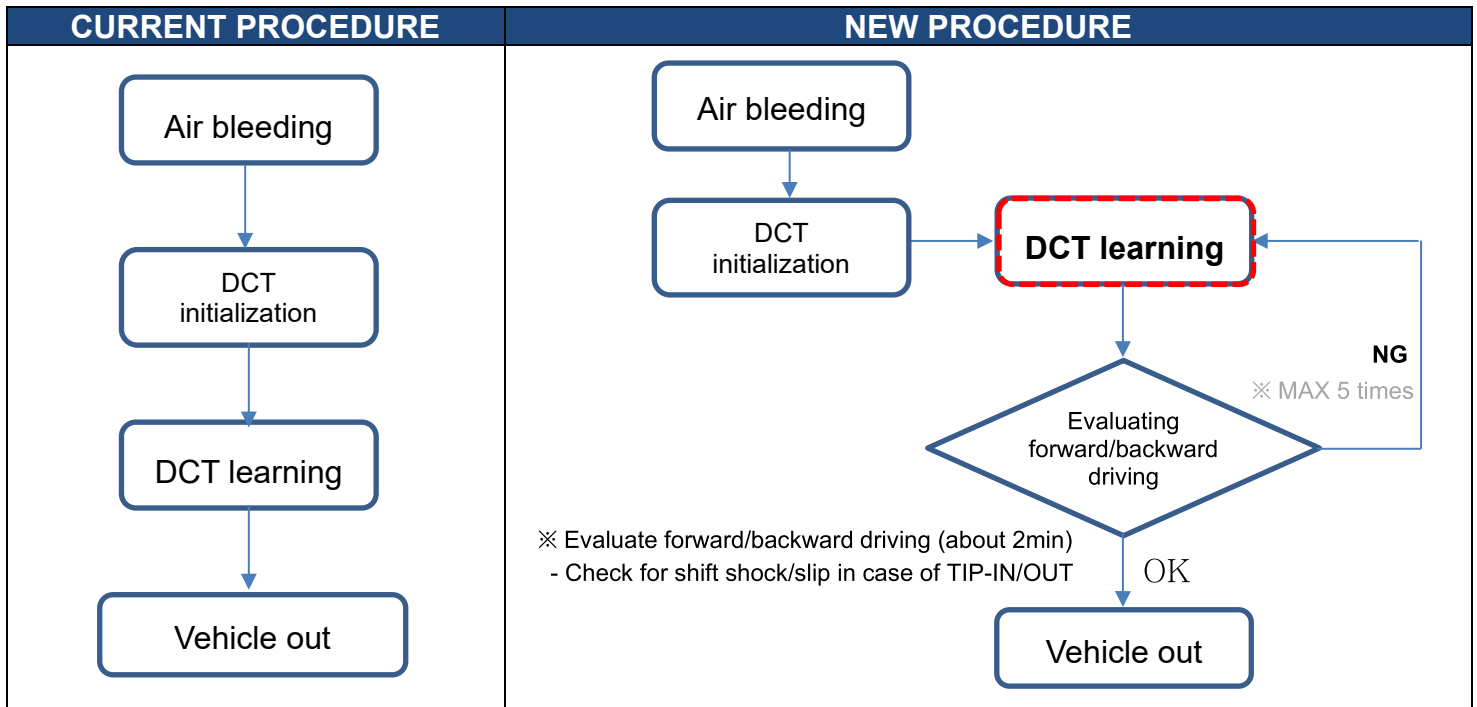
3. After replacing the DCT/TCM, perform the air bleeding/DCT initialization/DCT Learning according to the flow chart on page 3. See the table below regarding if DCT learning is required.

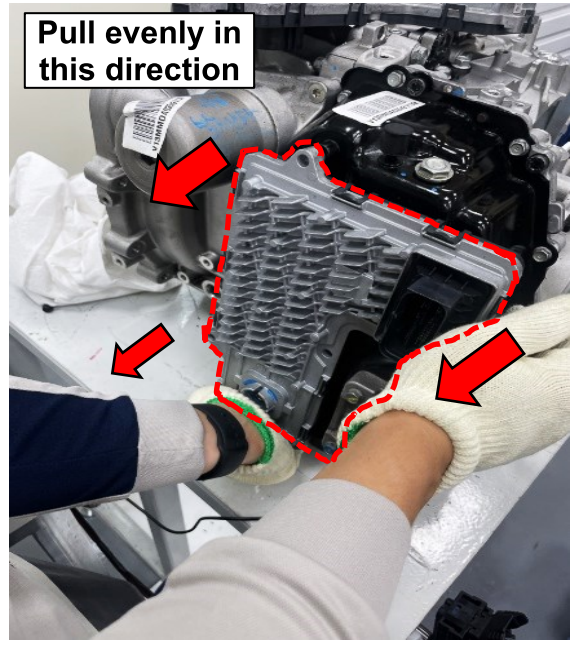
**CAUTION**  
Make sure the TCU 24-pin terminal is aligned properly during removal/installation, otherwise the pins may get damaged.

1. Remove the DCT TCM according to the vehicle shop manual.

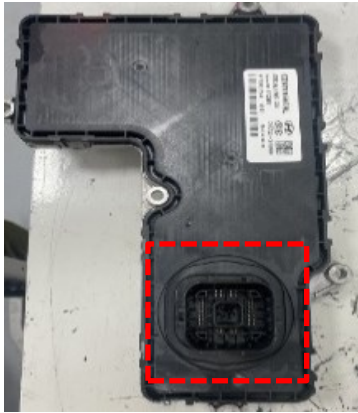
**Male terminal of TCM**

2. When reinstalling the TCM, make sure to align the connector on the TCM to the E-module on the DCT.
