GROUP NUMBER
CAMPAIGN 22-01-081H

INLET FITTING VALVE REPLACEMENT (CAMPAIGN T9B)

**Description:** Certain 2019-2021MY NEXO (FE) vehicles may exhibit a micro-leak in the inlet fitting valve area caused by a part that is out of specification. This bulletin outlines the procedure to replace each Inlet Fitting Valve on all three storage tanks.

**Applicable Vehicles:** Certain 2019MY ~ 2021MY NEXO (FE) vehicles.

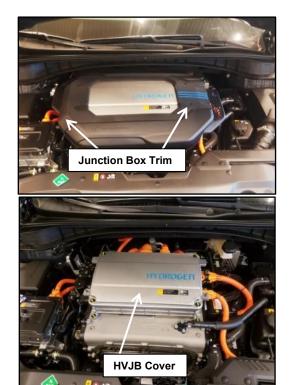
- 5. Wait 5+ minutes to allow the high voltage system capacitor to discharge.
- 6. Open the hood. Remove the junction box trim and cover.

High voltage junction box cover: Assembly bolt torque: 9.8 -~11.8 N.m

$(1.0 \sim 1.2 \text{ kgf.m}, 7.2 \sim 8.7 \text{ lb-ft})$

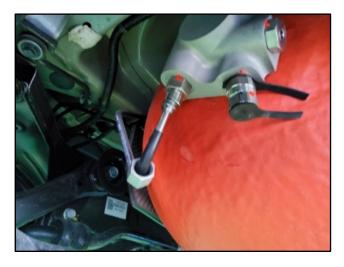
5. Loosen the fuel supply pipe and remove the inlet fitting valve using a socket wrench.

- The filter and the O-ring above the inlet fitting valve may fall out of the tank valve assembly while removing the inlet fitting valve. If separated, keep the parts clean until they are reinstalled.
- If any foreign substance enters the filter or the O-ring, it may disturb the seal of the valve.

Upper O-ring (Reuse)

Filter (Reuse)

Internal O-ring is preinstalled in the new inlet fitting valve

New inlet fitting valve assembly

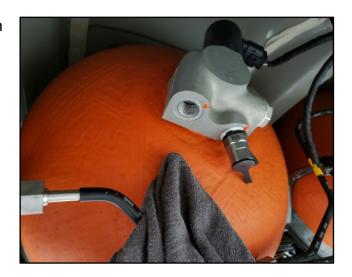
7. After removing each fuel supply line, cover the open end with a clean rag to prevent debris from entering the line.

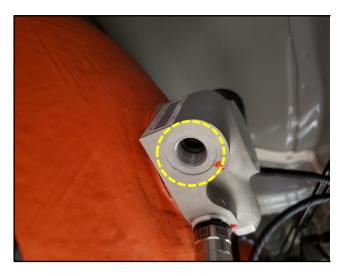
8. After removing the valve, clean the sealant from the threads in the area shown using an appropriate tool such as a pick or razor blade.

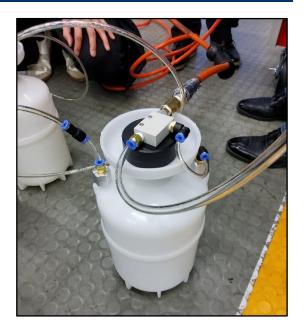
Attach an air hose to the suction tool. Check the tool has good suction at the end of the hose and the suction works properly while turning on and off. Use the tool to suction any foreign substance from the threads.

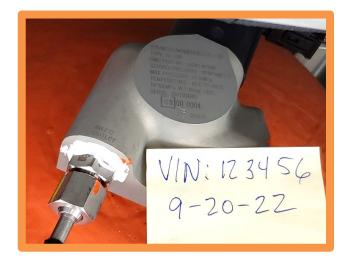
Using STUI, take THREE pictures; one picture for each of the three Inlet Fitting Valves replaced. (Similar to the photo to the right)

Include in the photo a piece of paper containing the last 6 digits of the VIN or the RO #, the date of the installation of the new Inlet Fitting Valve. Ensure the image is in focus and includes the Inlet Fitting Valve, the note, and the lettering on the tank valve. Upload the photo to STUI.

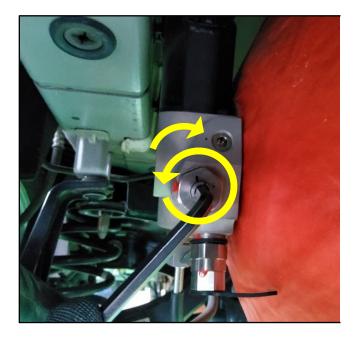
17. Open the manual valves on all 3 hydrogen tanks.

Using a **6mm** Allen wrench turn the manual valve counter-clockwise until it stops then rotate manual valve one half turn clockwise.

#### **Opening Torque:**

$3.6 \sim 7.2 \text{ lb-ft } (4.9 \sim 9.8 \text{ Nm})$
