GROUP	MODEL
BOD	2023MY Carnival (KA4)
NUMBER	DATE
311	October 2022

### SERVICE ACTION: FRONT DOOR WEATHERSTRIP INSPECTION AND REPLACEMENT (SA510)

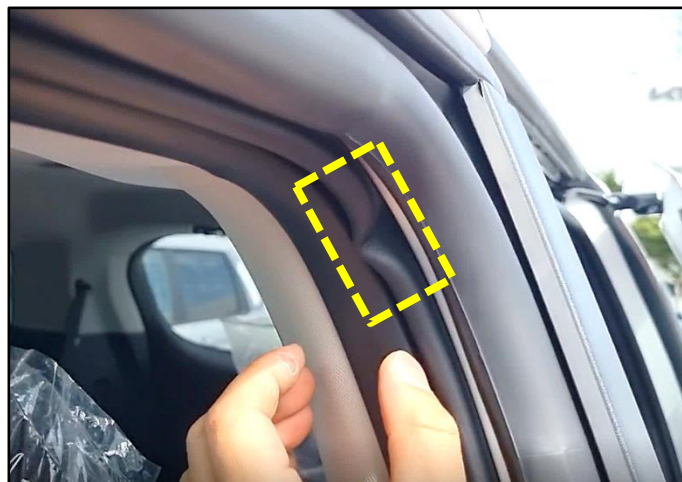
This bulletin provides information to inspect and, if necessary, replace the front door weatherstrip on some 2023MY Carnival (KA4) vehicles produced from July 14, 2022 through September 8, 2022, which may exhibit a deformation of the weatherstrip in the upper rear corner area (center 'B' pillar) of the front door. Kia is requesting the completion of this Service Action on all affected vehicles in dealer stock, prior to delivery. If deformation is present, replace the front door weatherstrip on the affected side(s). Before conducting the procedure, verify that the vehicle is included in the list of affected VINs.

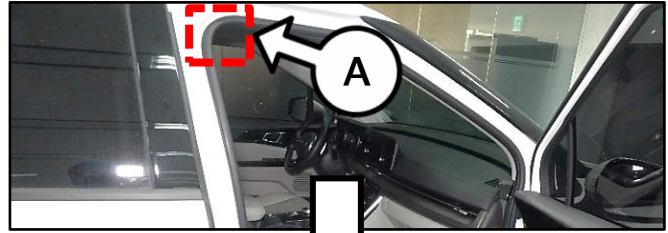
Press the weatherstrip in the upper "B" pillar corner areas shown with your finger and confirm the following:

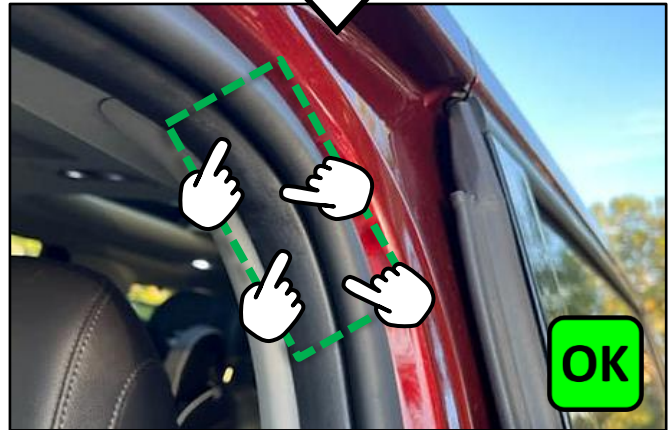
- If the weatherstrip **does not deform (OK)**, (retracts normally after pressing), then no further action is needed.

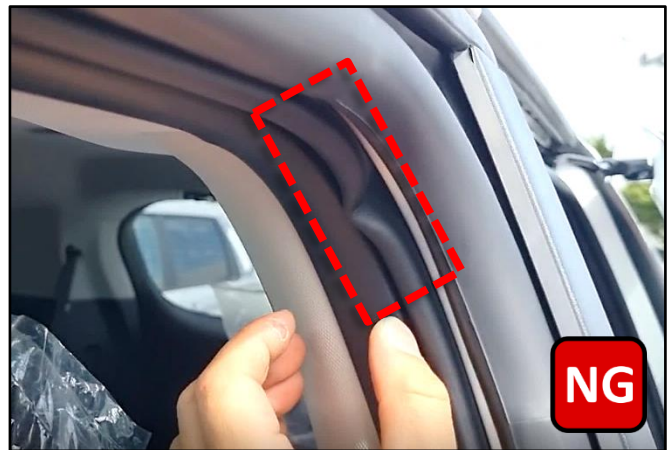
- If the weatherstrip **does deform (NG)**, (does not retract when pressed), then proceed to the 'Replacement Procedure' on page 3 to replace the weatherstrip on the affected door(s) (LH, RH, or Both).

**Note:** Replace the weatherstrip on the affected side(s) only.

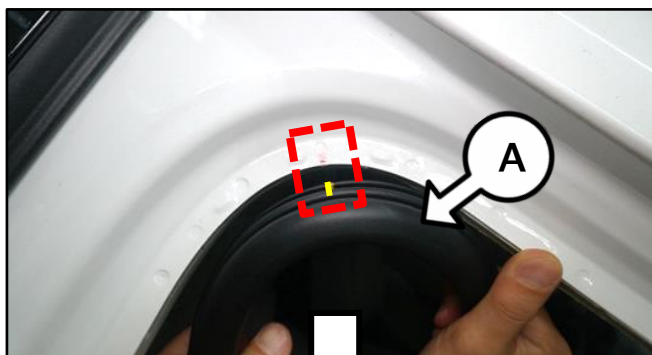
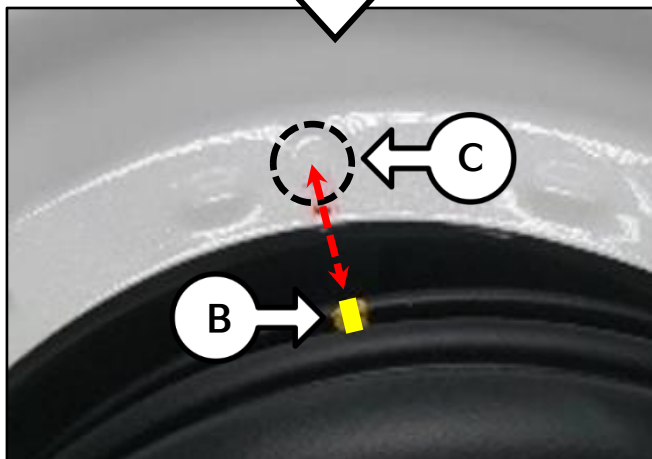
Locate the color marking on the new weatherstrip to differentiate between Left and Right side:

- Driver's (LH): White mark
- Passenger (RH): Yellow mark

Match the color mark (B) on the weatherstrip with the spot-welding mark (C) on the top rear corner of the door opening.
