**TECHNICAL SERVICE BULLETIN**  
**SB-63 2022 Allegro Bay 38 AB Water Tanks Heating Pad**

**Tiffin Motorhomes Technical Service Bulletin # SB-63**

**Models Involved:** 2022 Allegro Bay 38AB

**Purpose:** Provide instructions for connecting the 12v breaker power to water tank heat pad

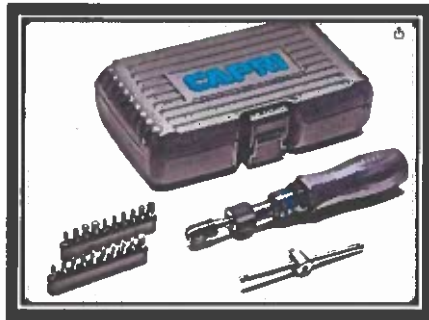
T20 Torque bit & driver

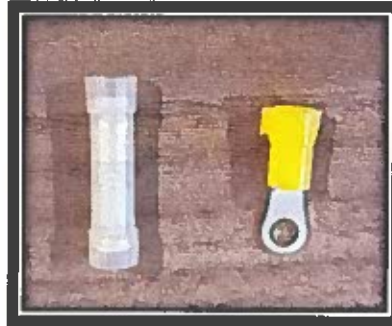
1 of 15932, 12-gauge filled butt connector

1 of 15922, ring terminal with a 3/16 hole

1 of 1348, 12-gauge wire – optional, 2 ft

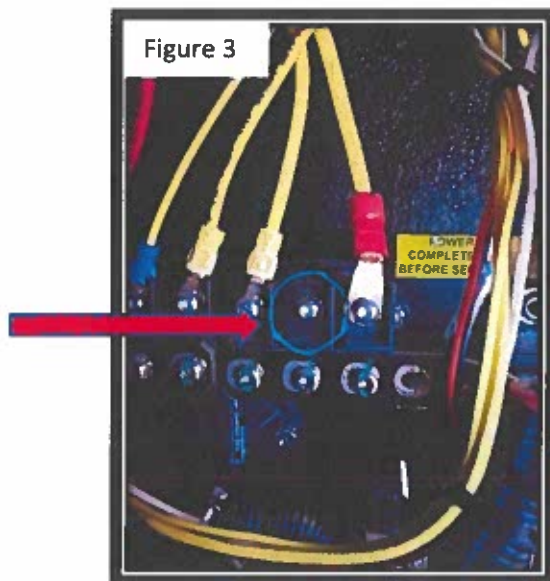
3. The tank heat wire should be located on this breaker spot circled the Figure 3 below, if the wire is installed, no repair is needed. Please file a claim to Tiffin Motorhomes using the code above.

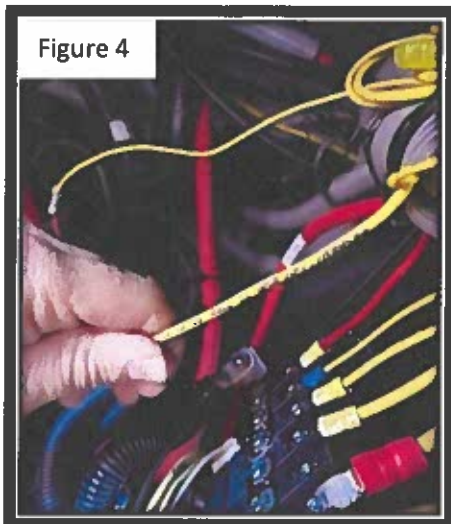
1. Locate the wire, "PWR TO TANK HEAT" will be printed on the wire, shown in Figure 4.
