SERVICE INFORMATION BULLETIN

APPLICABILITY: All Models

NUMBER: 12-241-22

SUBJECT: Trunk Weather Strip Installation

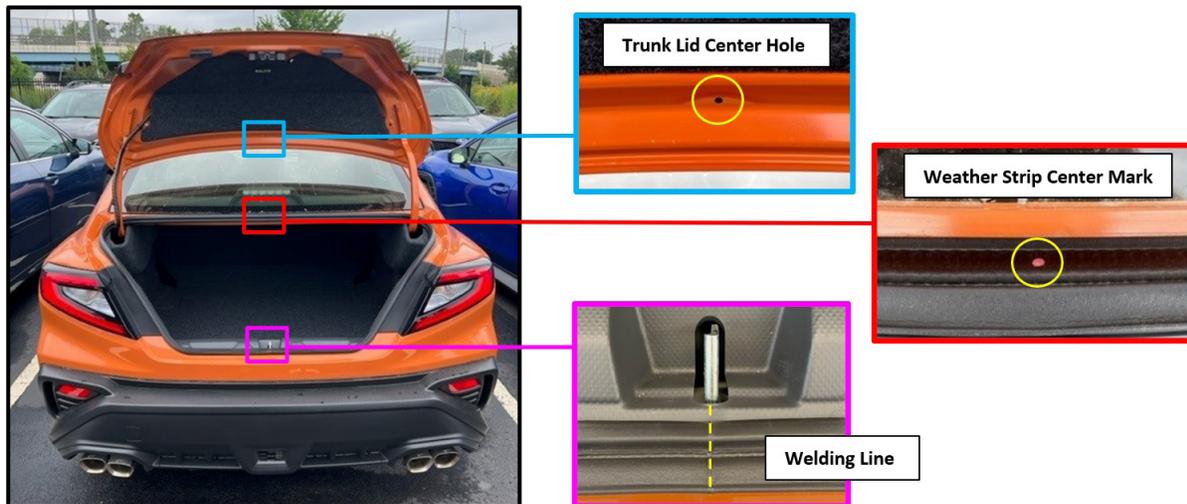
Installation Tips for Sedan Models (WRX is Shown):

Locate the trunk lid center hole, the weather strip center mark, and the center welding line located on the weather strip.

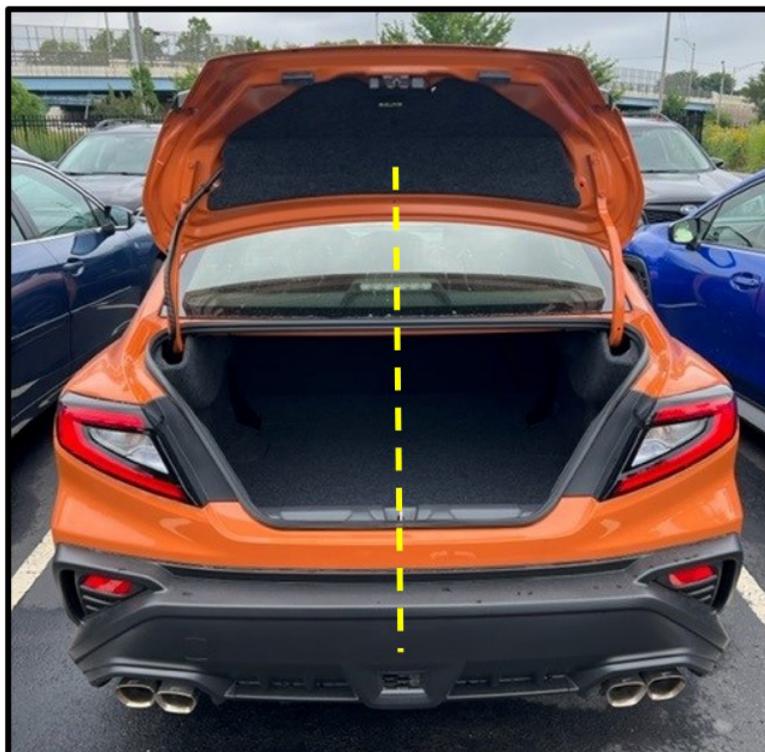
When installing the new seal, confirm the trunk lid center hole, the weather strip center mark and the welding line are all aligned with one another as shown below.

Confirm the entire weather strip is fully seated onto the body flange in all areas.

CAUTION: Any improper fitment can cause unwanted water intrusion. **ALWAYS** inspect the installation closely when completed to confirm proper fitment and alignment.

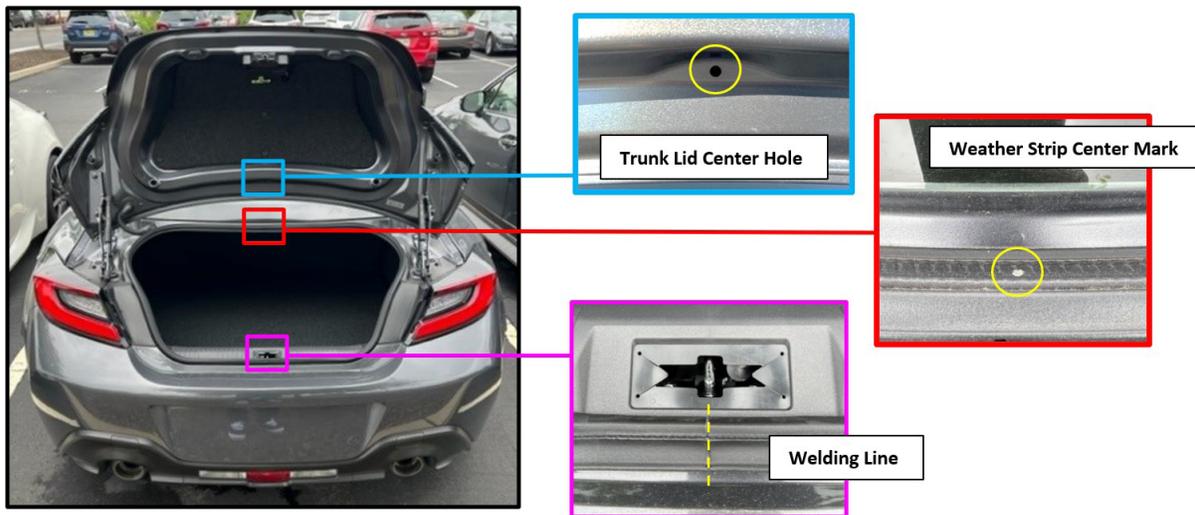
Installation Tips for Coupe Models (BRZ is Shown):

Locate the trunk lid center hole, the weather strip center mark, the center welding line located on the weather strip.

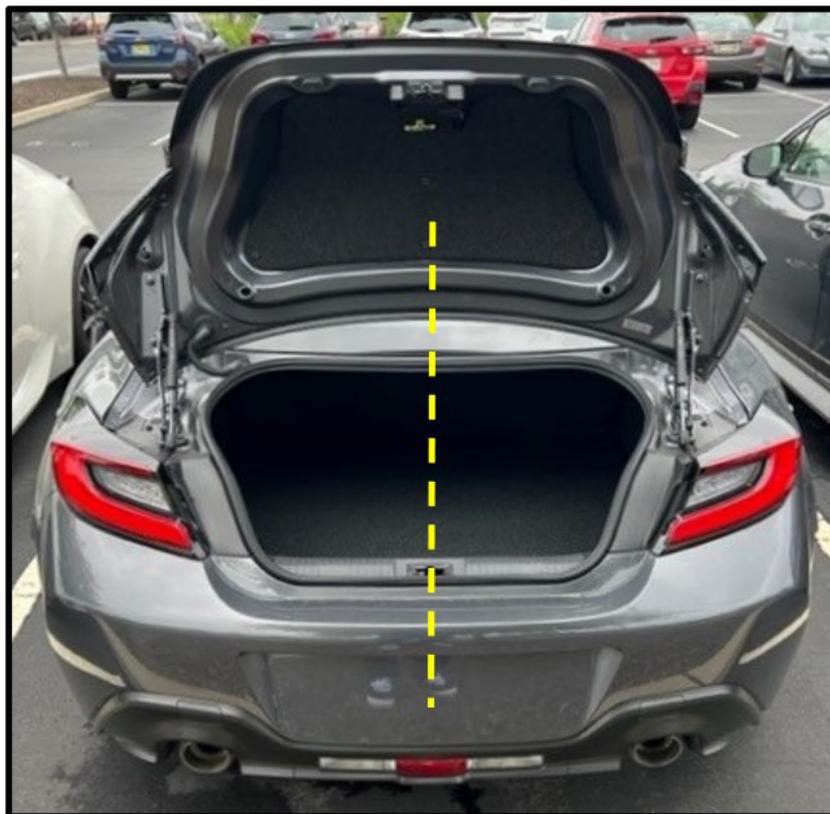
When installing the new seal, confirm the trunk lid center hole, weather strip center mark, and the welding line are all aligned with one another as shown below.

Confirm the entire weather strip is fully seated onto the body flange in all areas.

CAUTION: Any improper fitment can cause unwanted water intrusion. **ALWAYS** inspect the installation closely when completed to confirm proper fitment and alignment.

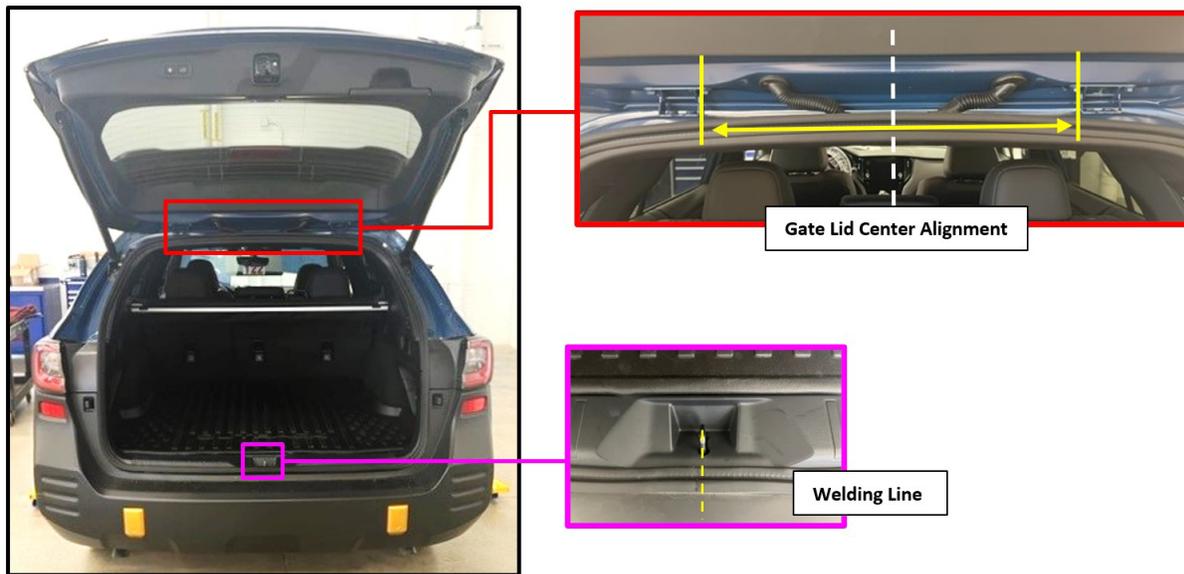
Installation Tips for Wagon Models (Outback Wilderness is Shown):

Locate the the welding line on the weather strip. Locate the center of the rear gate between the inner portion of the left and right gate hinge.

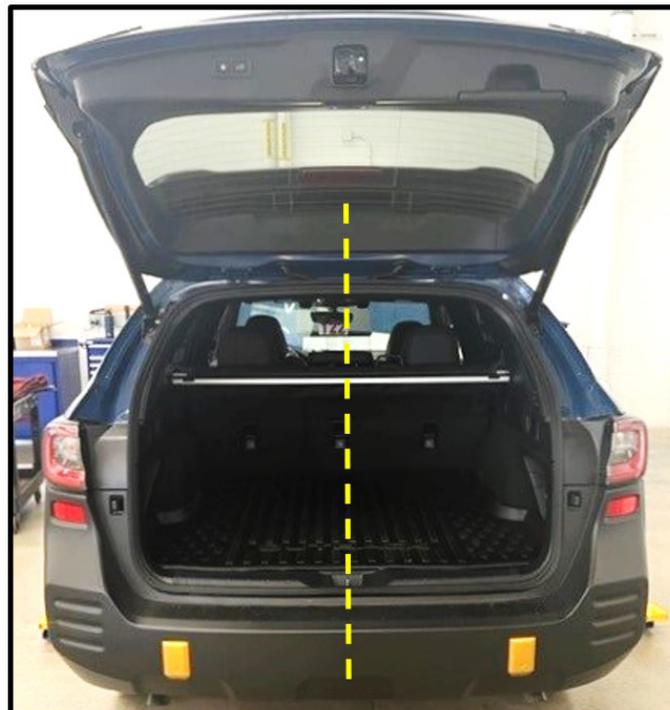
When installing the new seal, confirm the center of the gate lid and the welding line are aligned with one another as shown below.

Confirm the entire weather strip is fully seated onto the body flange in all areas.

CAUTION: Any improper fitment can cause unwanted water intrusion. **ALWAYS** inspect the installation to confirm proper fitment and alignment.
