SERVICE BULLETIN

Vermeer Corporation

FIELD CAMPAIGN SERVICE BULLETIN #: SVC2022-173

BC1800XL Standard
Manual Chip Chute
Weld Inspection Kit
(IK003077 Rev. 1)

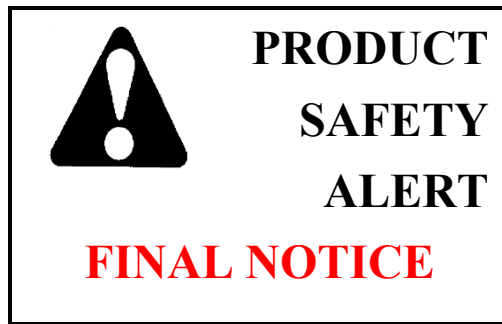
During manufacturing, the weld that secures the chip chute to the gear ring may not have been properly completed.

If the weld fails and the chip chute becomes loose, the chute may possibly separate from the gear ring. If partial separation occurs during chipping, chips will eject from the cutter housing. **Death or serious injury** is possible if chip chute separates while chipping and chips are ejected.

IK003077 Rev. 1 has been created to provide the necessary parts and instructions to inspect the weld. If the inspection finds that the weld was not

properly completed, a new chip chute will be installed. **This kit must be installed as soon as possible.**
