Service Campaign 496

M15x/M161 – Potential coolant leak from radiator delivery pipe

Certain Maserati Levante (M161), Quattroporte (M156), and Ghibli (M157) vehicles listed in ModisCS+ equipped with V6 engines are involved in a Service Campaign concerning a potential coolant leak from the radiator delivery pipe. This issue is related to excessive residual burr during the Thermal Pressure Switch Cover manufacturing process.

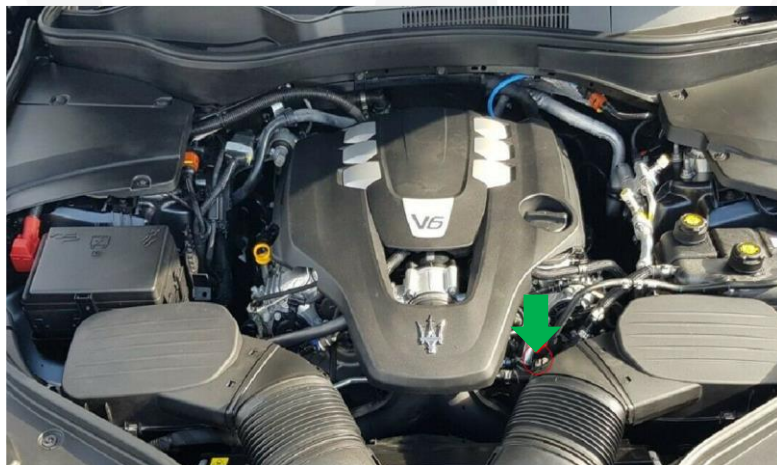
5. With the engine idling, open the front hood and check for drops or leaks of coolant between the Thermal Pressure Switch Cover and the Radiator Delivery Pipe. Located in the area indicated by the images below.

6. **OK** ▶ No coolant contamination or leak is found; the inspection is finished. No other actions are required.
7. **NOT OK** ▶ Coolant contamination is found and leaking. Take multiple CLEAR pictures at different angles of the leak. **Open BOL for "SUPPORT REQUEST" attach pictures, vehicle scan, and await further instructions.**

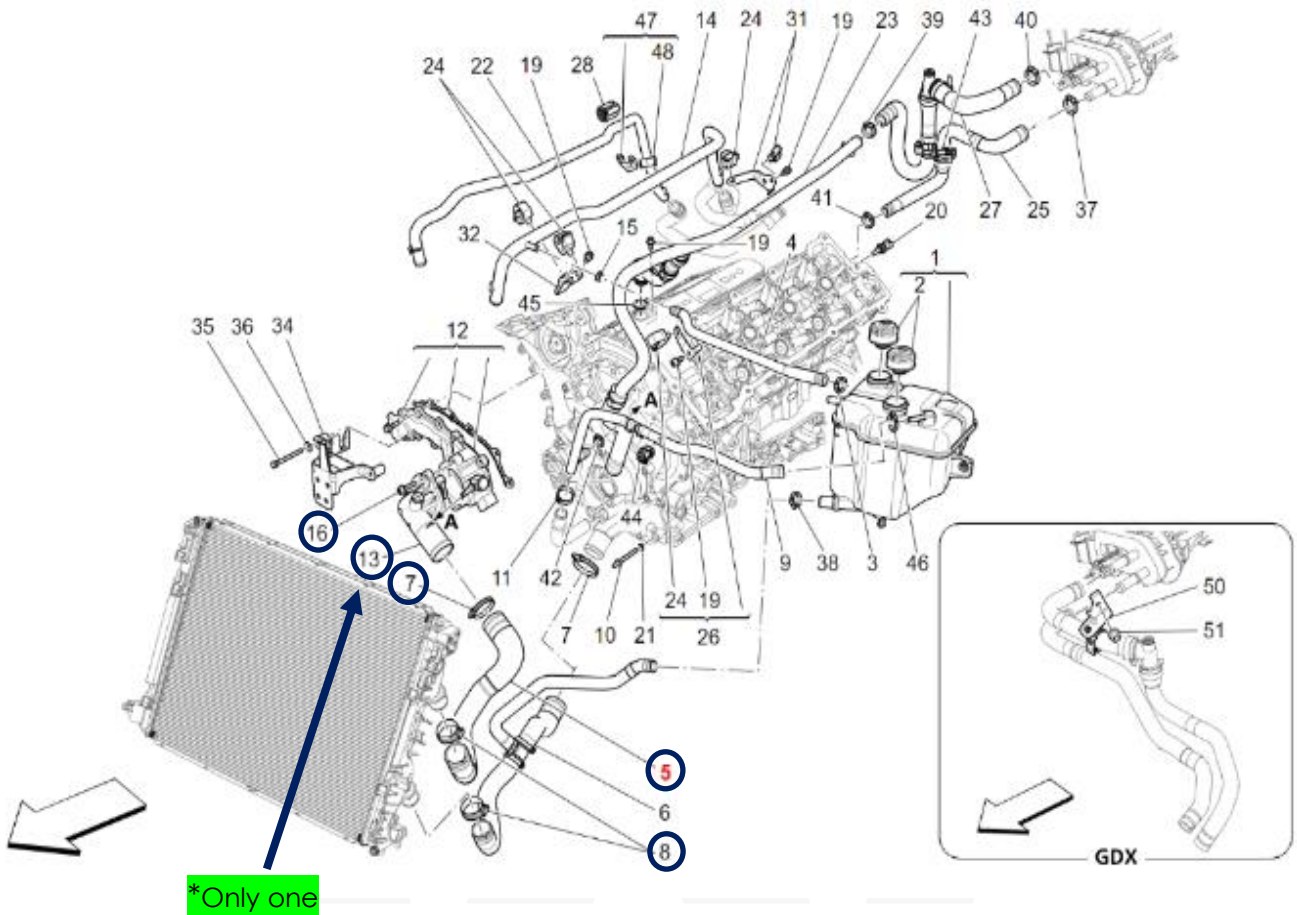
Section: 01.71 - 4 COOLING SYSTEM: NOURICE AND LINES

Description	QTY	Code
THERMAL PRESSURE SWITCH COVER*	1	330424
RADIATOR WATER DELIVERY PIPE	1	Component Code 1.71.008 Check the parts catalog for the PN based on your Model/Mkt
SCREW	2	231620
COLLAR	2	Check the parts catalog for the PN based on your Model/Mkt
COOLANT (PETRONAS PARAFULL 50/50)	1	900030457
