GROUP	MODEL
BOD	2023MY Niro EV/HEV/PHEV (SG2 EV, P/HEV)
NUMBER	DATE
310 (Rev 1, 11/18/2022)	October 2022

TECHNICAL SERVICE BULLETIN

SUBJECT: **SERVICE ACTION: FRONT CARPET FLOOR MAT ANCHOR INSPECTION AND REPLACEMENT (SA509)**

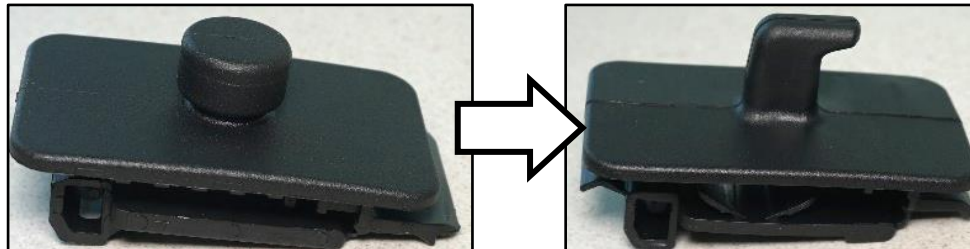
NG: Ring Type Anchor
(non-U.S. specification)

OK: Hook Type Anchor
(U.S. specification)

- Inspect the front carpet floor mat anchors on both the driver (LH) and passenger (RH) sides.
 - If the floor mat anchor installed is the 'hook type' (OK), no further action is required.
 - If the floor mat anchor installed is the 'ring type' (NG), then proceed below to the 'Replacement Procedure' to replace all three (3) front floor mat anchors with the correct type.

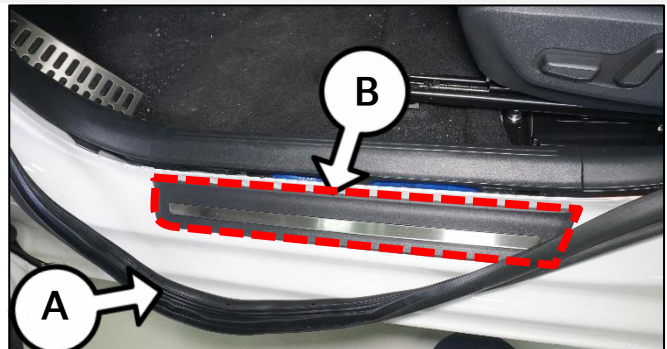
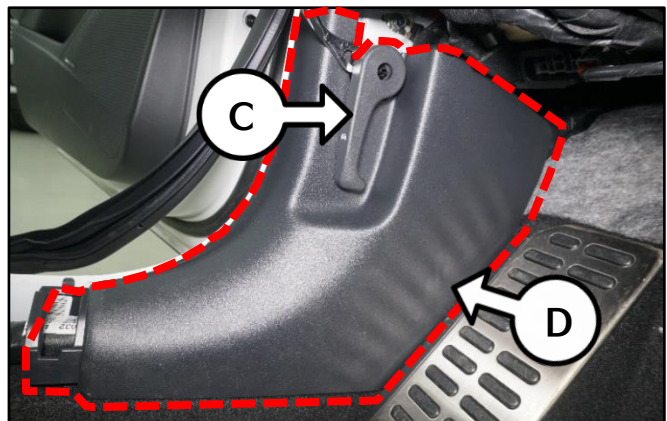
- Remove the components listed below by referring to "Body (Interior and Exterior) → Interior Trim → Cowl Side Trim → Repair procedures" in the applicable Shop Manual on KGIS to access both left and right sides, floor mat anchors.
 - Front door weatherstrips (A)
 - Front door scuff trims (B)
 - Hood latch release handle (C)
 - Cowl side trims (D)

Use a non-marring trim removal tool (such as Snap-on® Part Number PBN5 or equivalent) to avoid damaging trim pieces.

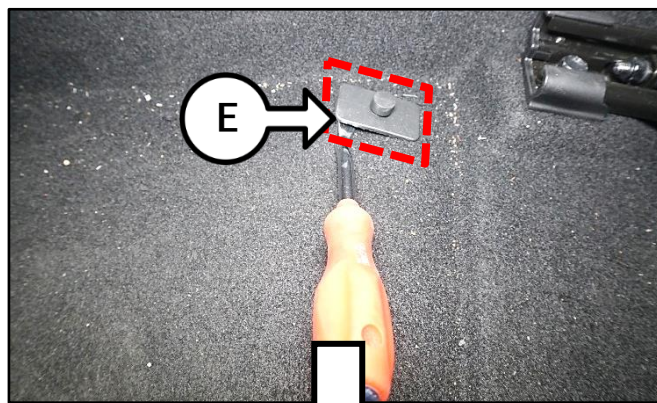
2a. Using a trim removal tool, unlock the anchor (E) from below to detach it from the base (F) located underneath the floor carpet.

2b. Remove the anchor (E).

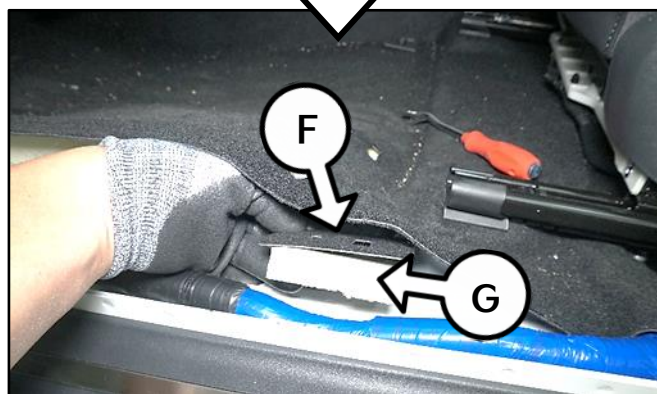
3. Remove the loose anchor base (F) and anchor pad(s) (G) from underneath the carpet.

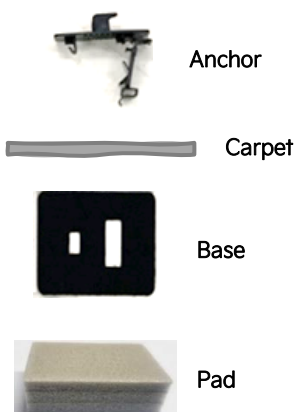
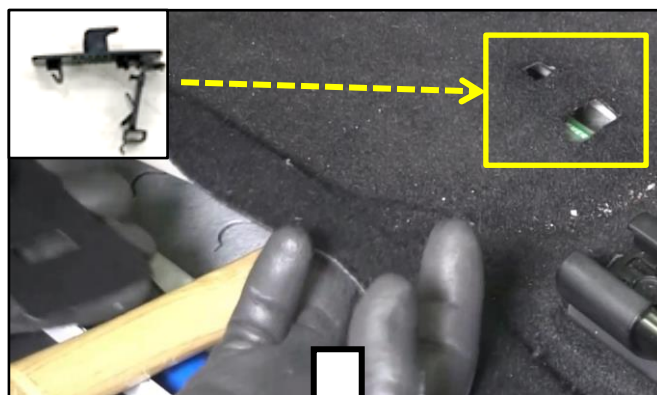
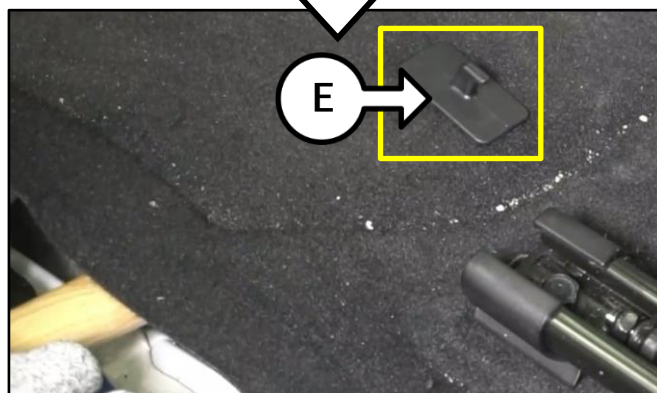
4. Install the (3) new anchors:

- Two (2) driver (LH) side
- One (1) passenger (RH) side

Follow the order shown below:

Insert a hard object between the carpet and body floor to attach/snap the new anchor (E) to the base (F) under the carpet. Refer to step 3.

Note: Hooks are pointed towards the rear.

For HEV/PHEV models, be sure to use the correct thickness pads by referencing the table guide below.

*Note: The (35mm) pad, must be used for the left driver side, inboard anchor.

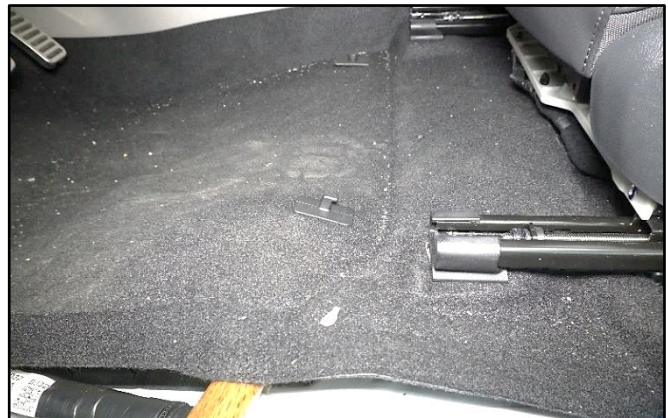
5. Reinstall all removed parts in reverse order of removal.
6. Verify that all three (3) new floor mat anchors are securely in place:
 - Two (2) on driver (LH) side
 - One (1) on passenger (RH) side
7. Install and secure the front carpet floor mats onto the new anchors.
