**Campaign 538**

# Service Campaign 538 Grecale Puddle Light Check

DATE: OCTOBER 20 2022

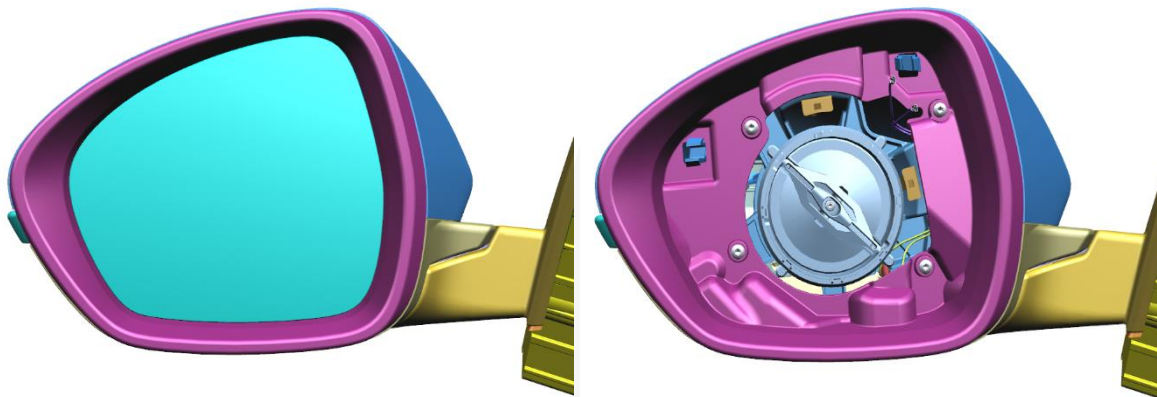
The potential issue of the puddle light comes from the pinching of the light electrical connections inside the mirror moving mechanism. The area to check is located behind the reflector, as shown in the below image.

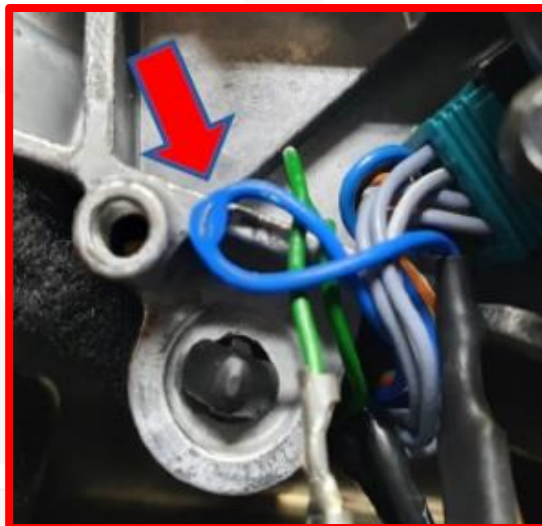
The goal of the check is to verify the integrity of the internal wiring and the lack of pinching located in the reported area.

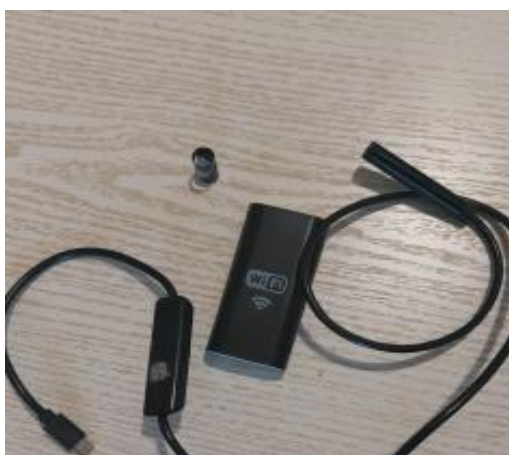
**Example 1** – Generic USB endoscope for mobile phone - from consumer electronics

To perform this check without removing the reflector, avoiding operations that could lead to accidental damages, it is suggested to use a generic flexible endoscope (USB, wireless, etc.) that has a suitable optical head size for this purpose (<7mm).

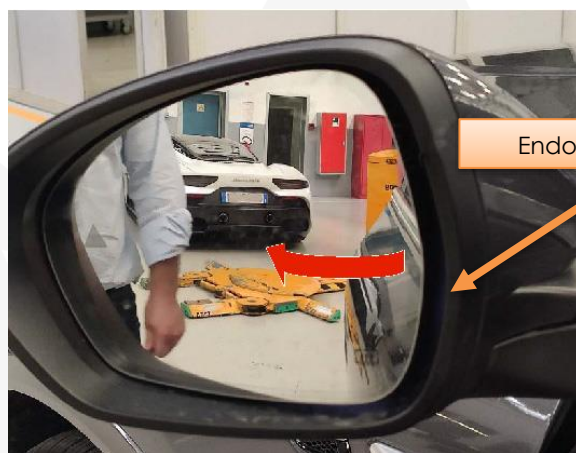
1. Always check in ModisCS+ to see if the vehicle is involved in this campaign and if the The campaign has not been previously performed.
2. Check the outside rear view mirror, both left and right.  
Since it is a very delicate aesthetic component, to carry out the check and avoid the removal of the reflector, the use of an endoscope is recommended.
3. Acting on the appropriate control console on the door panel, move the reflector towards the outside to create a convenient access space (gap) as shown in the figure.

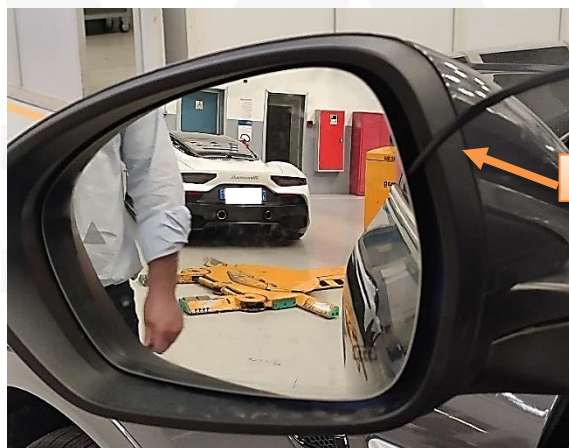
4. Insert the endoscope head in the gap, as shown in the figure.

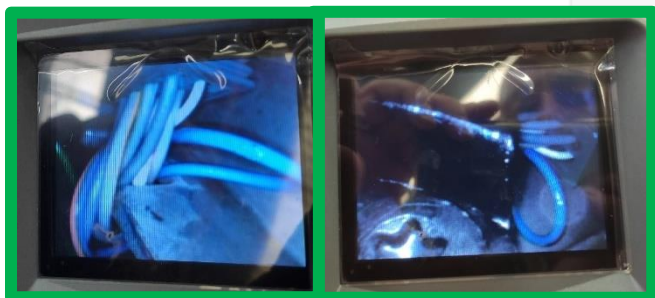
OK

5. Move the endoscope to find the right frame that allows to easily look the are where the puddle lamp wirings are located. Check the integrity and right routing of the cables, carefully checking that the cables do not show pinches or damages.

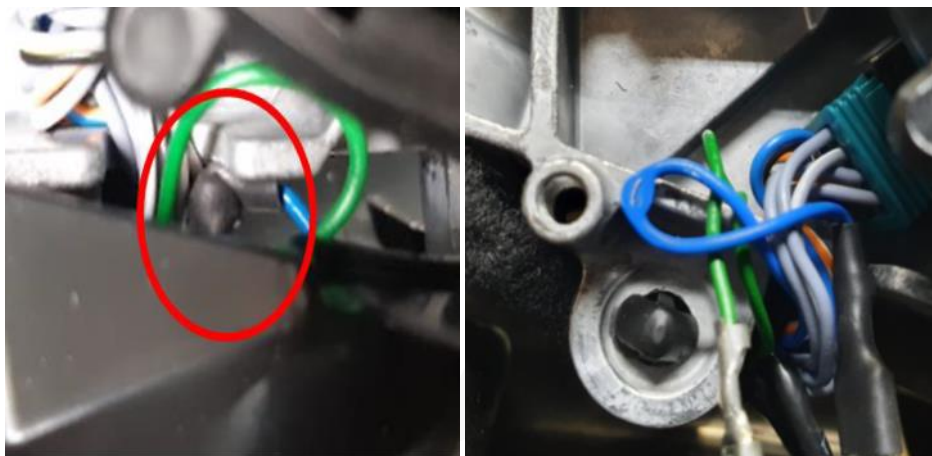
7. Damages examples:

This intervention is needed to check the right functionality of the component and to restore it in case of **NOT OK**. The cause of this potential (but very unlikely) issue could come from a pinching of the electrical connections of the light, located inside the body of the mirror, near the mirror moving mechanism.

*Examples of damage: check cables or protective sheaths pinches*

6. In case of pinches or damage of the cables, proceed with the replacement of the mirror assembly, following the reported procedure:

8. Repeat the check operation on the passenger's side.
9. In case of pinches or damaged cables, proceed with the replacement of the mirror assembly, following the reported procedure:  
**9.35.001 - EXTERNAL REAR VIEW MIRROR, PASSENGER'S SIDE - Removal/refitting or replacement**
10. The operation is completed.
