# XOS Technical Service Bulletin

Bulletin No.: TSB-002-22

Subject: Turn Signal & Hazard Indicators Inoperative

Applicability: All 2021-2022 Xos SV05 Trucks

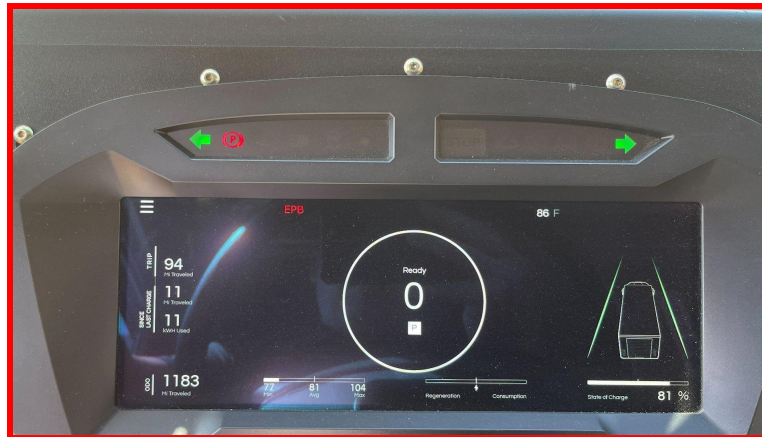
1. Confirm the customer's concern. The turn signal indicators on the instrument cluster are always ON (Image 1). Neither turn signals or the emergency flashers are operable. Replacement of the relay flasher is required to resolve the customer concern.

Image 1 - Both turn indicators are always ON

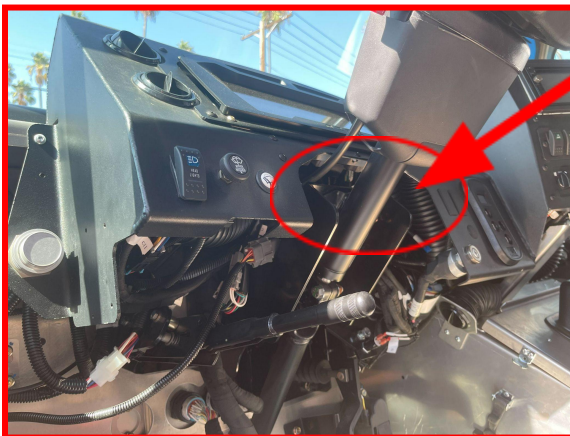
**Image 2 - Behind steering column support & lower instrument cluster**

2. Remove the flasher relay assembly located as shown in Images 2 and 3 by disconnecting the terminal connections and loosening the ground screw.

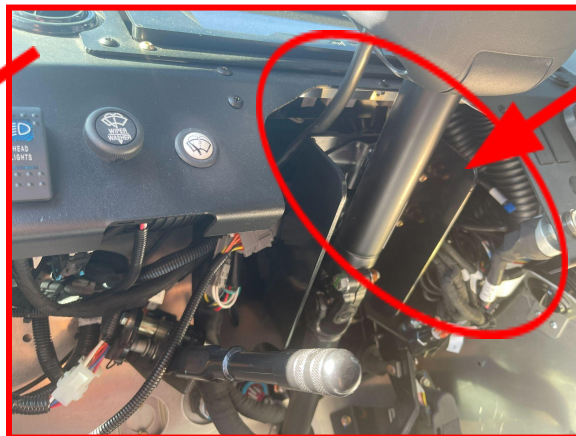
**Image 3 - Harness can be located on this side of the steering column**

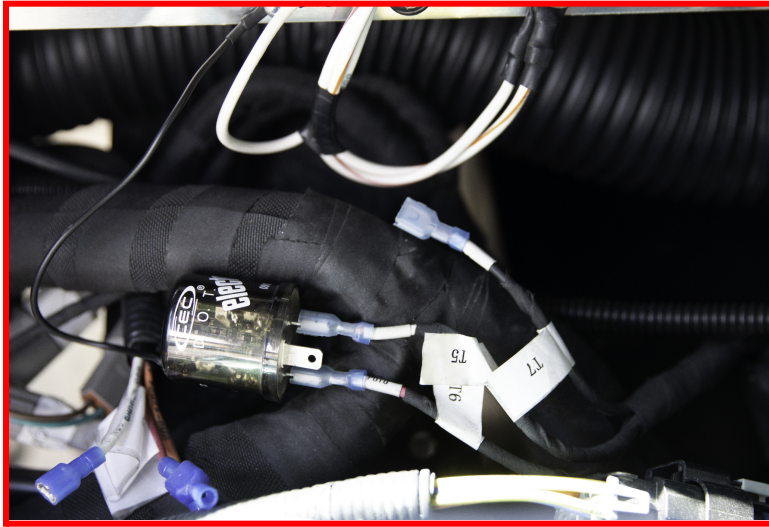
NOTE: Reconnecting terminal T7 to the replacement flasher relay may result in premature failure of the new part.

**Image 4: Flasher Relay with terminal “T7” properly removed**

3. Identify the wire and terminal labeled "T7". Secure this wire and terminal away from the flasher relay. Use the cable tie and secure T7 to the harness, it will not be reused.

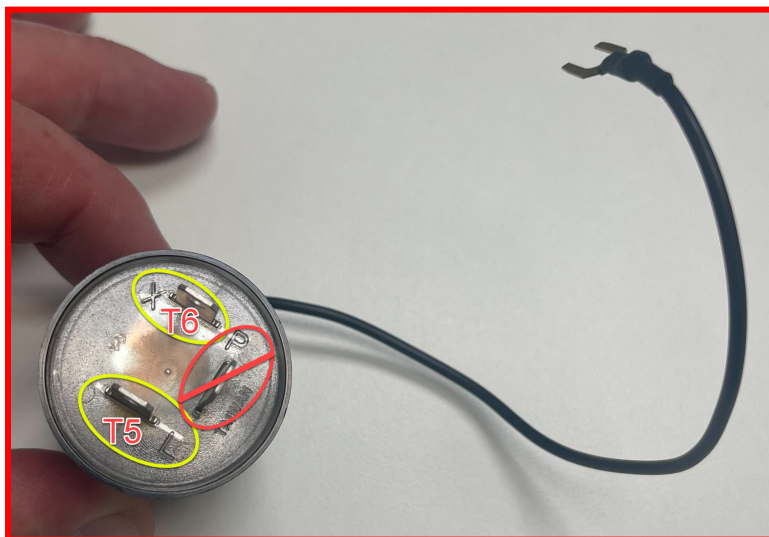
**Image 5: Flasher Relay terminals and related vehicle connection**

4. Install the new flasher relay, connecting the ground terminal, T5 & T6 as shown in Image 5
  - T5 is connected to terminal “L” of the flasher relay
  - T6 is connected to terminal “X” of the flasher relay
  - Terminal “P” of the flasher relay is NOT used
