SERVICE BULLETIN

Subject: General Software Improvement Bulletin Bulletin Type: Field Fix Conditional

Bulletin No: TS45-FC-2205

Vehicle Model: TS45

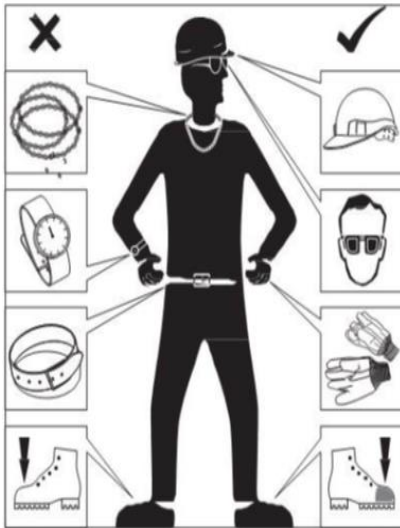
1. Mechanical Requested Dress Code

- ✓ Always wear protective clothing
- ✓ Do not wear any worn or loose-fitting clothing
- ✓ Remove jewelry before starting to work
- ✓ In case of long hair, use hairnet
- ✓ The illustration on the left shows some of the correct and incorrect clothing
- ✓ Sharp edged items should be avoided in order not to scratch vehicle (i.e. belts, watches, necklace)

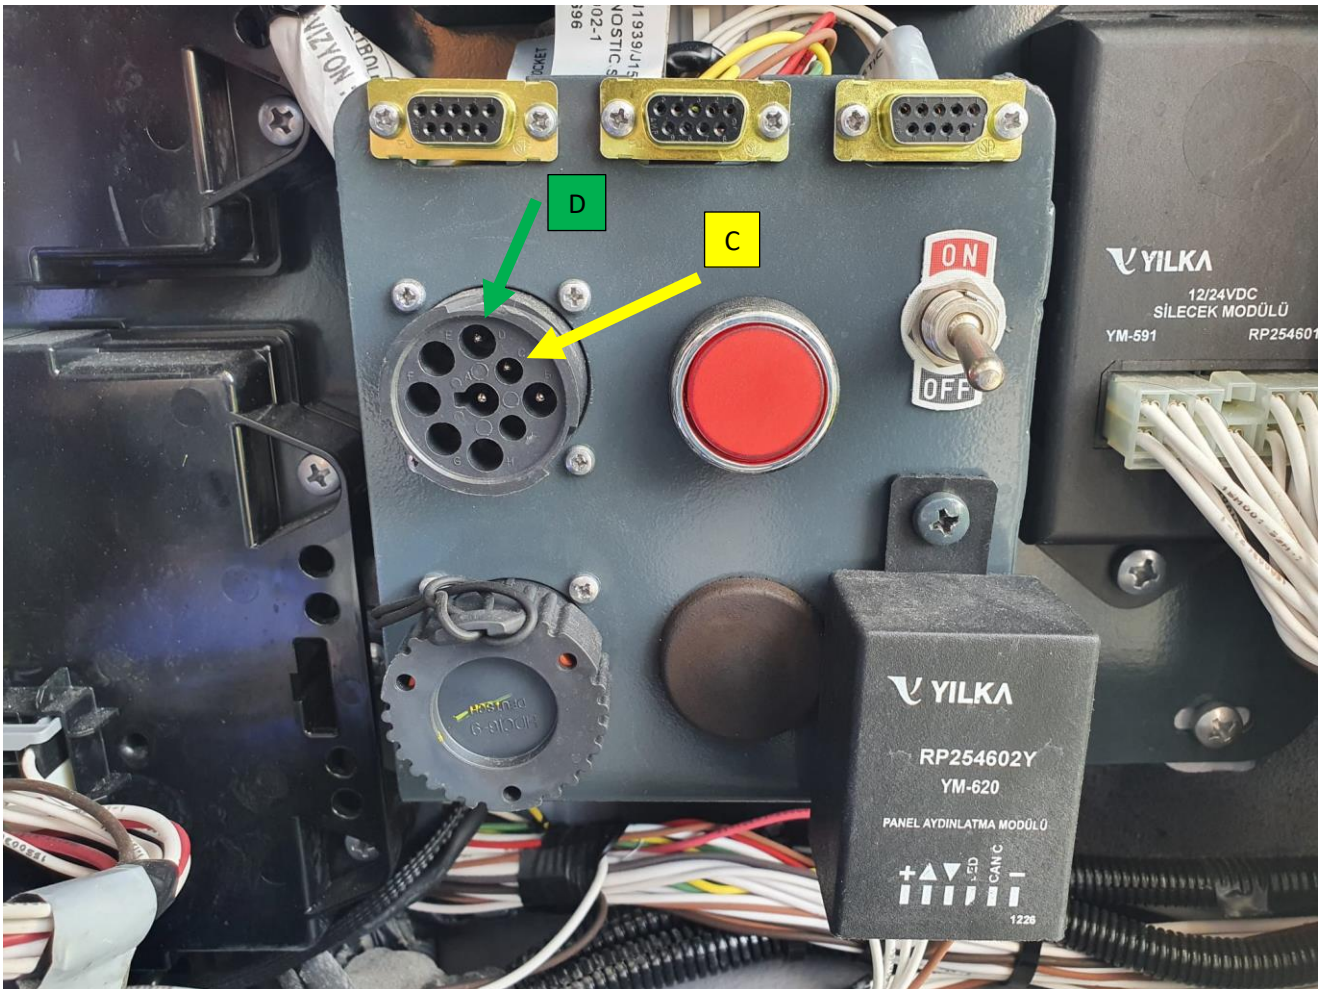
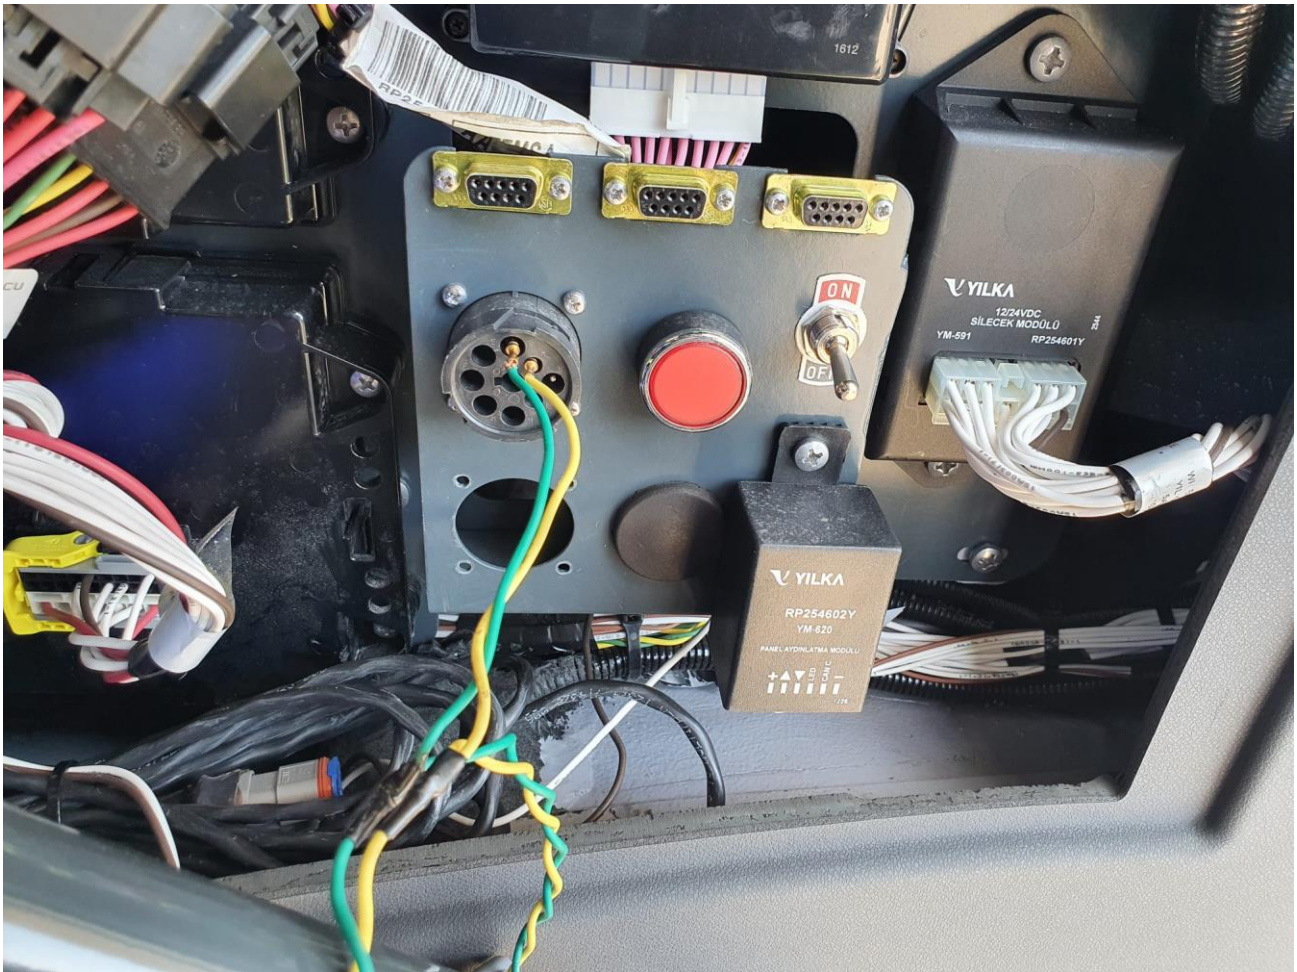
2-Connect your computer to the vehicle by using the CANalyzer interface. Plug the USB part into your computer and connect your CAN cable to the 9 pinned OBD port with the **D** pin low and the **C** pin high.

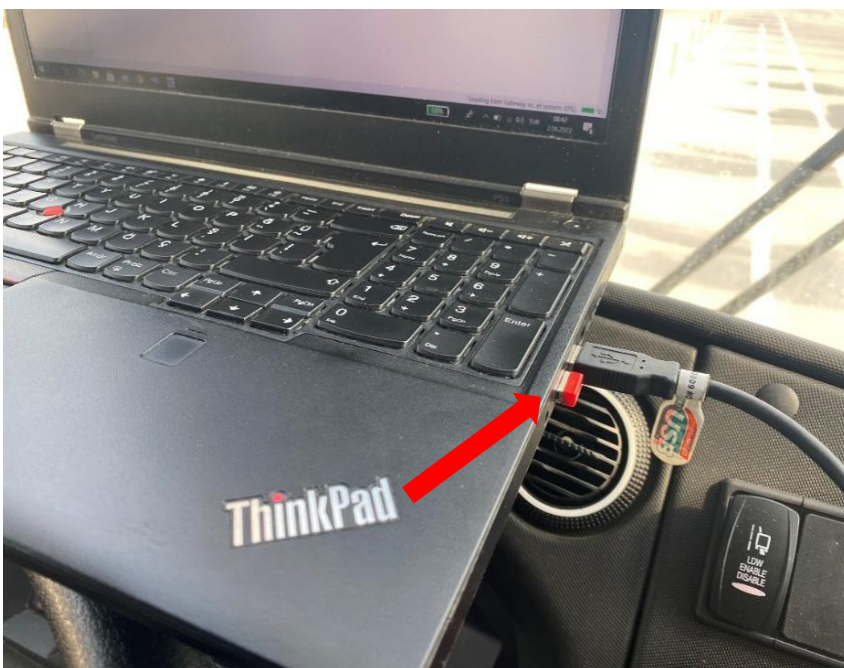
4- Make sure that the KIBES dongle is inserted to your computer.

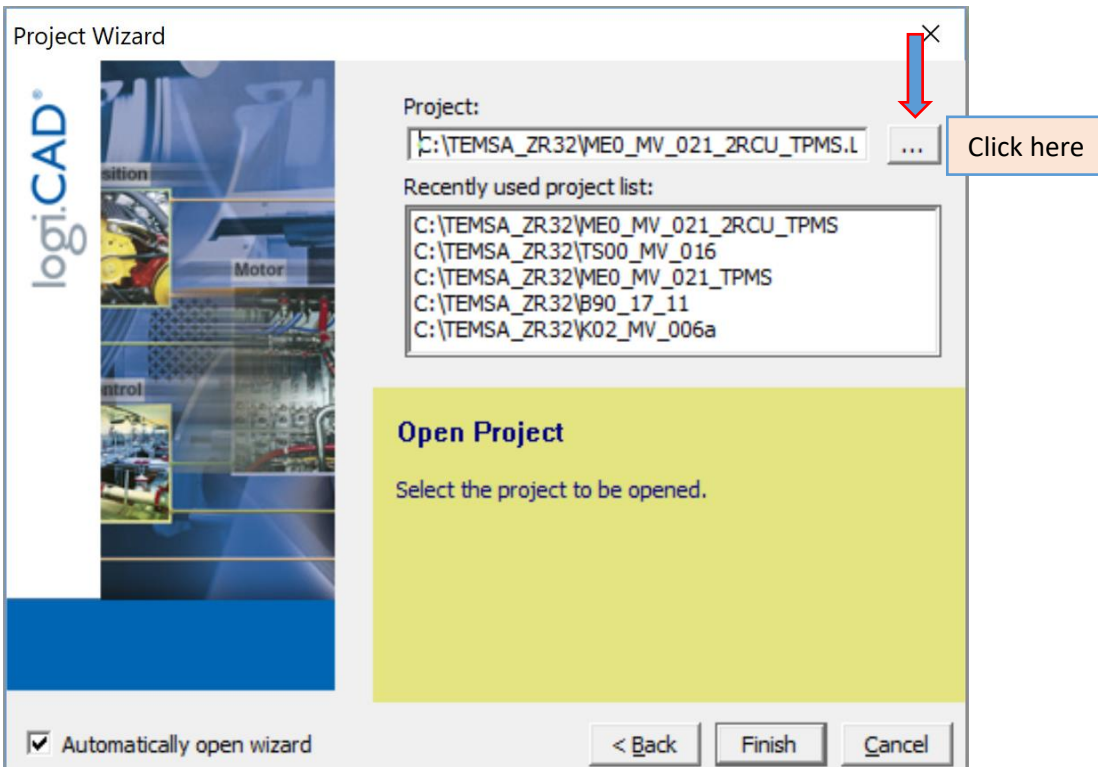
5- Select the "Open Project" selection and click "next".

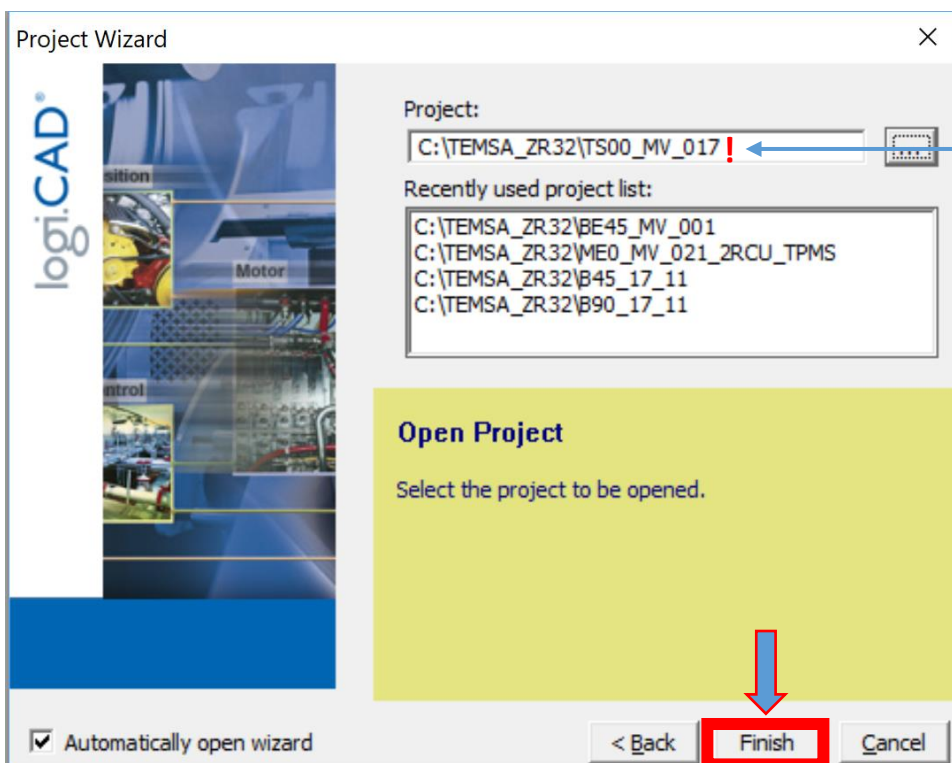
2- Select **TS00_MV_020**. Then click “ok” after that click “Finish”.

Hint: The software version must be selected correctly. The number shown in the picture may be representative.

Make sure you choose the right program.

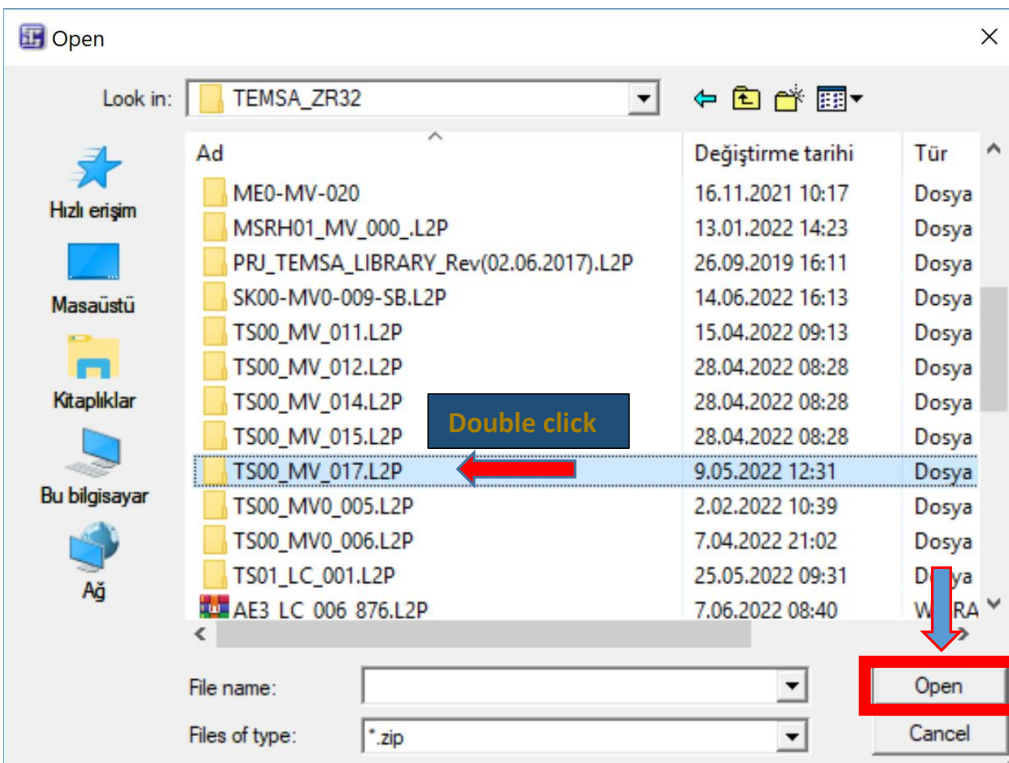
9- You should find program in your workspace then double click the program.

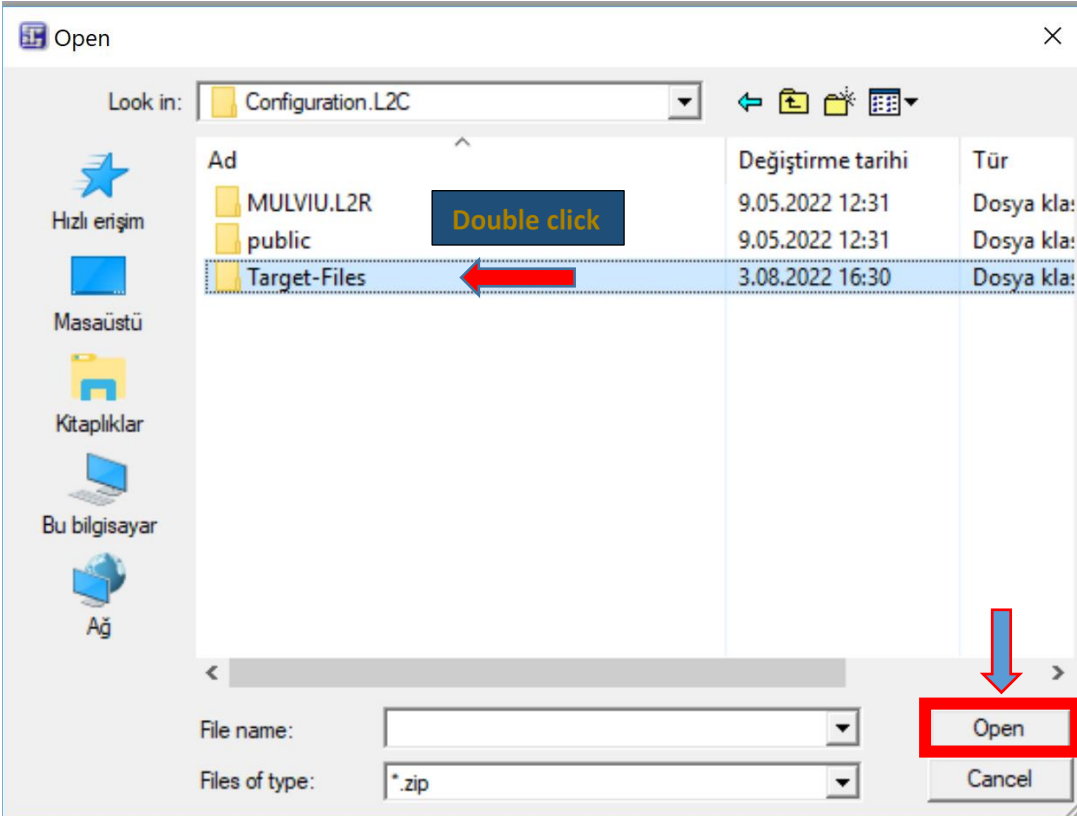
10- Click on “MRT” then click “Open”.

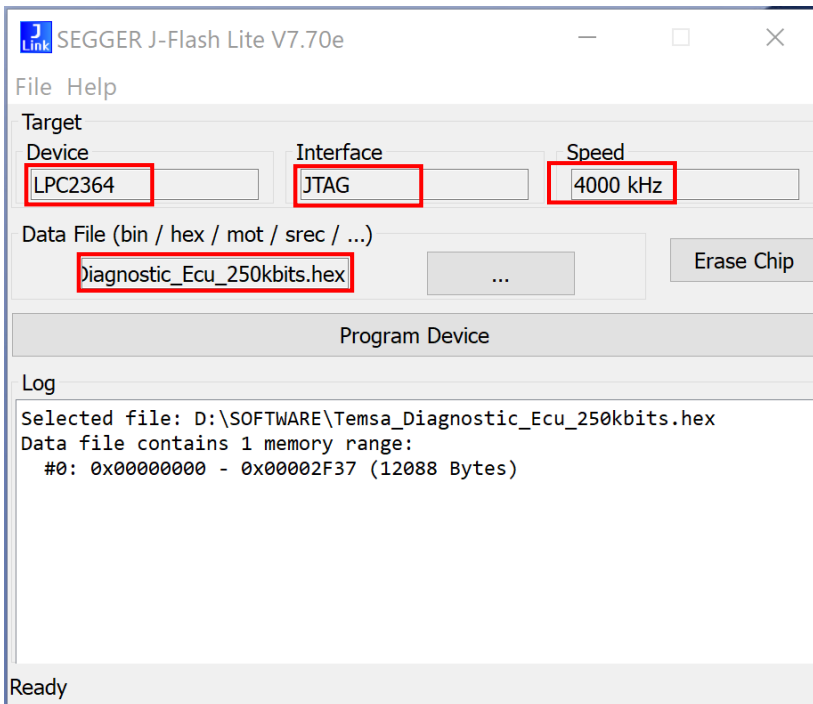
22. You should check all things (in the red boxes) are correct. After that click "Program Device".
