# TECHNICAL SERVICE BULLETIN

## Technical Service Bulletin: 10-1577

Forest River is alerting you to an issue involving certain 2023 Rockwood and Flagstaff Travel Trailer Recreational Vehicles. Please see the information below which describes the issue and provides you with details on the steps you should take to have your vehicle repaired.

# TECHNICAL SERVICE BULLETIN 10-1577 REMEDY INSTRUCTIONS

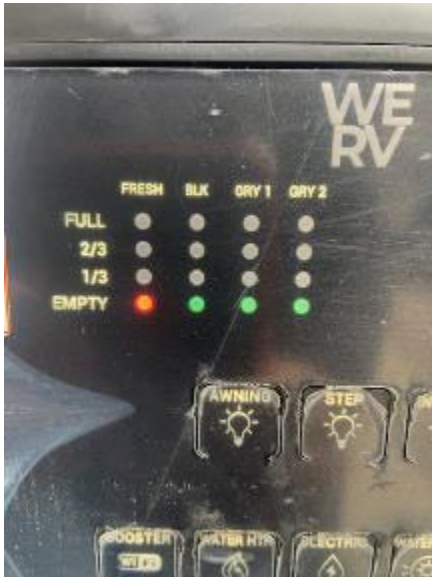
FIG. 1

- IF THE MONITOR PANEL IS EQUIPPED WITH "GRY 1" AND "GRY 2" (FIG.1) – CLAIM INSPECTION CODE ONLY
- IF THE MONITOR PANEL IS EQUIPPED ONLY WITH "GRY 1" (FIG. 2) – MOVE TO REMEDY

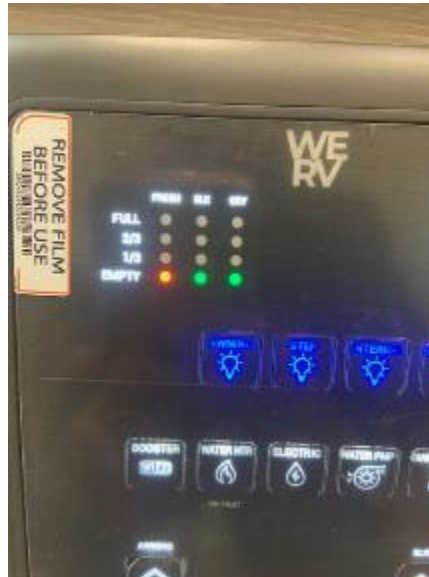
FIG. 2

The current monitor panel installed in certain vehicles may not have the second grey water tank display.
