Technical Service Bulletin

Subject: WHITE STAINS FROM UNDER OUTER MIRROR BASE	Bulletin No.: 09-001/22
	Last Issued : 11/09/2022

Some vehicles may experience white-streak stains appearing on the front door that look like they seeped out from under the outer mirror base. This is caused by water intruding from gaps of the outer mirror body and/or the hinge of the outer mirror, and corrosion occurring on the aluminum die-cast inner base in the outer mirror. Water, including white-salty corrosion, may drip out from gaps under the outer mirror base resulting in white stains on the front door. To eliminate this concern, the front outer mirror inner base has been modified.

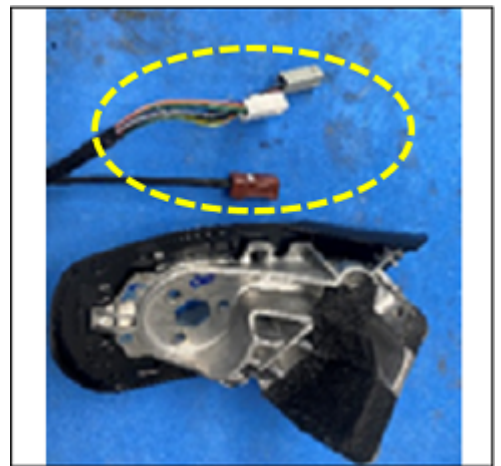
Finished to pull out

- (1) Connector: White
- (2) Connector: Gray
- (3) Connector: Brown

f. Remove the harnesses (1), (2), and (3) from the inner base.
NOTE: Removal order - 1st: White (1), 2nd: Gray (2), 3rd: Brown (3)

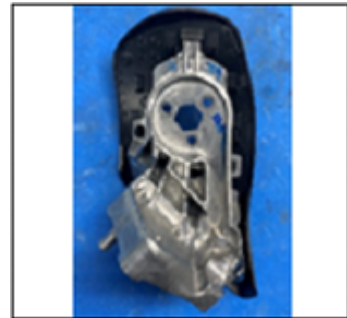
(1) Inner base
(2) Base cover (upper)

g. Attach a new base cover (upper) (2) to a new inner base (1).

h. Pass the harnesses through the inner base with the base cover (upper).

NOTE: Pass the harnesses through the inner base in the reverse order of pulling them out.
