Topic	V8 Kovomo - Bentayga - Water pump drive gear cover (Deletion)
Market area	Russische Föderation (5RU),Australia E04 Bentley rest Asia and Australia (6E04),China 796 VW Import Comp. Ltd (Vico), Beijing (6796),Germany E02 Bentley rest Europe (6E02),Japan E03 Bentley Japan (6E03),Korea, (South) E08 Bentley South Korea (6E08),United Arab Emirates E06 Bentley Middle East and Africa (6E06),United Kingdom E01 Bentley UK (6E01),United States E05 Bentley USA and rest America (6E05)
Brand	Bentley
Transaction No.	2065918/2
Level	EH
Status	Released for publishing
Release date	03-Nov-2022

V8 Kovomo engine

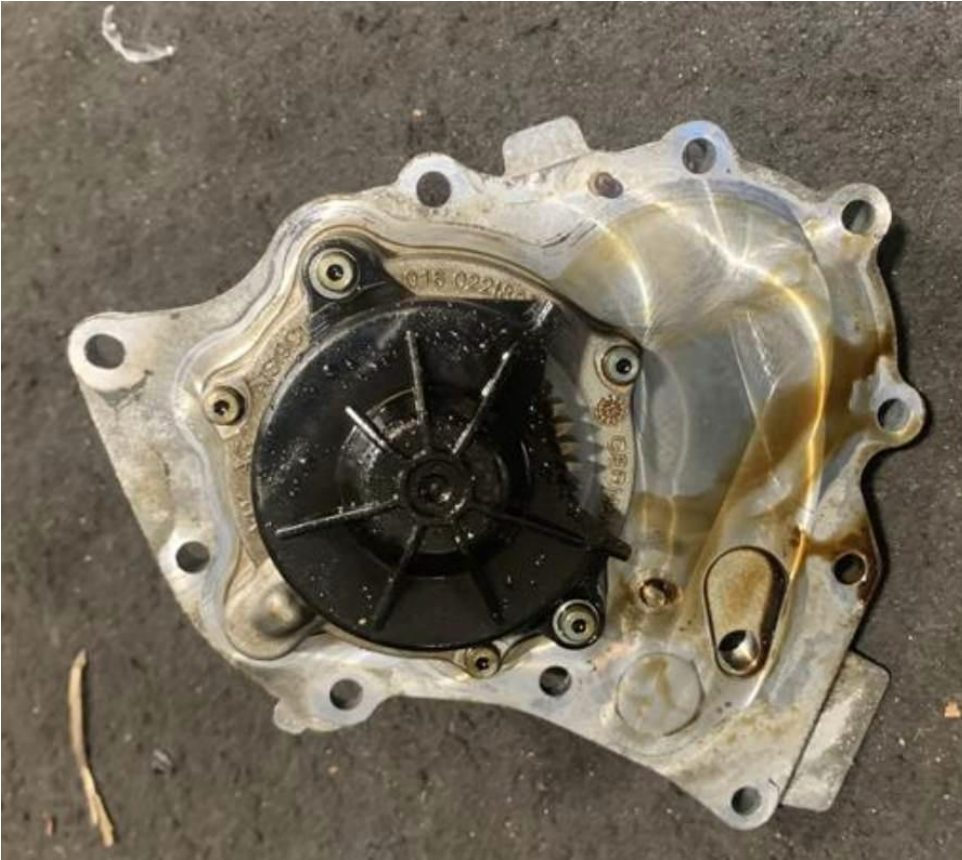
Figure 1

The original water pump has a cover fitted directly over the top of the water pump drive gear (Figure 1)

- The cover is no longer fitted on replacement water pumps, the cover is not required and MUST not be transferred to the new water pump

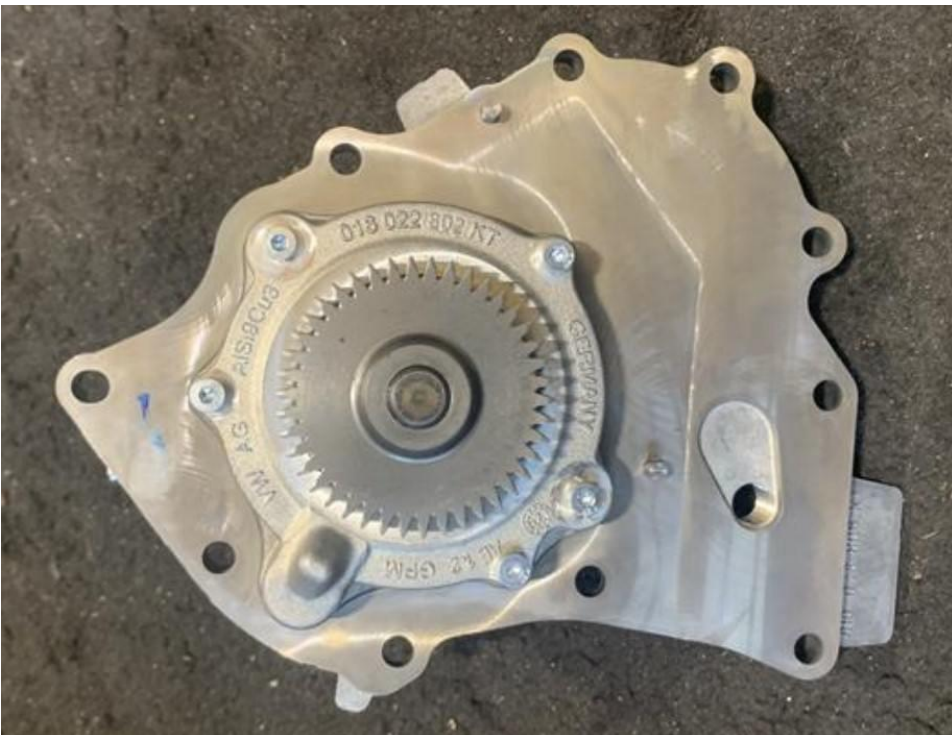
However the replacement water pump does not have a cover fitted (Figure 2)

The operative should fit the new water pump without the cover as shown in Figure 2
