Date: November 3, 2022
To: Dealer Principal, General Manager, Service Manager
From: Richard Kenton, Technical Director
Dan Schwartz, Service Area Manager

The purpose of this bulletin is to help you deal with this type of customer complaint, and then guide you through the installation of the **upper chain sliding shoe** (Part No. 44712611A) with the application of the new **neoprene pad** (Part No. 86613441A) on motorcycles that have not been upgraded yet.

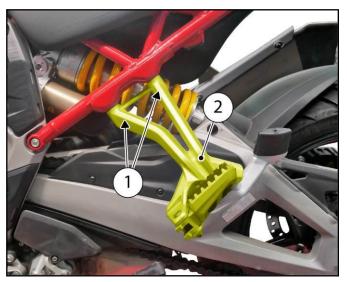
- 1. Check the wear of the final drive chain (See Service Bulletin SRV-SRB-20-050) and proceed as indicated:
 - With the chain in good condition, follow the procedure from point 2
 - With the chain NOT in good condition (replacement is necessary), follow the procedure from point 9 (it is not necessary to cut the new final drive upper chain sliding shoe)
- 2. Remove the 2 screws M8 (1) and remove the LH rear footpeg assembly (2).

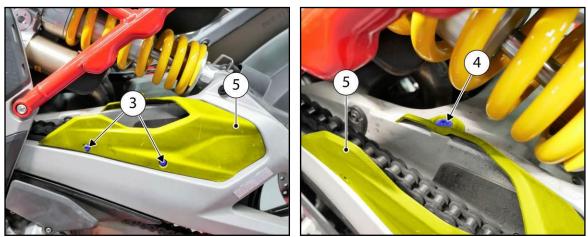
Remove the 2 self-tapping screws (3) and the screw M5 (4). Remove front chain guard (5).

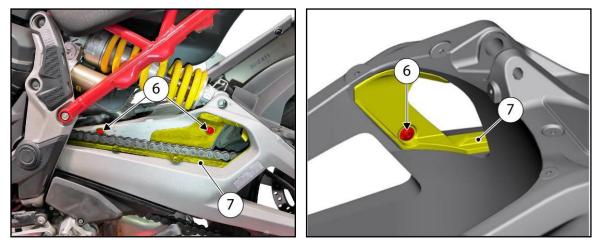
4. Loosen 3 M5 screws (6) securing the upper chain sliding shoe (7).

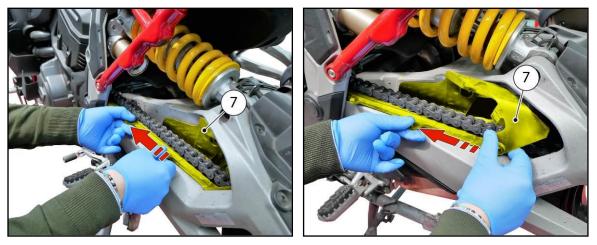
5. Slide the upper chain sliding shoe (7) forward and pull it out from its seat.

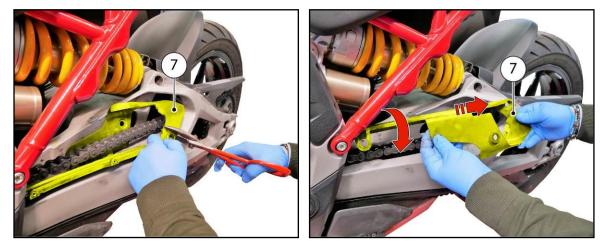
6. Cut the upper chain sliding shoe (7) where indicated, rotate it and then remove it.

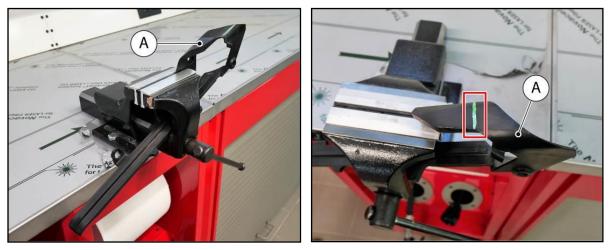
7. Position the new sliding shoe (A) Part no. 44712611A in a bench vice. With a felt-tip pen, mark where to make the cut on the **upper chain sliding shoe (A)**, as shown in the figure.

Make sure the vice is equipped with rubber protections so as not to damage the upper chain sliding shoe (A).

8. Cut the upper chain sliding shoe, taking care not to damage it.

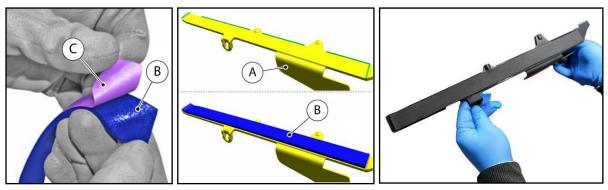
9. Take the **neoprene pad (B) Part no. 86613441A** to be applied to the **upper chain sliding shoe (A)**.

Remove the **double-sided adhesive film (C)** and apply the **pad (B)** on the lower side of the **upper chain sliding shoe (A)**.

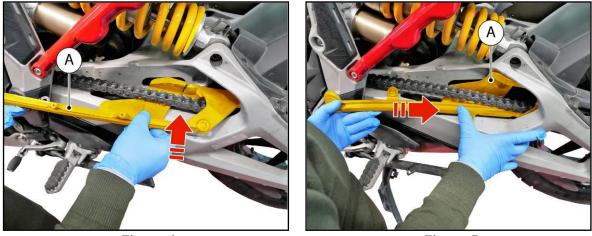
Figure A

10. Position the **upper chain sliding shoe (A)** inside the swinging arm, <u>routing the final drive</u> <u>chain through the cut made previously</u> (*Figure A*).

Insert the rear part of the **upper chain sliding shoe (A)**, as indicated by the arrows, inside the swinging arm *(Figure B)*.

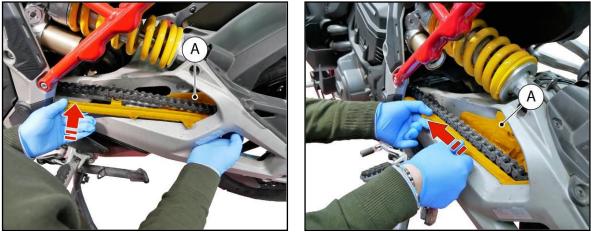
Figure C

Position the front part of the **upper chain sliding shoe (A)** (*Figure C*).

Finally insert the front part of the upper chain sliding shoe (A) (Figure D).

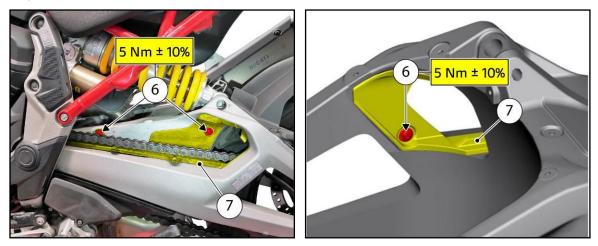
11. Apply LOCTITE 243 to the threads of the **3 M5 screws (6)**. Tighten the **3 M5 screws (6)** to a torque of <u>5 Nm ± 10%</u>.

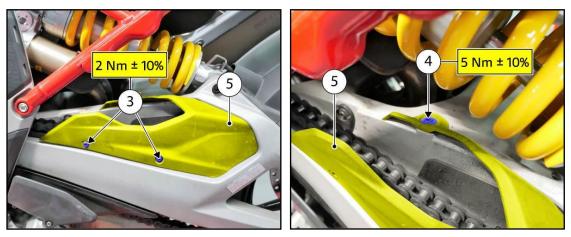
Apply LOCTITE 243 to the threads of the M5 screw (4). Tighten 2 self-tapping screws (3) to a torque of <u>2 Nm ± 10%</u> and M5 screw (4) fastening the chain upper guard (5) to a torque of <u>5 Nm ± 10%</u>.
