## Staining/Surface Damage on Door Trim Strips and Side Window Trim Element

Topic number	LI72.00-P-075505
Version	3
Function group	72.00 - General
Date	11/17/22
Validity	MODEL 247.7
Reason for change	Customer complaint clarification
Reason for block	Clarification of complaint

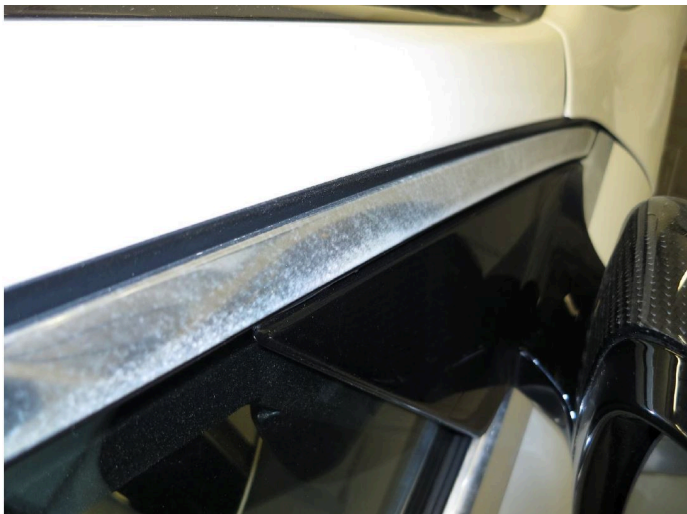
Attachments	
File	Description
<a href="#">Bild 2.jpg</a>

Example of complaint relating to door upper trim strip in silver look
<a href="#">Bild 3.jpg</a>	Example of door trim bar complaint on models with code P55 AMG Night Package

1. Check if the complaint cannot be rectified by polishing the trim bars with the polish.
2. If the complaint cannot be rectified, replace the door beltline trim bars, door upper trim bars and rear side window with trim element with optimized protective coating.

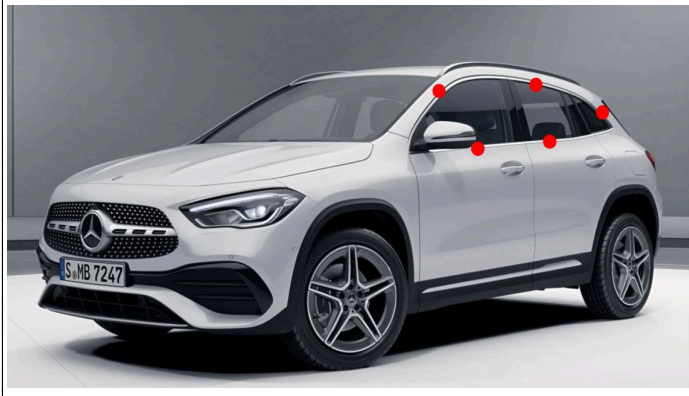
Bild 1.jpg

Overview of affected component parts
