## **SERVICE CAMPAIGN**

### **CONVENTIONAL TRANSMISSION JUMPER HARNESS REPLACEMENT**

CAMPAIGN NO: M0370

**SUBJECT VEHICLES:** Certain 17MY-20MY Conventional trucks equipped with a J08 engine.

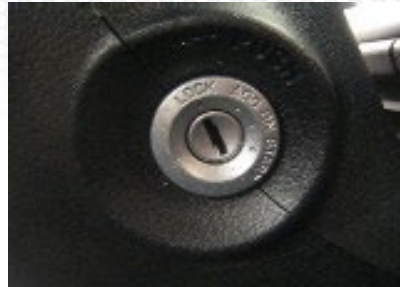
1. Park the vehicle on a level and solid surface. Confirm the engine is stopped, the starter switch is in the off (LOCK) position, and the key is removed.

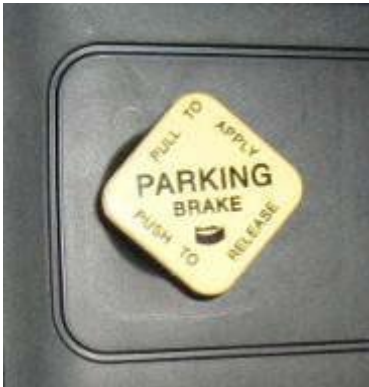
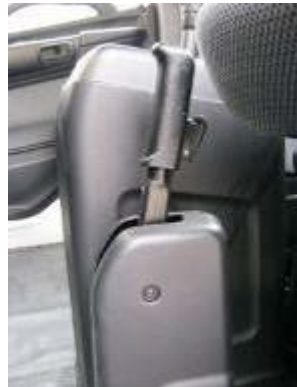
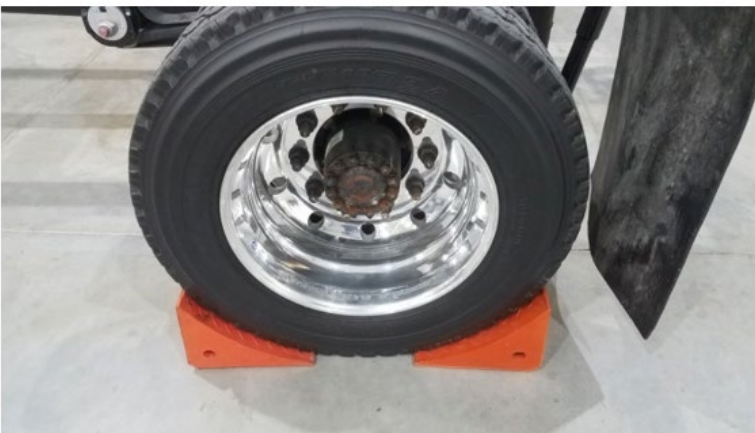
2. Apply the parking brake. Chock all of the wheels.

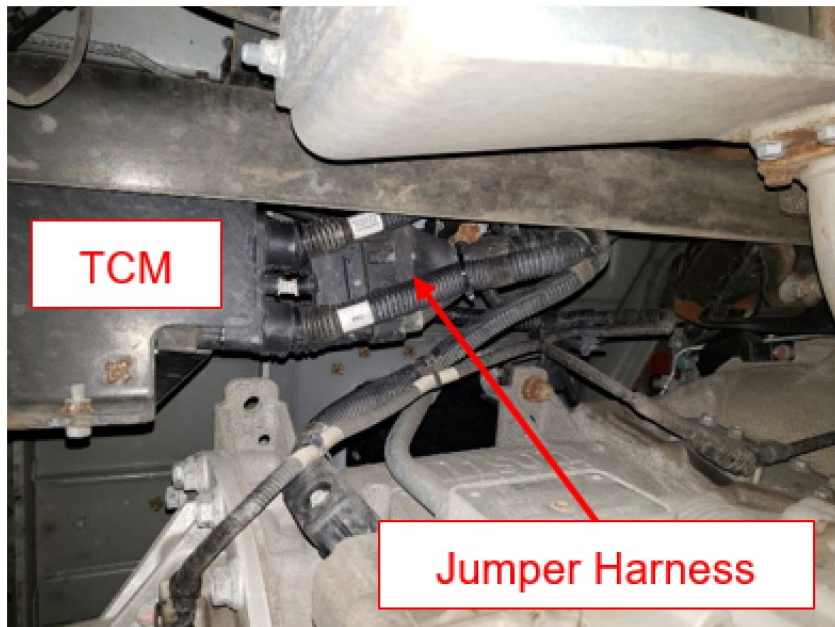
1. Working on the right-hand side of the transmission from under the vehicle, locate the jumper harness that connects between the transmission control module (TCM) and the chassis harness. Cut any zip ties securing this jumper harness to the vehicle.

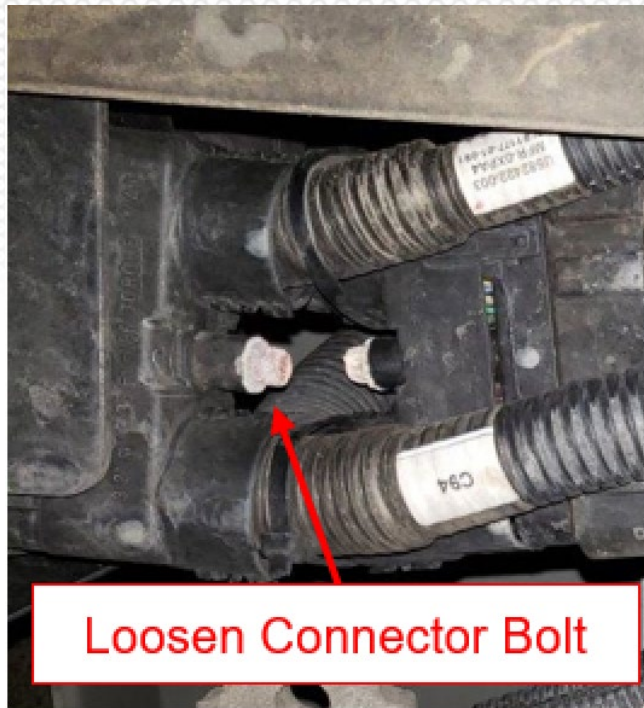
2. Loosen the bolt securing the jumper harness connector to the TCM. Disconnect this connector.

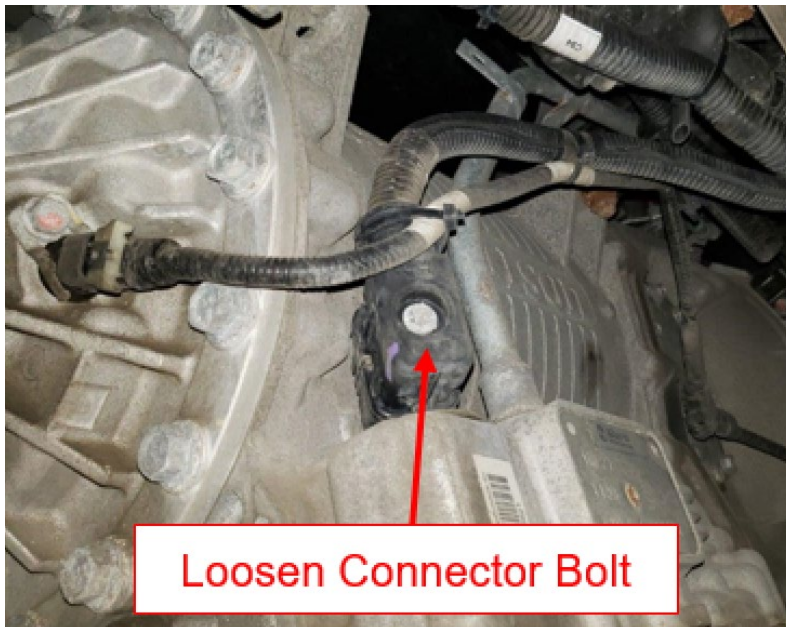
3. Loosen the bolt securing the jumper harness to the valve body connection on the right rear corner of the transmission. Disconnect this connector.

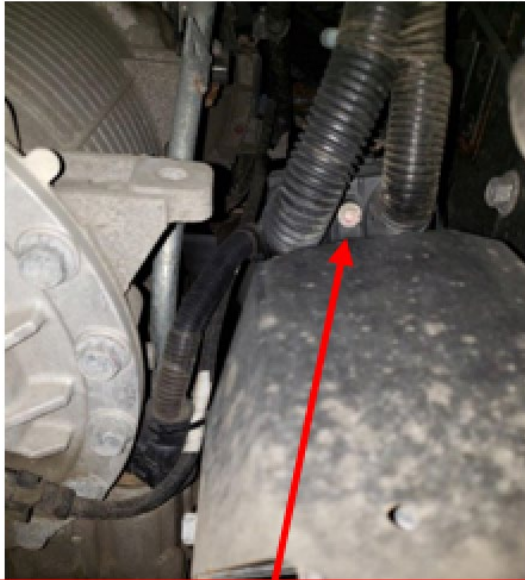
**Loosen Connector Bolt**

4. Loosen the bolt securing the jumper harness to the original chassis harness TCM connection. Disconnect this connector.

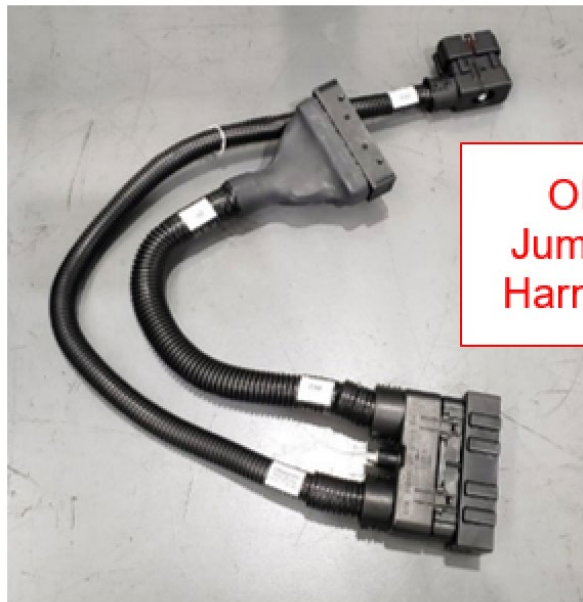
**Old  
Jumper  
Harness**

5. Cut any remaining zip ties securing the old jumper harness to the vehicle. Remove and discard the old jumper harness.

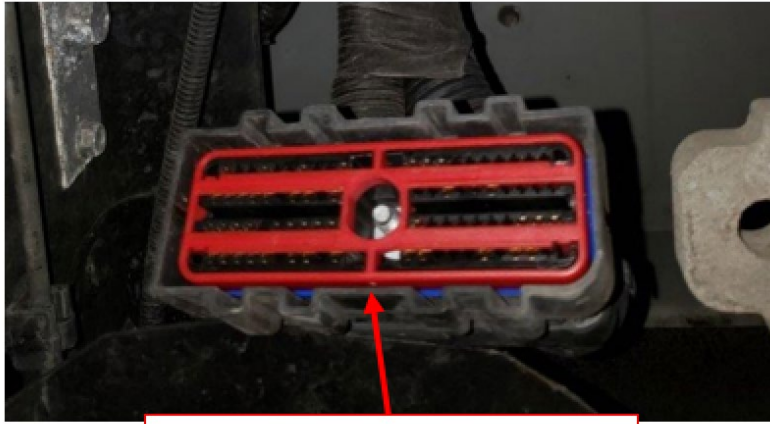
Inspect

6. Carefully inspect the TCM connection on the chassis harness where the old jumper harness was attached for signs of water intrusion or corrosion. Dry the connection if water is present. If corrosion is present, chassis harness replacement will be necessary.

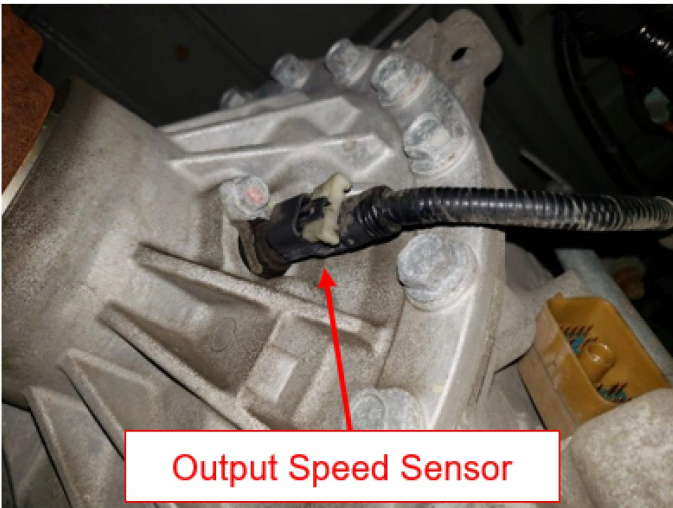
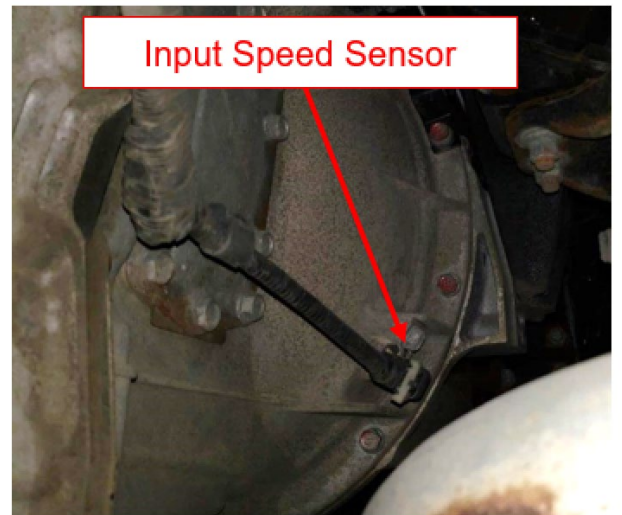
7. Disconnect the transmission input and output shaft speed sensors by first sliding the white locking clip away from the sensor and then releasing the connector.

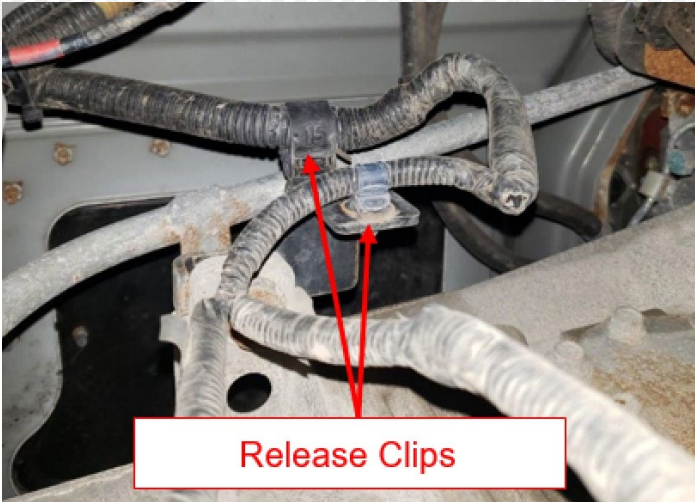
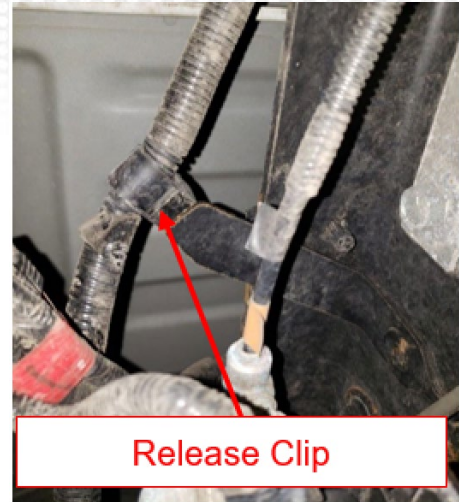
8. Release the harness clips securing the speed sensor wire branch of the chassis harness to the transmission and chassis. Position this wire branch out of the way over the rear of the transmission until later in this procedure. The speed sensor connections will be incorporated into the new jumper harness.

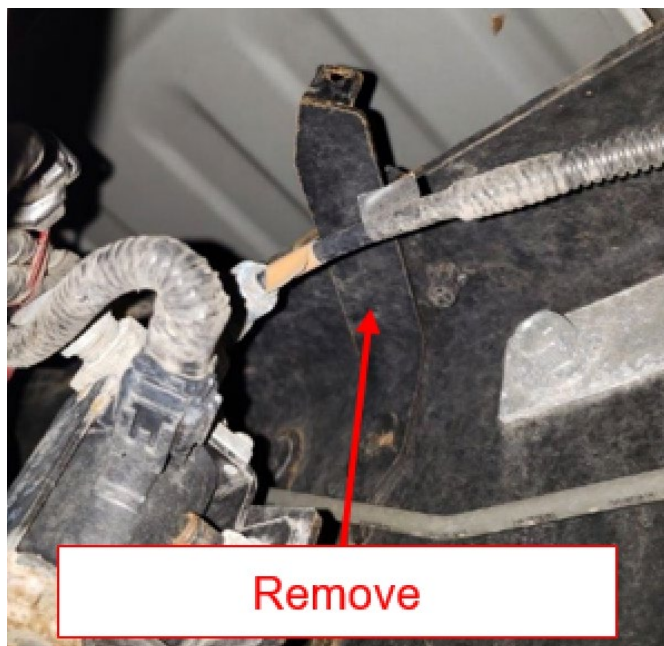
9. Remove the wire harness bracket above the exhaust brake control solenoid from the frame rail by removing the single nut from the outside of the frame rail.

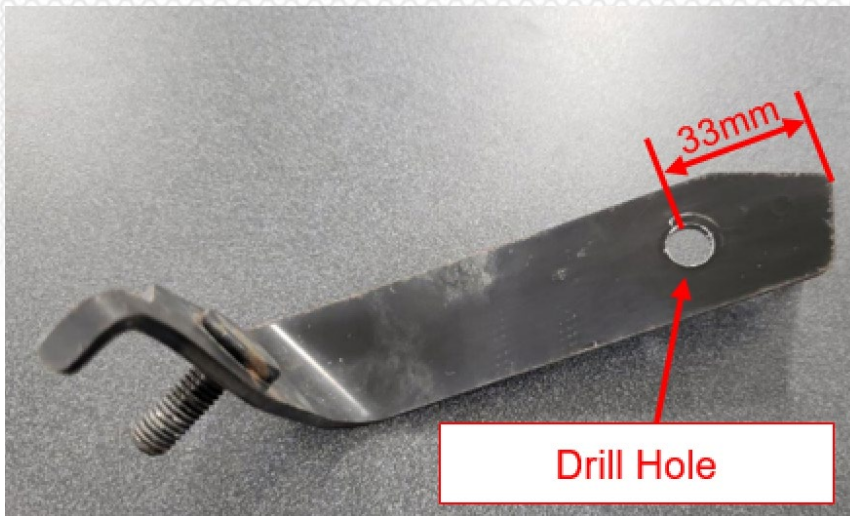
**10.** Mark and drill a 3/8-inch hole 33mm from the end of the wire harness bracket removed in step 9.

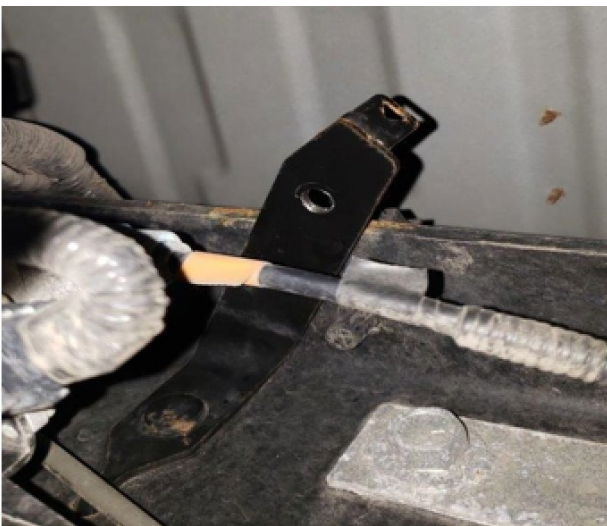
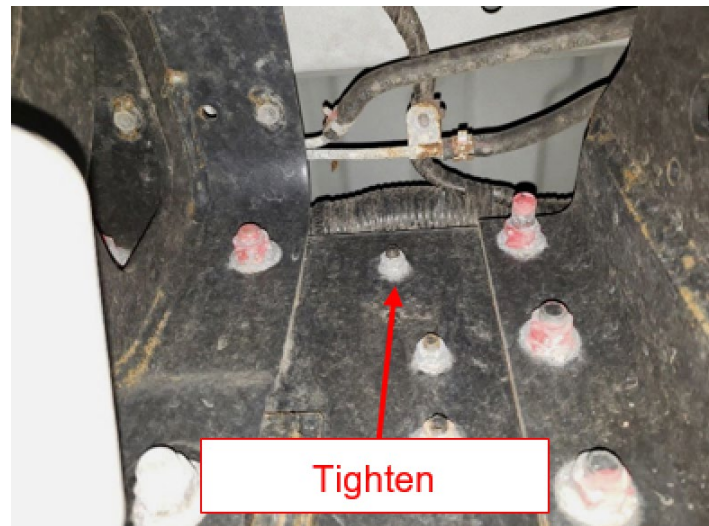
**11.** Reinstall the wire harness bracket. Tighten the nut to specified torque.

**Specified Torque:** 16 lb-ft (22 Nm)

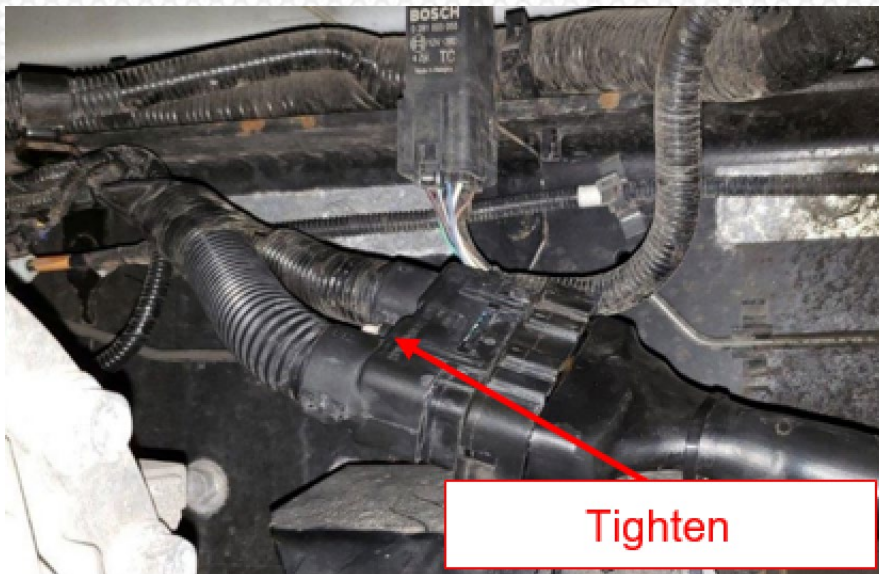
**12.** Attach the new US82125001 jumper harness to the chassis harness TCM connection and position above the TCM mounting bracket. Tighten the connector bolt to the specified torque.

**Specified Torque:** 26 lb-in (3 Nm)

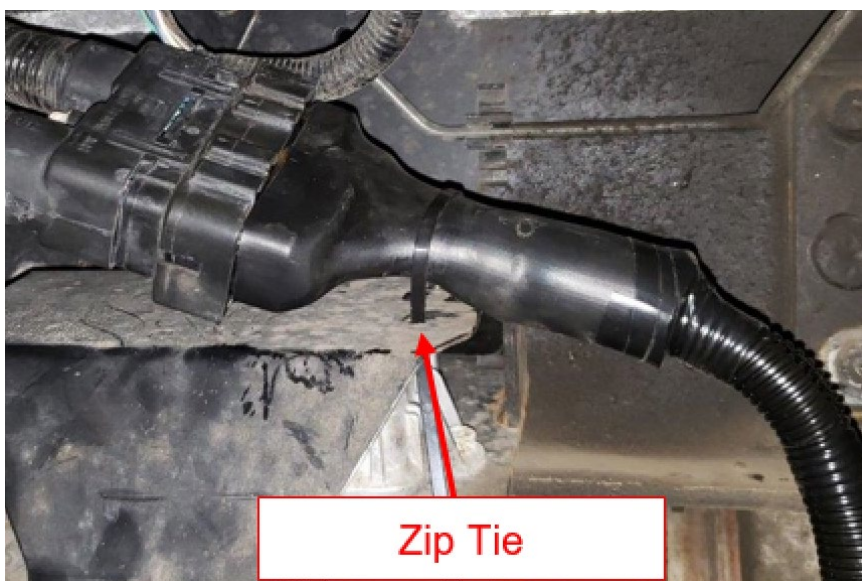
**13.** Run a zip tie through the two holes in TCM cover and secure the jumper harness to the TCM cover.

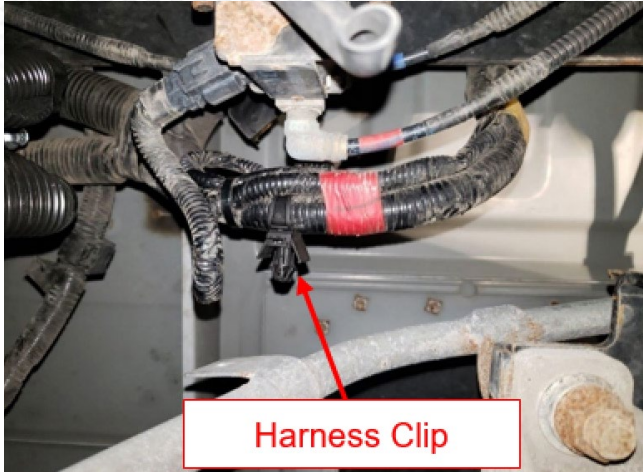
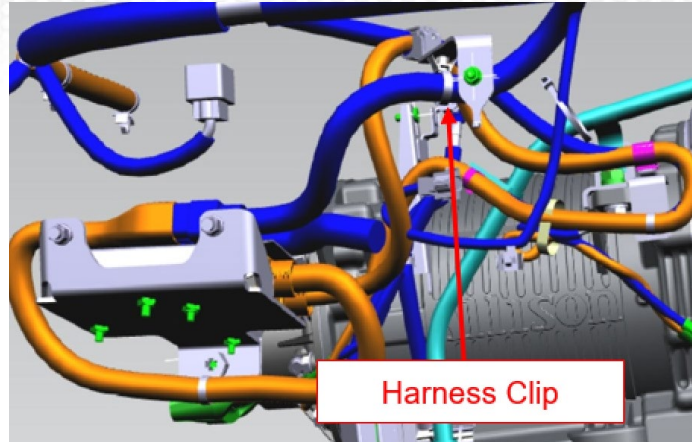
**14.** On the section of chassis harness that runs above the exhaust brake solenoid and connects to the jumper harness above the TCM in step **13**, install the 827112610A harness attachment clip. Attach from the underside to the hole drilled in the bracket in step **10**. Refer to the depiction below on the right, where the frame rail is not shown.

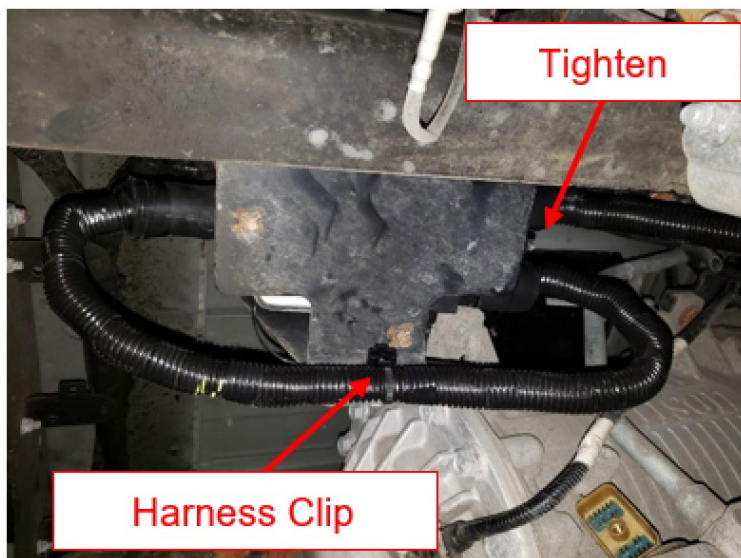
**15.** Route the jumper harness underneath the TCM mounting bracket. Attach the jumper harness clip to the exposed bolt as shown and connect the jumper harness to the TCM. Tighten the connector bolt to the specified torque.

**Specified Torque:** 26 lb-in (3 Nm)

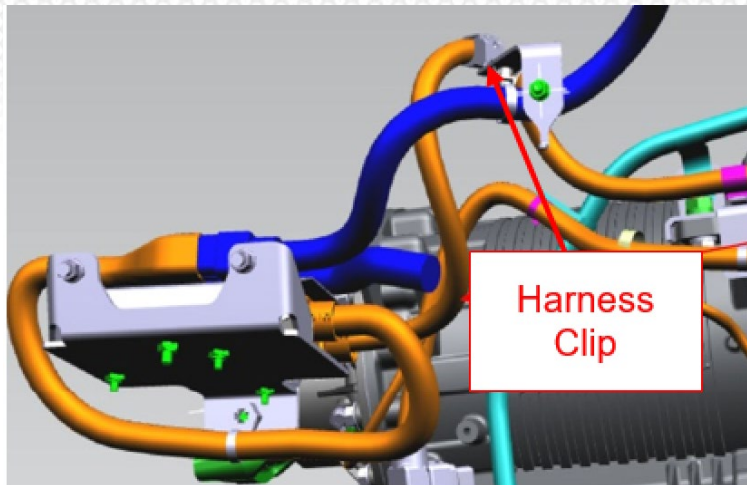
**16.** Route the remaining portion of the jumper harness up and over the frame rail bracket, attaching the clip shown to the right where the original chassis harness was previously installed. Refer to the depiction on the right, where the jumper harness is shown in orange and the frame rail is not shown.

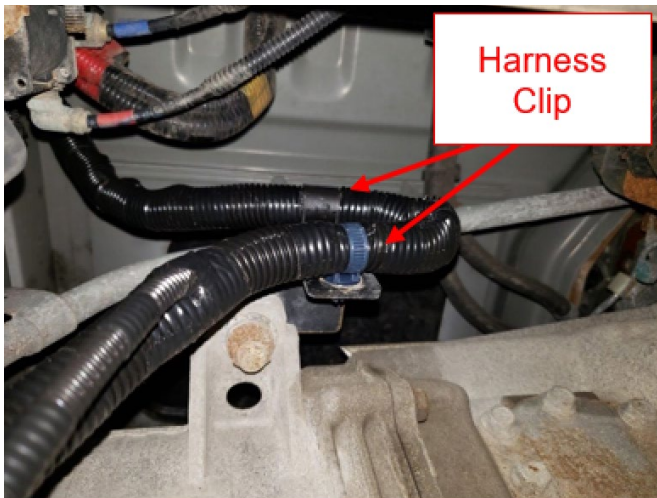
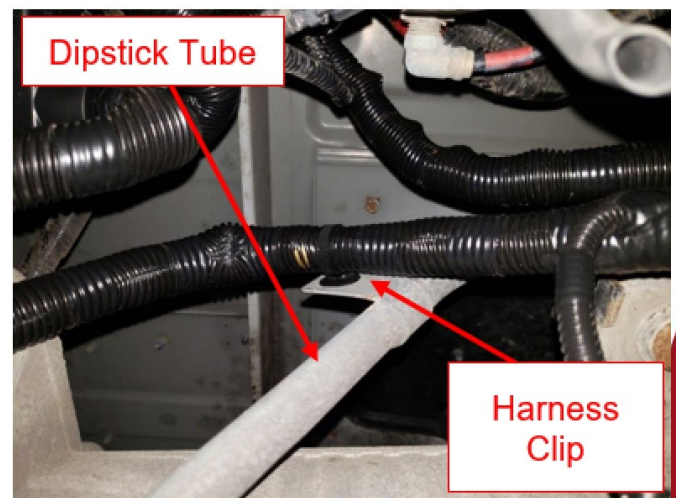
**17.** There are three harness clipping points on the right side of the Allison 3000 Series transmission. Route and connect the jumper harness to all three locations as shown.

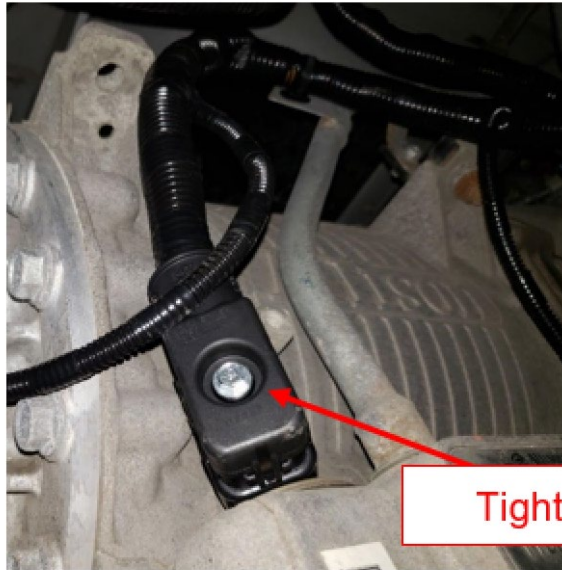
**18.** Connect the valve body connection on the jumper harness to the transmission. Tighten the connector bolt to the specified torque.

**Specified Torque:** 26 lb-in (3 Nm)

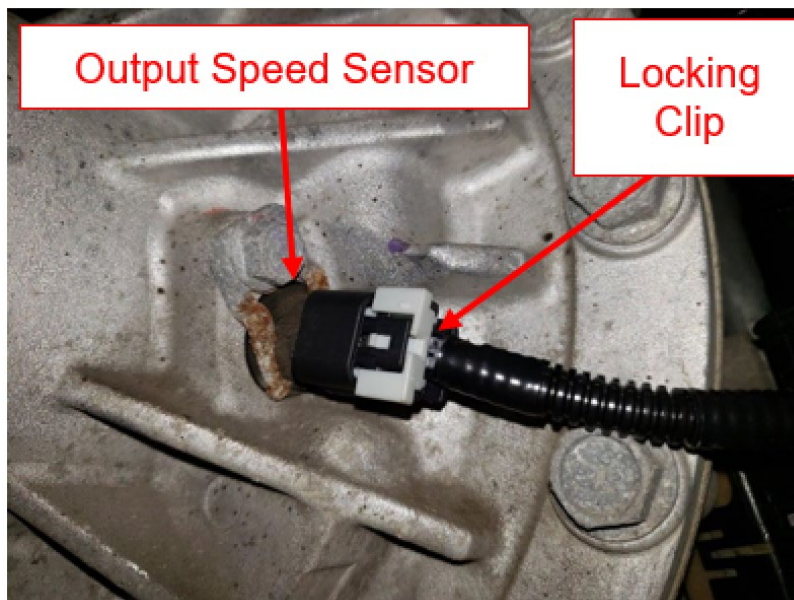
**19.** Connect the output shaft speed sensor connection on the jumper harness to the output shaft speed sensor. Ensure the white locking clip is pushed inwards after completing the connection.

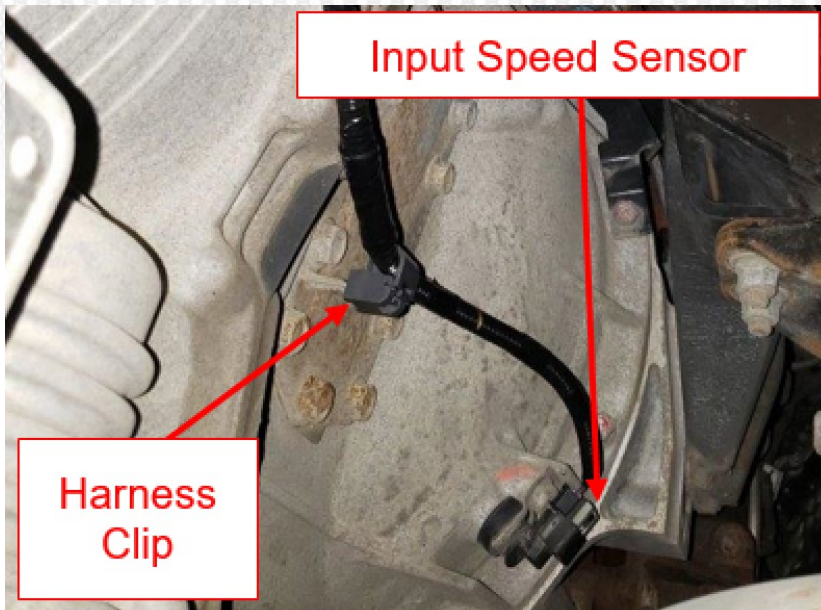
**20.** Connect the input shaft speed sensor connection on the jumper harness to the input shaft speed sensor. Ensure the white locking clip is pushed inwards after completing the connection. Attach the harness clip to the tab on the side of the transmission.

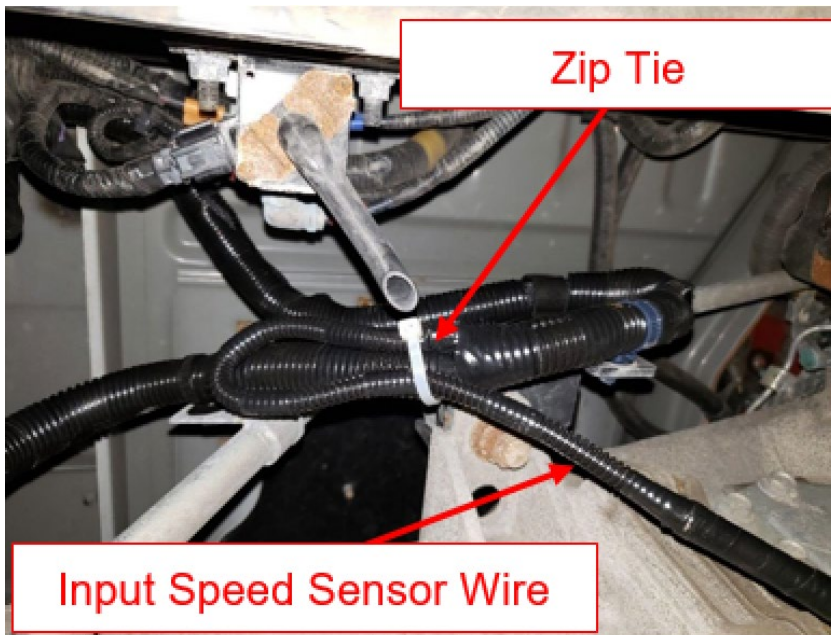
**21.** Zip tie any excess length on the input shaft speed sensor wire to the jumper harness as shown.

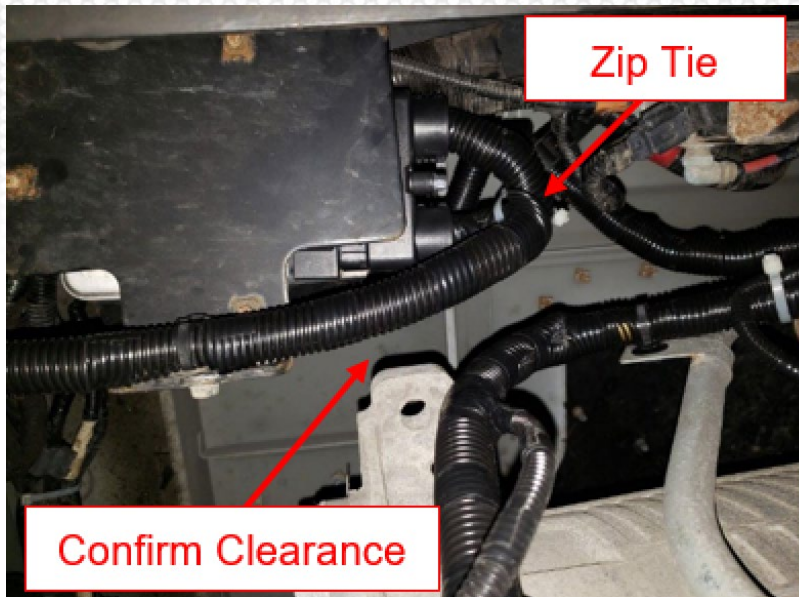
**22.** Zip tie the branches of the jumper harness together as they exit the connection at the TCM to ensure at least one inch of clearance between these harness branches and the transmission.

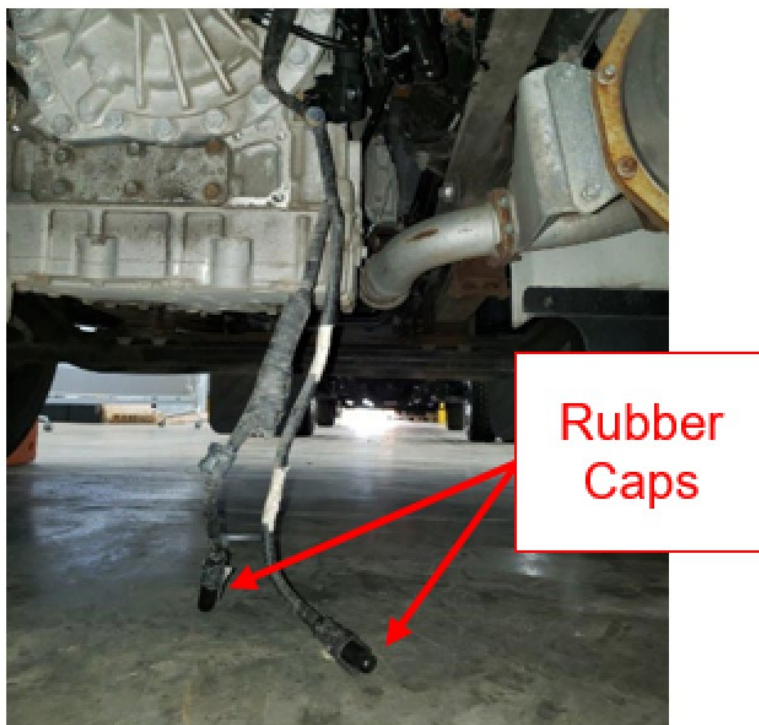
**23.** Install the HN001234305 rubber caps on the unused speed sensor connections of the chassis wire harness that were positioned aside in step 8.

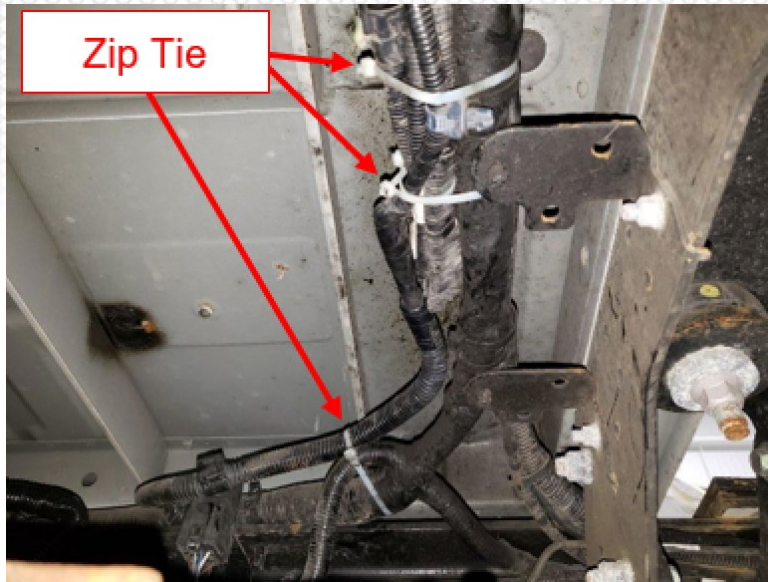
**24.** Bundle the unused chassis wire harness speed sensor section and zip tie to the main section of the chassis wire harness on the underside of the cab.
