# HYUNDAI

## Technical Service Bulletin

22-01-086H

**SUBJECT:** HYDROGEN STACK PRESSURE SENSOR INSPECT AND REPLACE  
(CAMPAIGN T9C)

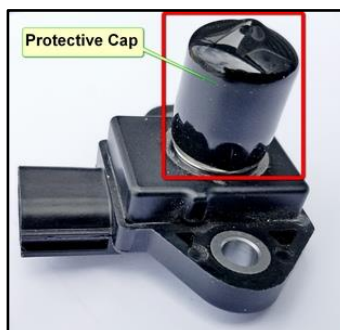
- Damage to the sensor may occur if the metal foil membrane (A) contacts other objects. Do not touch or allow sensor membrane to contact other objects.
- Use extreme care when handling and installing the sensor. Keep protective cap installed until the sensor is ready to install.

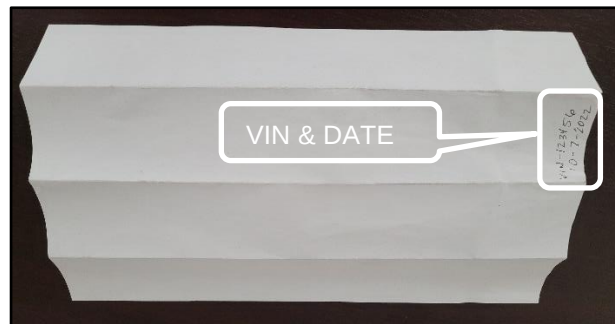
- Using a letter size sheet of paper, fold it four (4) times lengthwise. Place the VIN and inspection date on the end of the paper. Insert the folded paper next to the stack pressure sensors with the VIN and date visible when taking the STUI photo.

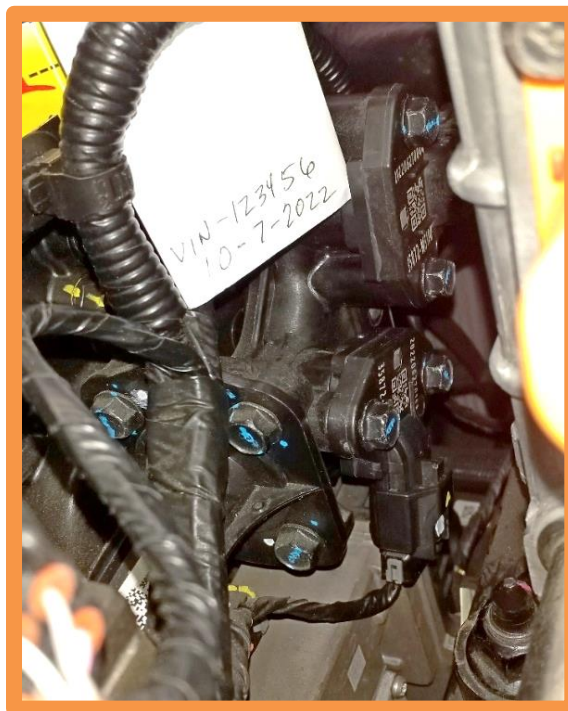
- If the sensor is labeled same as the “After Improvement” image (no white label), then submit STUI photo of the sensors and note, the procedure is complete.

Using STUI, photograph the stack pressure sensors with the current labels. Include in the photos a piece of paper containing the last 6 digits of the VIN and the date of the repair. Ensure the photo is in focus and captures the stack pressure sensor labels and the note. Upload the photo to STUI.

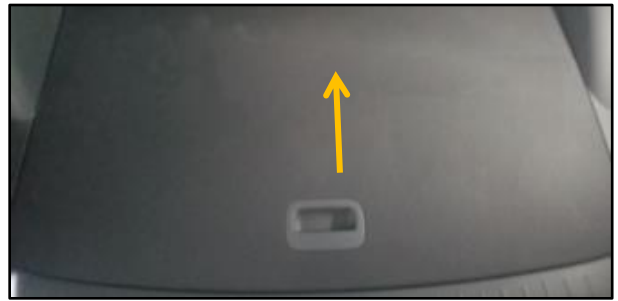
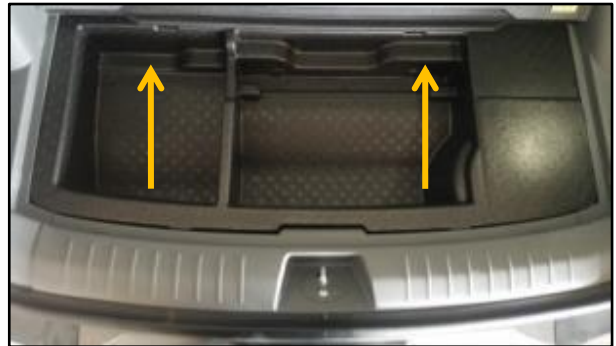
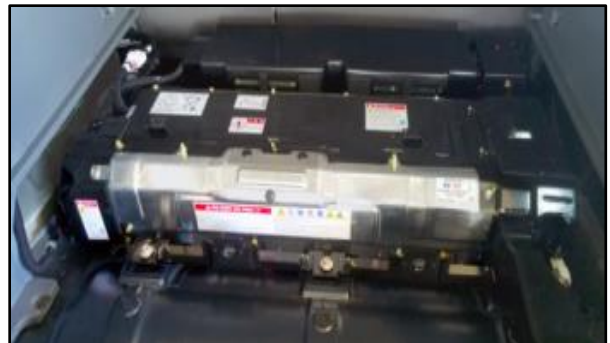
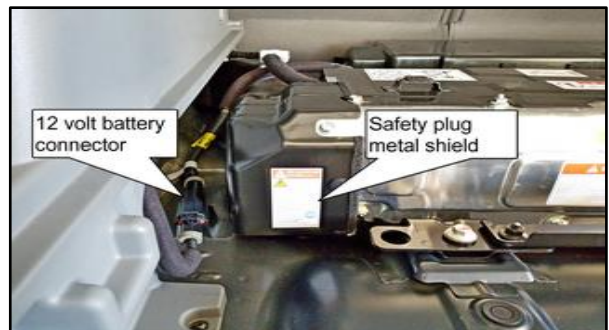
1. In the rear cargo area, remove the floorboard and cargo tray to access the 12-volt battery connector and high-voltage battery safety plug.

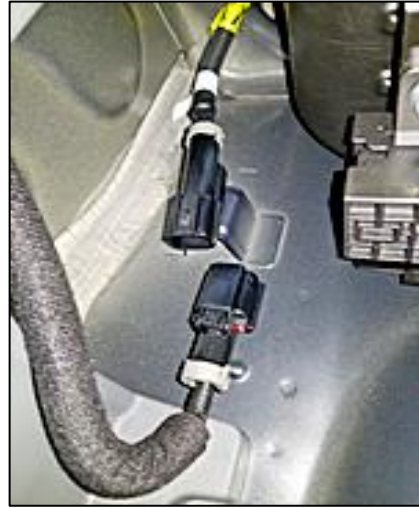
2. Disconnect the 12-volt battery negative (-) connector.

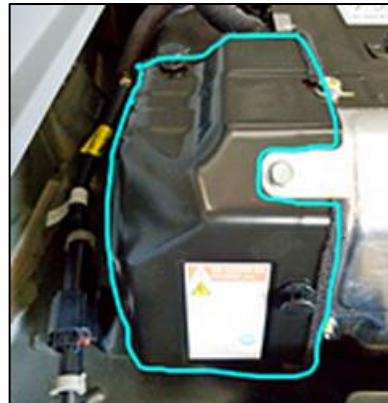
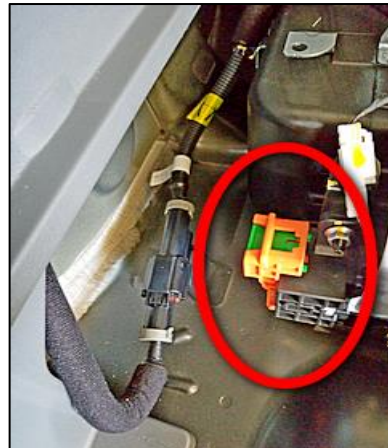
3. Remove the metal shield to access the high voltage safety plug.

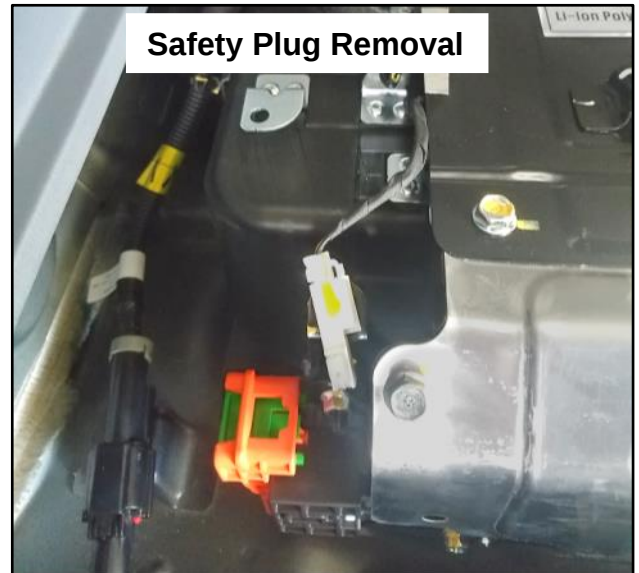
4. Follow A-D below to remove the orange high voltage safety plug.

Store the removed safety plug in a secure location outside and away from the vehicle.

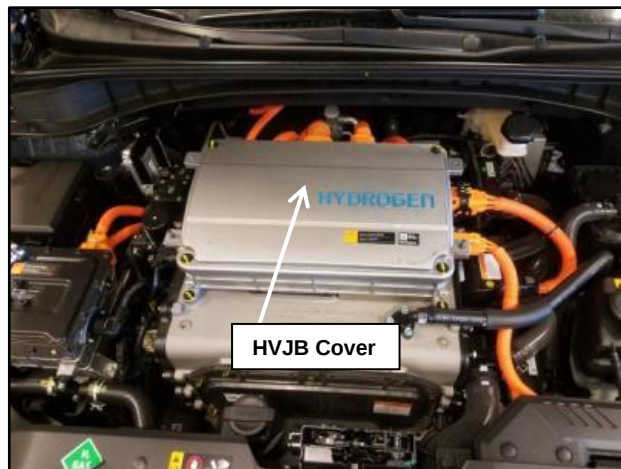
6. Open the hood. Remove the junction box trim and cover.

**High Voltage Junction Box (HVJB) cover:**

**Assembly bolt torque:**
