# HYUNDAI Technical Service Bulletin

| GROUP<br><b>CAMPAIGN</b> | NUMBER<br><b>22-01-050H</b> |
| DATE<br><b>NOVEMBER 2022</b> | MODEL(S)<br><b>Santa Cruz (NXT)</b> |

**SUBJECT:** NXT EMISSIONS SPECIFICATION STICKER RELABELING  
(SERVICE CAMPAIGN 980)

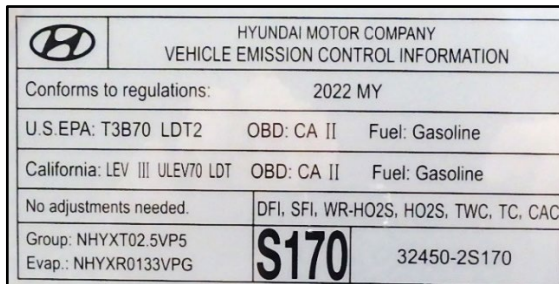
**Labels ending with part number 2S170 or 2S171 belong to 2.5L Turbo-GDI Vehicles.  
New part number will end with 2S172.**

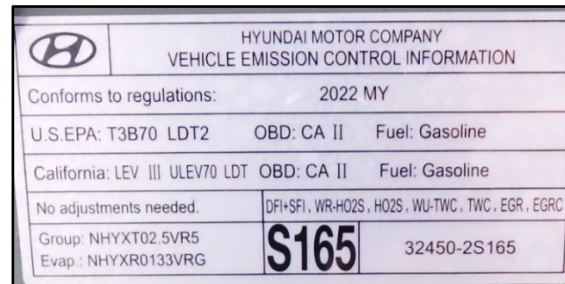
**Labels ending with part number 2S165 or 2S166 belong to 2.5L GDI Vehicles (non turbo).  
New part number will end with 2S168.**

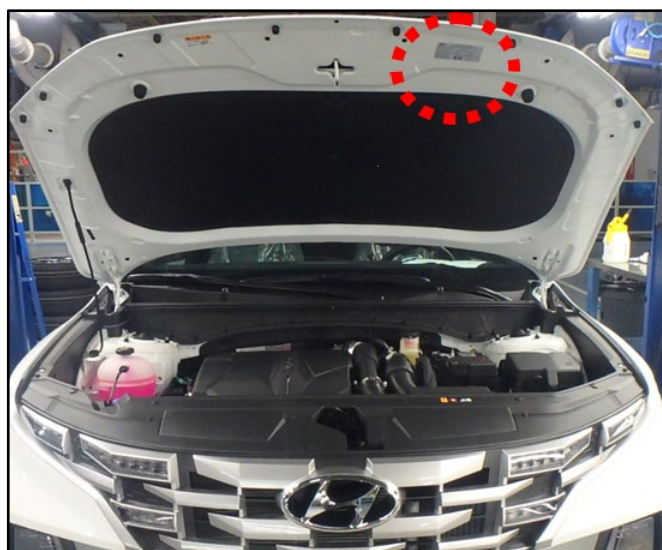
1. Open the hood panel and locate the emissions label outlined in the figure to the right.

**Identify which engine the vehicle is equipped with. The type of engine will determine the necessary label.**
