BODY & CHASSIS

Powered Loadspace Cover Does Not Open Correctly	23MY New Range Rover (L460),
<p>Customer Voice:</p> <ul style="list-style-type: none">- A customer may report that the powered loadspace cover does not open properly when actuated. <p>Technical Description:</p> <ul style="list-style-type: none">- The loadspace cover may not initiate the fold properly due to incorrect hinge break point angle. <p>Status:</p> <ul style="list-style-type: none">- SSM 75746 has been published to provide an interim solution to the concern.- The felt tape is from the Automotive Squeaks & Rattles Kit (JLR-NSL1001) available to order through Bosch.- Replacement Felts & Foam Packs (JLR-NSL1001/7) are also available to replenish the kit.

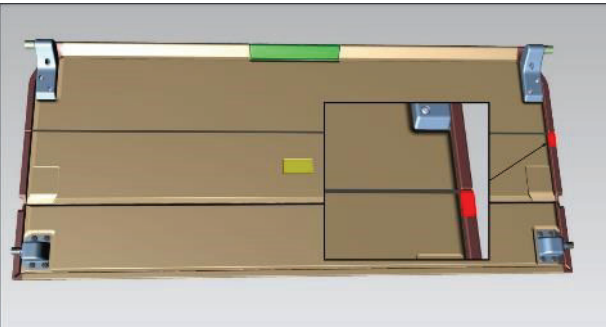
<p>A 3D cutaway diagram of the loadspace cover mechanism. The diagram shows the cover in a partially open position, revealing the internal hinge assembly and the motor. The cover is brown, and the hinge components are blue and red. A green bar is visible on the top edge of the cover. The diagram is set against a light gray background.</p>
