# Service Campaign 984 – Underbody Corrosion Preventative Service - Dealer Best Practice

December 01, 2022

In certain areas, a vehicle's underbody may exhibit corrosion due to road-salt usage. As a preventative measure, a cavity wax coating is applied to the internal surfaces of underbody components and an undercoating spray is applied to exterior surfaces of specified underbody components. The service campaign describes the procedure to perform this preventative service on certain 2011 – 2016 Elantra's (MD/UD).

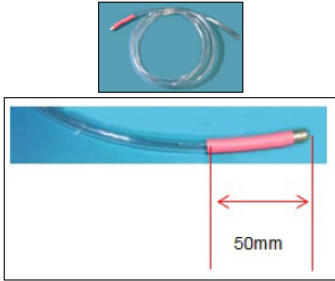
09624-2H101-QQH	This is a newly developed nozzle that has an improved wax application spray pattern.  The pink tubing is to signal the user to stop spraying when pulling the nozzle out.  <u>This nozzle must be used for this service procedure.</u>
"Outside" Nozzle

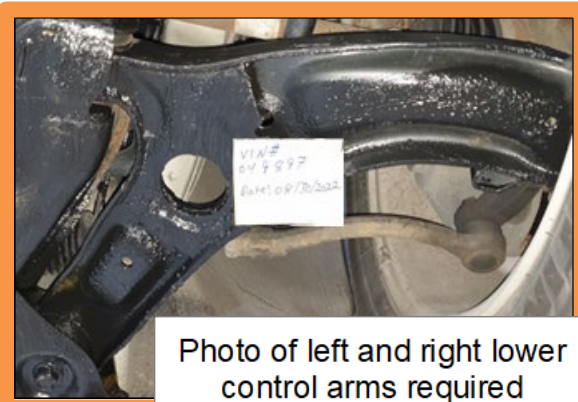
Photo of left and right lower control arms required

Ensure STUI photos of the black undercoating applied in the specific areas noted below with the last 6 digits of the VIN and the date of repair are included & uploaded. **Refer to TSB 22-01-089H.**
