Title: Turbocharger Oil Supply Tube Retrofit

Applies To: ProStar® 122, ProStar® 113, WorkStar®, CAT®, TranStar®, PayStar®, LoneStar® models equipped with 2010 MaxxForce® 11 & 13, N13 Engines

DESCRIPTION

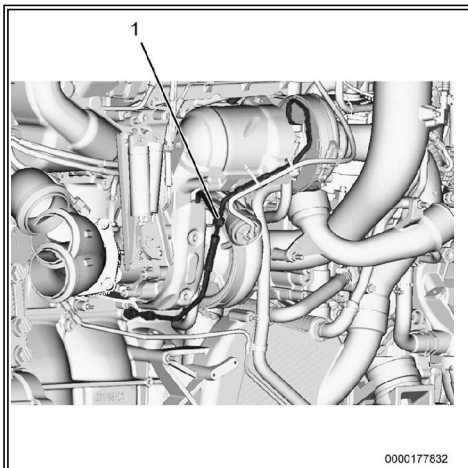
Figure 1: Old Style (Factory Installed) Turbocharger Oil Supply Tube.

Item 1: Turbocharger oil supply tube

To prevent property damage, the factory installed oil supply tube must not be reused or damage to equipment will occur. If oil supply tube will not come out of the high-pressure turbocharger due to seizure, cut the oil supply tube into two pieces and leave the line in the high-pressure turbocharger for ease of removal, then discard oil supply tube.

9. Remove and discard turbocharger oil supply tube (Figure 1, Item 1).

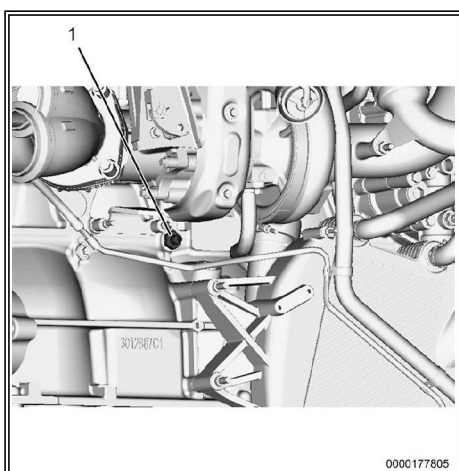
Figure 2: Turbocharger Oil Supply Tube Male Stud Fitting.

Item 1: Turbocharger oil supply tube male stud fitting

10. Remove and discard turbocharger oil supply tube male stud fitting (Figure 2, Item 1).

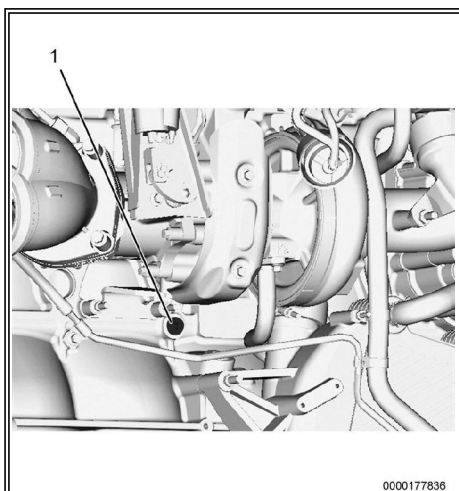
Figure 3: Oil Supply Tube Hex Socket Plug.

Item 1: Oil supply tube hex socket plug

11. Install oil supply tube hex socket plug (Figure 3, Item 1) into oil supply inlet port in block. Using torque wrench, tighten socket plug to 52 lb-ft (70 N•m).

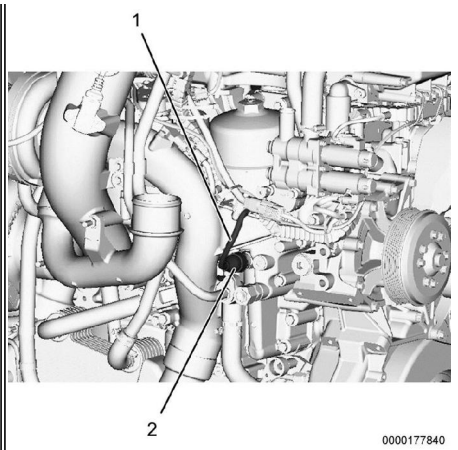
Figure 4: Engine Oil Pressure (EOP) Sensor.

- Item 1: EOP sensor connector
- Item 2: EOP sensor

12. Disconnect connector (Figure 4, Item 1) from EOP sensor (Figure 4, Item 2).
13. Remove EOP sensor and gasket, and **save for reuse**.

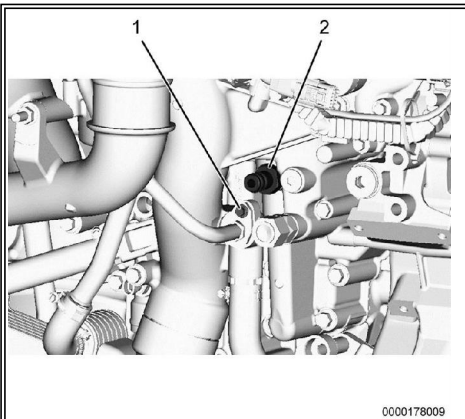
Figure 5: Adapter Assembly Fitting.

- Item 1: M6 bolt
- Item 2: Adapter assembly fitting

14. Remove M6 bolt (Figure 5, Item 1) from heater return tube and discard.

NOTE: Install adapter fitting with the two O-rings facing out towards the operator.

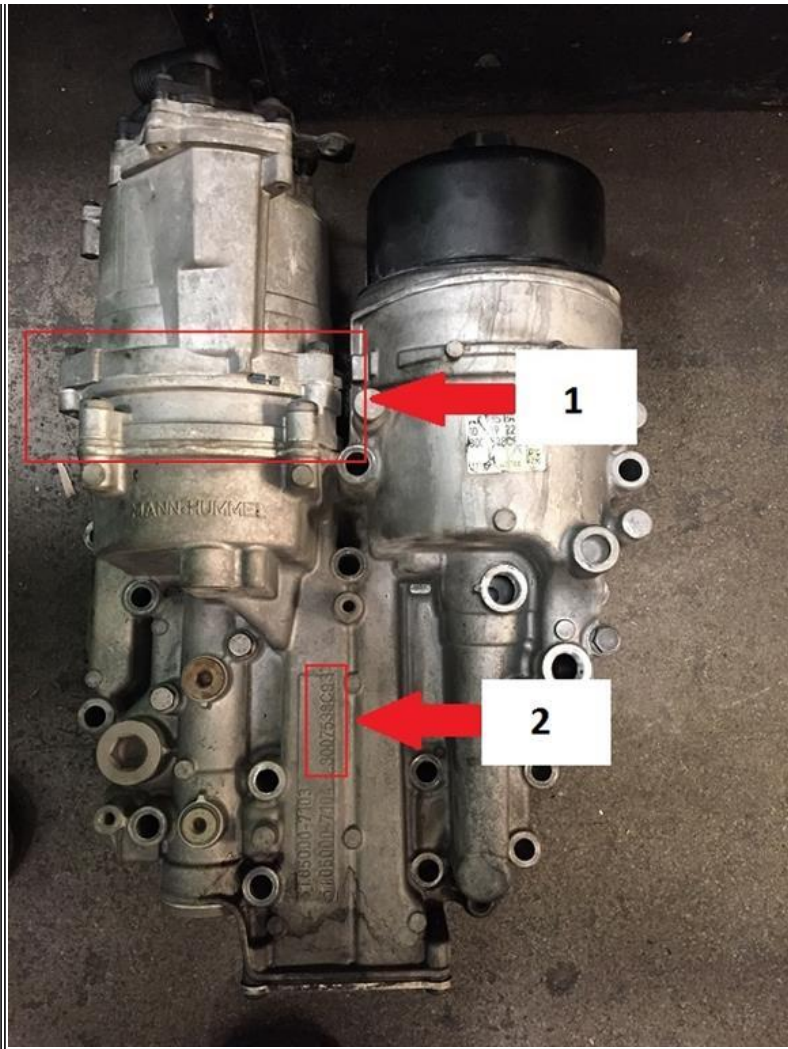
Figure 6: Oil Module

- 15a. Inspect oil module for breather jet plate and / or part number:
 If the oil module part number starts with 300 and has a jet plate continue to step 15b for torquing procedure. See Figure 6 for example
 If the oil module part number starts with 709 and does not have a jet plate continue to step 15c for torquing procedure. See figure 7 for example.

1. Jet Plate
2. Oil Module Part Number

15b. Install adapter assembly fitting (Figure 8, Item 2). Using torque wrench, tighten fitting to 26 lb-ft (35 N•m).

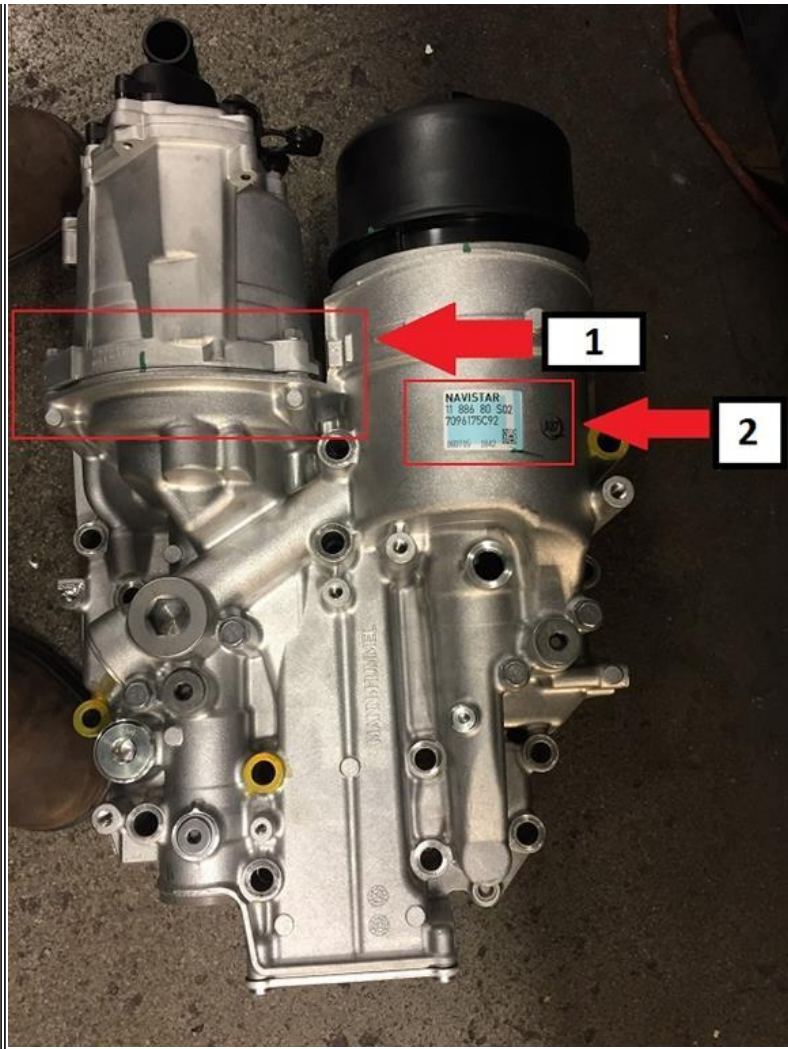
Figure 7: Oil Module

- 1. No Jet Plate
- 2. Oil Module Part Number

15c. Install adapter assembly fitting (Figure 8, Item 2). Using torque wrench, tighten fitting to 26 lb-ft (35 N•m).

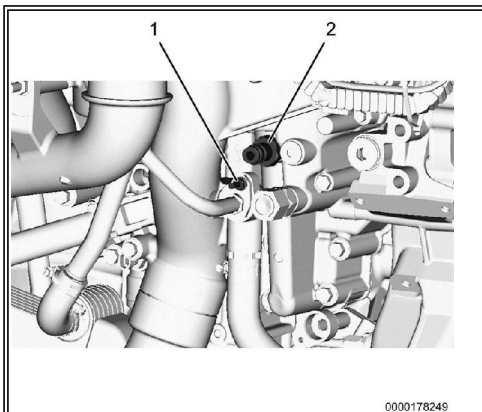
Figure 8: M6 Stud Bolt.

- Item 1: M6 stud bolt
- Item 2: Adapter assembly fitting

16. Install M6 stud bolt (Figure 8, Item 1). Using torque wrench, tighten stud bolt to 10 lb-ft (13 N•m).

17. Using P-80[®], lubricate adapter fitting (Figure 8, Item 2).

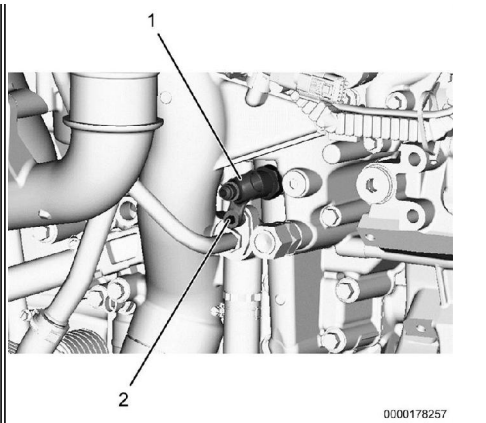
Figure 9: Oil Supply T-fitting.

- Item 1: Oil supply T-fitting
- Item 2: M6 stud bolt

18. Slide oil supply T-fitting (Figure 9, Item 1) over adapter assembly fitting and M6 stud bolt (Figure 9, Item 2).

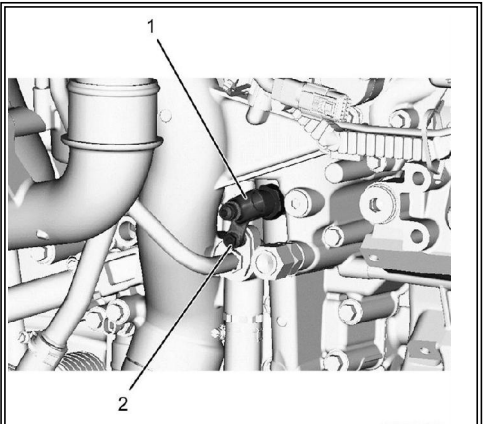
Figure 10: Install Oil Supply T-fitting.

- Item 1: Oil supply T-fitting
- Item 2: M6 nut

19. Install M6 nut (Figure 10, Item 2) to oil supply T-fitting (Figure 10, Item 1). Using torque wrench, tighten nut to 10 lb-ft (13 N•m).

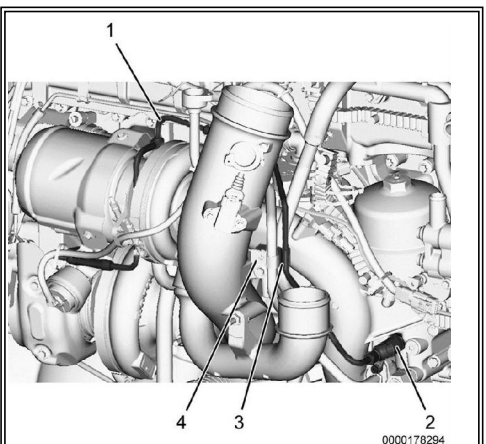
Figure 11: Turbo Oil Supply Tube Position.

- Item 1: Turbo oil supply tube
- Item 2: Oil supply T-fitting
- Item 3: Turbo oil supply tube bracket
- Item 4: Heater and cooler line bracket (2)

20. Remove M8 bolt from heater and cooler line brackets (Figure 11, Item 4) and discard.

21. Align turbo oil supply tube (Figure 11, Item 1) with oil supply T-fitting (Figure 11, Item 2) and turbocharger oil supply openings.
22. Loosely install turbo oil supply tube flare nut end onto oil supply T-fitting.
23. Position turbo oil supply tube bracket (Figure 11, Item 3) BETWEEN heater and cooler line brackets (Figure 11, Item 4).

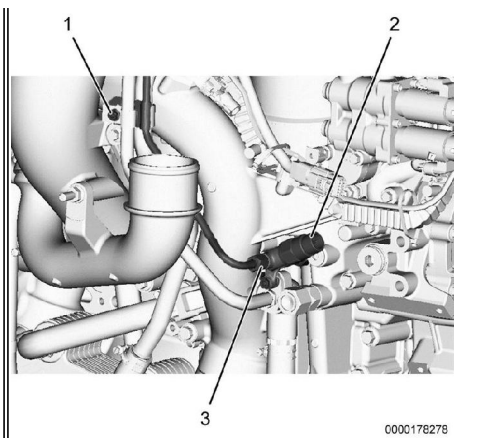
Figure 14: Turbo Oil Supply Tube T-fitting Flare Nut.

- Item 1: M8 nut
- Item 2: EOP sensor
- Item 3: Turbo oil supply tube T-fitting flare nut

28. Install M8 nut (Figure 14, Item 1) over turbo supply line bracket, heater and cooler line brackets and stud bolt in high-pressure turbocharger air inlet duct.

Using torque wrench, tighten nut to 23 lb-ft (31 N•m).

29. Install turbo oil supply tube flare nut (Figure 14, Item 3) to T-fitting. Using torque wrench, tighten nut to 19 lb-ft (26 N•m).

30. Install EOP sensor (Figure 14, Item 2) to T-fitting. Using torque wrench, tighten sensor to 33 lb-ft (45 N•m).

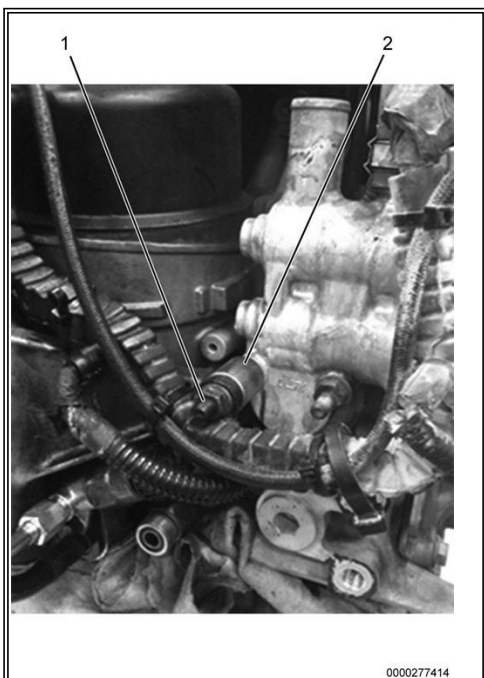
Figure 15: Rear CCV Stud.

- Item 1: 1819245C1 Stud Bolt
- Item 2: 62917010831 Spacer

NOTE: The EOP connector may contact the engine harness on early MaxxForce® 11 & 13 (EPA 10) Engines.

- Remove rear coolant control valve (CCV) stud bolt, and install spacer with longer stud bolt (Figure 15, Items 1 and 2).
- Install EOP sensor connector.
- Secure engine harness to longer stud with original nut. Tighten nut to standard torque.

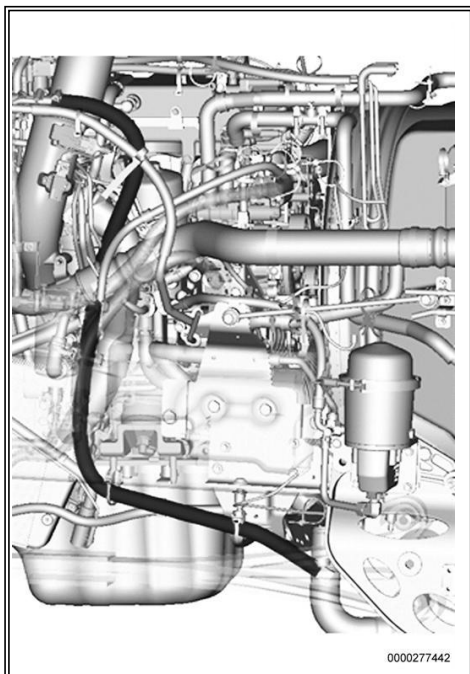
Figure 16: Sleeper Heater Hose Existing Routing.

Some ProStar® 122 vehicles experience the sleeper heater hose routed in the way of the new turbocharger oil supply tube. Use the following procedure to reroute the sleeper heater return hose away from the oil supply tube.

1. Drain cooling system.
2. Remove sleeper heater hose from bottom radiator hose (Figure 16) .

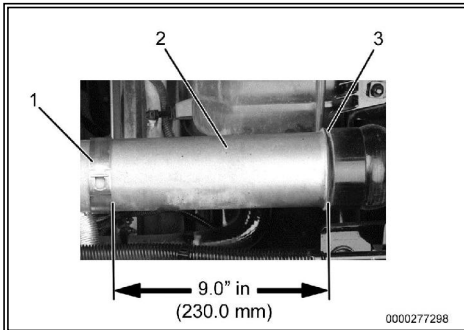
Figure 17: Clamp Measurement.

- Item 1: 3535872C1 Clamp
- Item 2: CAC pipe
- Item 3: CAC rubber boot

NOTE: Orientate CAC clamp saddle parallel with CAC pipe.

5. Measure approximately 9.0 in (230 mm) on CAC pipe (Figure 17, Item 2) from end of CAC rubber boot (Figure 17, Item 3) towards rear of vehicle for clamp (Figure 17, Item 1) installation.

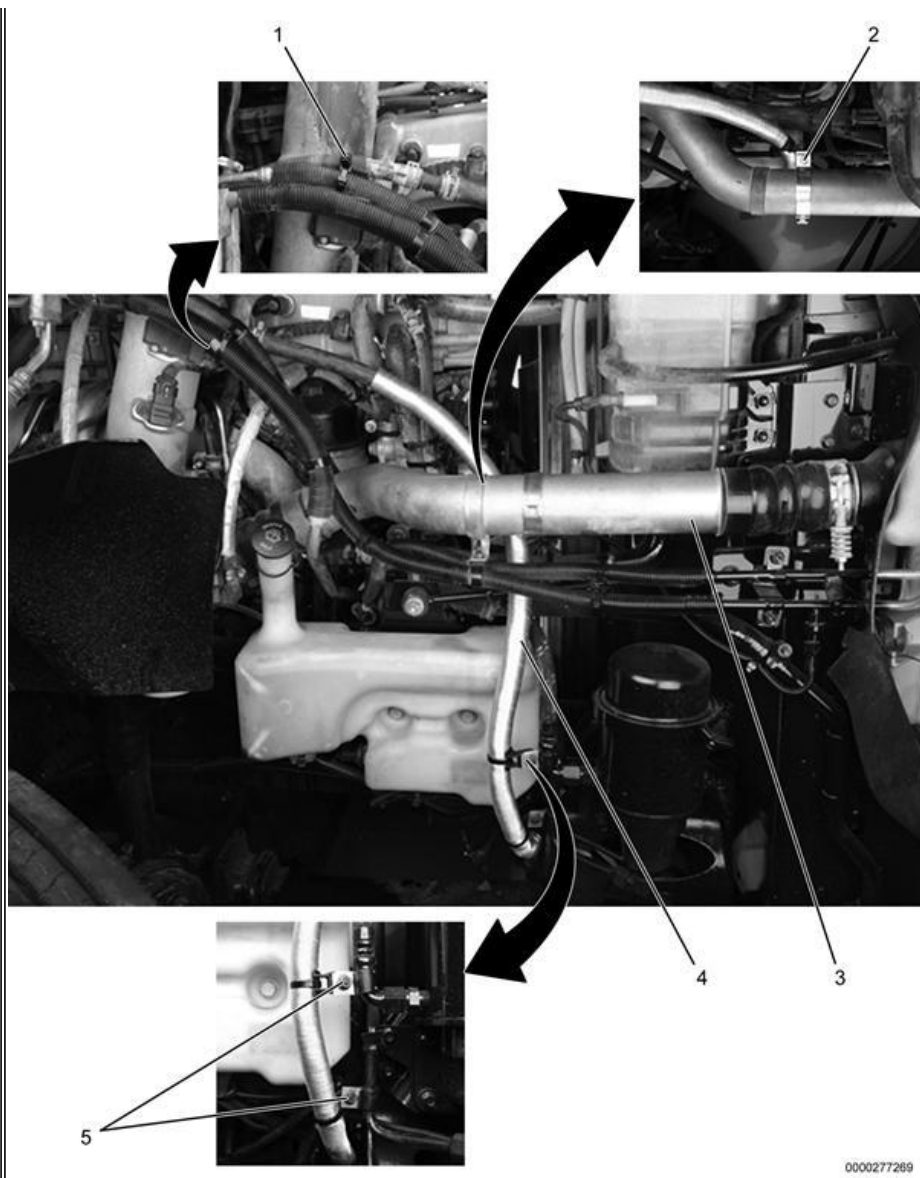
Figure 18: ProStar® 122 Heater Hose Route Overview.

- Item 1: Tie strap
- Item 2: 3535872C1 Clamp
- Item 3: CAC pipe
- Item 4: Heater hose
- Item 5: Swivel clamp (2)

6. Install clamp (Figure 18, Item 2), carriage bolt, and nut onto CAC pipe (Figure 18, Item 3). Using torque wrench, tighten nut to standard torque value.
7. Secure heater hose (Figure 18, Item 4) to CAC pipe clamp using sideways saddle, bolt nut, and one tie strap.
8. Using tie strap (Figure 18, Item 1), secure heater hose (Figure 18, Item 4) to A/C hose.
9. Using two sideways swivel clamps (Figure 18, Item 5), two tie straps, two M8 bolts, and two M8 nuts, secure heater hose to oil centrifuge supply and return lines.
10. Attach heater hose (Figure 18, Item 4) to lower radiator hose. Using torque wrench, tighten clamp to standard torque value.

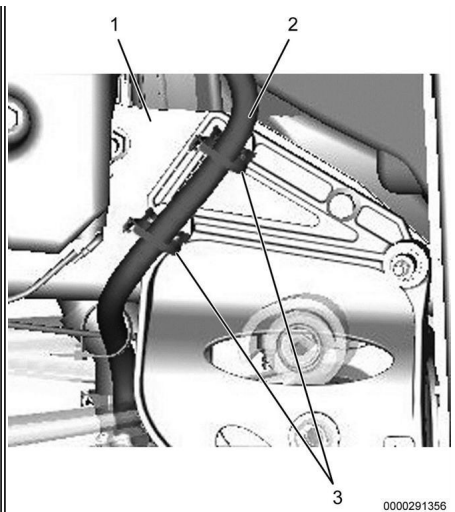
Figure 19: Frame Mounted Heater Hose Routing.

Item 1: Frame
 Item 2: Heater hose
 Item 3: Tie strap (4) (2 not shown)

11. Using two 3948245C1 spin huck saddles and four tie straps (Figure 19, Item 3), secure heater hose (Figure 19, Item 2) to frame (Figure 19, Item 1).
12. Attach heater hose to lower radiator hose. Using torque wrench, tighten clamp to standard torque value.
13. Fill cooling system.

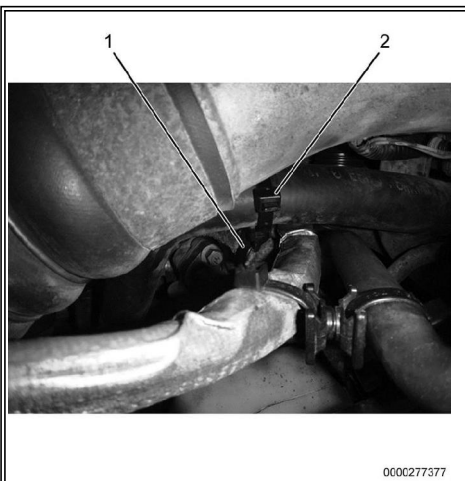
Figure 20: Deaeration Tank Hose.

Some ProStar® 113 and TranStar® vehicles may experience the coolant deaeration tank hose or an in-transit heat hose rubbing on the turbocharger oil supply tube. Use the following procedure to secure either hose away from the oil supply tube.

Item 1: Deaeration tank hose
 Item 2: Tie strap (2) (1 not shown)

1. Pull deaeration tank hose (Figure 20, Item 1) towards deaeration tank until it clears turbocharger oil supply tube.
2. Using two tie straps (Figure 20, Item 2), and a swivel saddle, secure deaeration tank hose to oil centrifuge supply line.
3. Verify deaeration tank hose or in-transit heat hose is not rubbing on turbocharger oil supply tube or CAC pipe.
4. Close hood.
5. Remove wheel chocks.

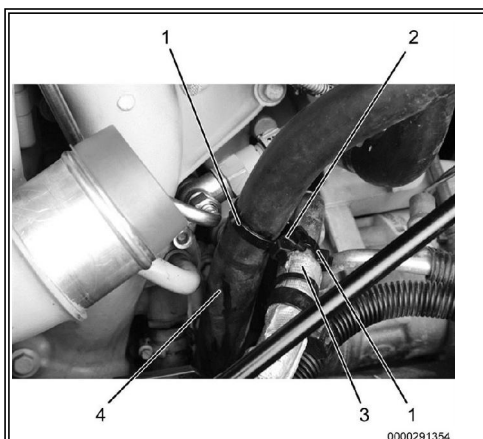
Figure 21: Surge Tank Hose.

Some CAT® vehicles equipped with MaxxForce® 11 & 13 (EPA 10) engines could experience coolant deaeration tank hose rubbing on turbocharger oil supply tube.

Item 1: Tie strap (2)
Item 2: Swivel saddle
Item 3: A/C suction line
Item 4: Deaeration tank hose

1. Pull deaeration tank hose (Figure 21, Item 4) back to its original location towards deaeration tank until it clears turbocharger oil supply tube.
2. Using two tie straps (Figure 21, Item 1), and a swivel saddle (Figure 21, Item 2) secure deaeration tank hose to A/C suction line (Figure 21, Item 3).
3. Verify deaeration tank hose is not rubbing on turbocharger oil supply line or CAC pipe.
4. Close hood.
5. Remove wheel chocks.

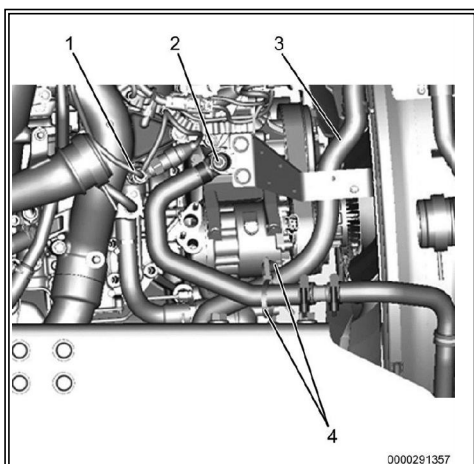
Figure 22: Water Bypass Hose.

NOTE: Some PayStar® and TranStar® vehicles may experience water bypass hose rubbing on turbocharger oil supply tube. Use following procedure to secure bypass hose away from turbocharger oil supply tube.

Item 1: Turbo oil supply tube
Item 2: 90-degree elbow fitting
Item 3: Deaeration tank hose
Item 4: Tie strap (2)

1. Rotate 90-degree elbow fitting (Figure 220, Item 2) down until bypass hose clears turbo oil supply tube (Figure 22, Item 1).
2. Using two tie straps (Figure 22, Item 4), and a swivel saddle, secure water bypass hose to deaeration tank hose (Figure 22, Item 3).
3. Verify no other hoses are rubbing on turbocharger oil supply line or CAC pipe.
4. Close hood.
5. Remove wheel chocks.

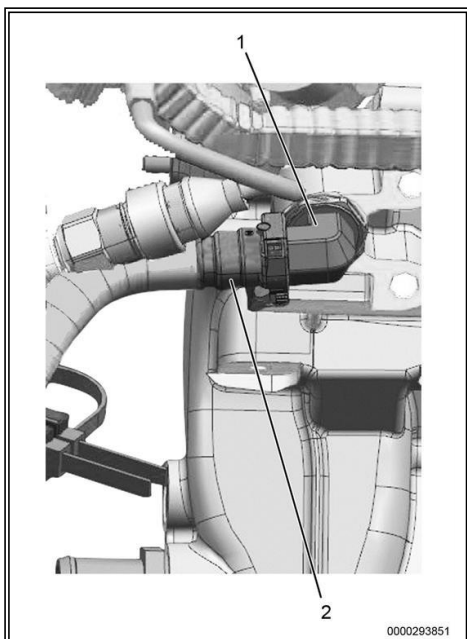
Figure 23: Coolant Deaeration Tank Supply Hose.

NOTE: Some PayStar®, WorkStar®, and TranStar® vehicles equipped with SCR and manual transmissions may experience DEF coolant supply hose rubbing on turbocharger oil supply tube. Use the following procedure to install a spacer for manual transmission equipped chassis.

- Item 1: 90-degree elbow fitting
Item 2: DEF coolant supply hose

1. Drain cooling system.
2. Remove DEF coolant supply hose (Figure 23, Item 2).
3. Remove 90-degree elbow fitting (Figure 23, Item 1).

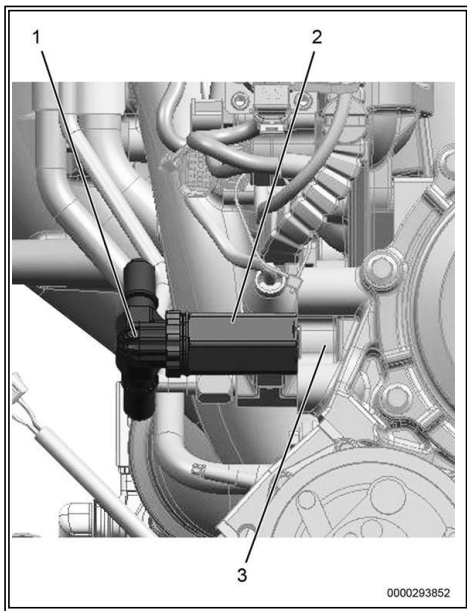
Figure 24: Coolant Deaeration Tank Supply Hose Spacer.

- Item 1: 90-degree elbow fitting
- Item 2: 4037501C1 Spacer
- Item 3: Coolant distribution housing

4. Install spacer (Figure 24, Item 2) into coolant distribution housing (Figure 24, Item 3).
5. Install 90-degree elbow fitting (Figure 24, Item 1) and DEF coolant supply hose.
6. Fill cooling system.
7. Close hood.
8. Remove wheel chocks.

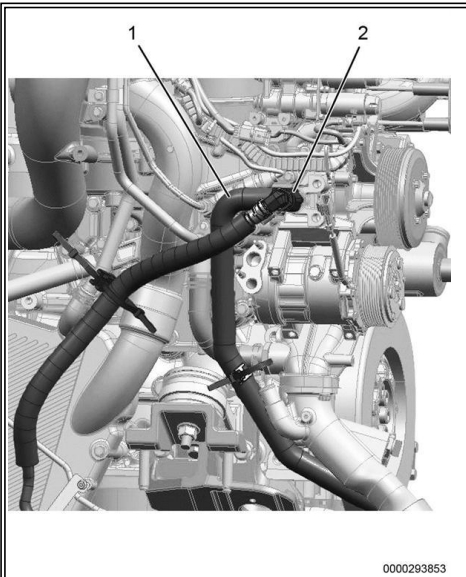
Figure 25: SCR Equipped Water Bypass Hose.

NOTE: Some TranStar® vehicles equipped with SCR and automatic transmissions may experience DEF coolant supply hose rubbing on turbocharger oil supply tube. Use the following procedure to install a spacer for manual transmission equipped chassis.

- Item 1: 90-degree elbow fitting
- Item 2: Water bypass hose

1. Drain cooling system.
2. Remove water bypass hose (Figure 25, Item 2) from 90-degree elbow fitting (Figure 25, Item 1).
3. Remove water bypass hose from deaeration tank and discard.

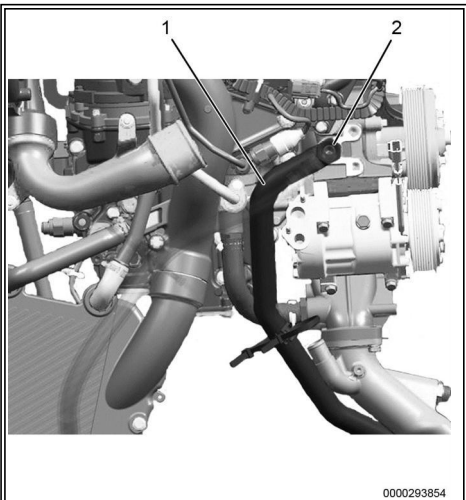
Figure 26: SCR Equipped Water Bypass Hose Replacement.

- Item 1: Water bypass hose

Item 2: 90-degree elbow fitting

4. Rotate 90-degree elbow fitting (Figure 26, Item 2) down 1/8 turn.
5. Install new water bypass hose (Figure 26, Item 1) to deaeration tank and 90-degree elbow fitting.
6. Clip new bypass hose in original location.
7. Fill cooling system.
8. Close hood.
9. Remove wheel chocks.
