SIB 52 09 21

## NOISE FROM SEAT RAILS DURING SEAT OPERATION

# Service greasing of first row seat structure (ISR)

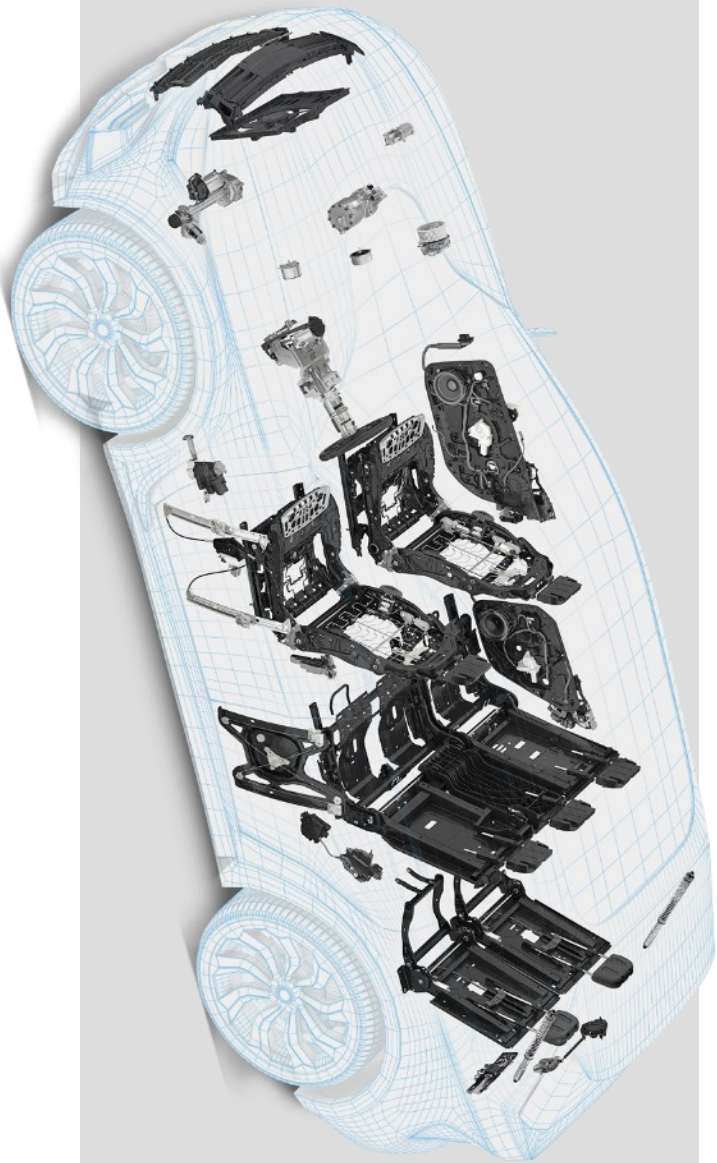
# 1SR greasing overview

All spindles can be greased on motors and LV spindles to help with noises

Follow procedure attached to this bulletin to lubricate the seat rail assembly.

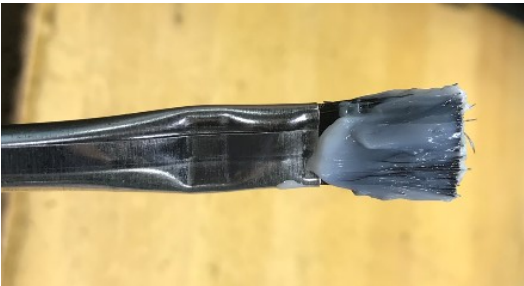
Brush needed to apply grease

Preferred grease for all spindles on 1SR structure is P/N 83 23 **0396713** Klubersynth LF 44-22

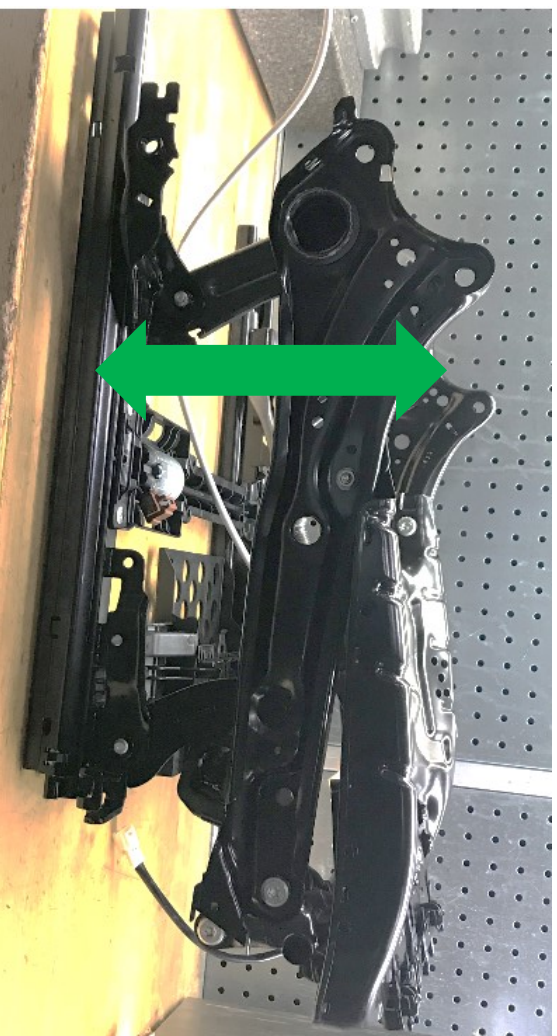
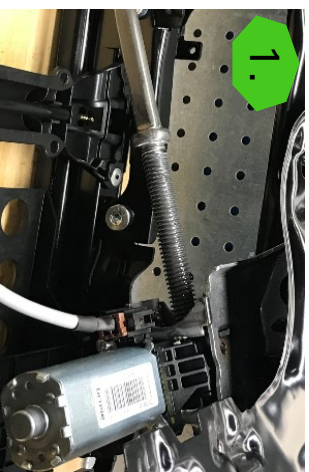
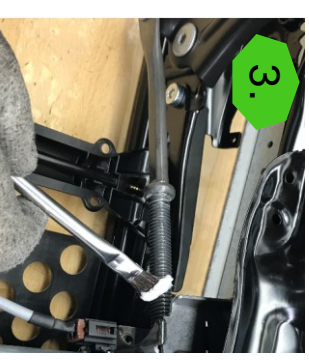
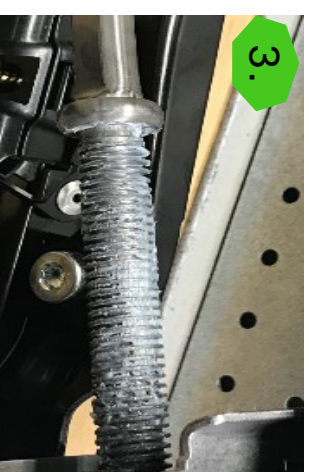
# SHV motor spindle greasing

Function seat adjuster full up and leave seat adjuster up for all greasing

1. Locate HV spindle once seat is all the way up.
2. Apply even amount of grease to brush.
3. Spread grease along the entire HV motor spindle.
4. Once grease is spread function seat full down and up 3x to distribute grease evenly along the spindle.

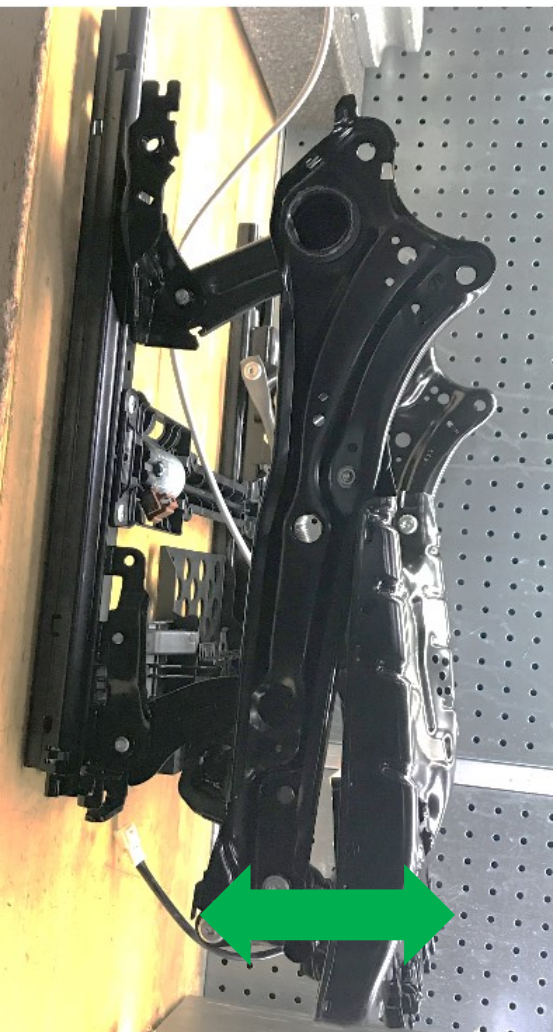
# SNV motor spindle greasing

Function Cushion (NV) motor full up and leave seat adjuster up for all greasing

1. Locate NV spindle once NV is driven all the way up.
2. Apply even amount of grease to brush.
3. Spread grease along the entire HV motor spindle.
4. Once grease is spread over spindle function Cushion motor full down and up 3x to distribute grease evenly along the spindle.

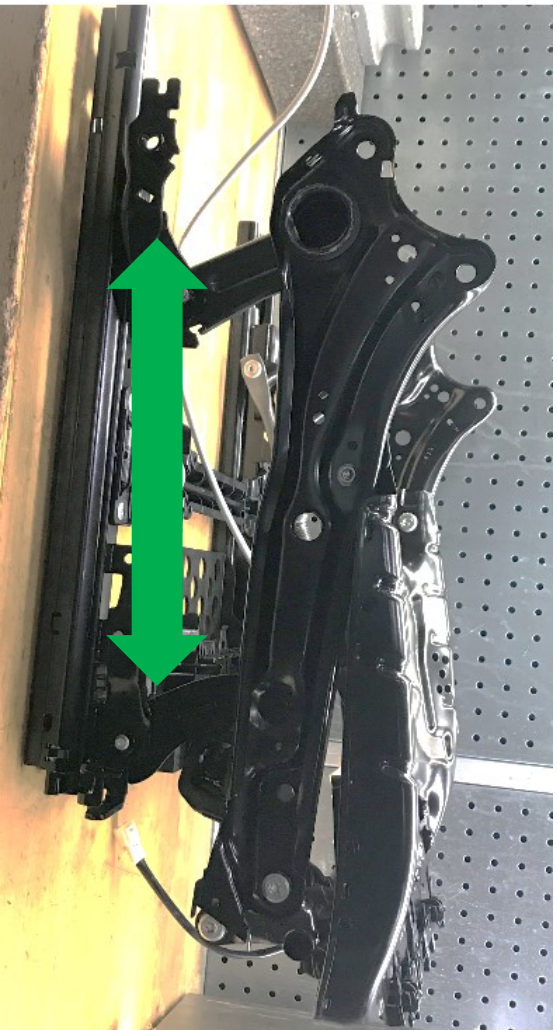
## IB and OB LV spindle greasing

Function Length adjuster full forward to grease front of spindles and full rear to grease rear of spindles

1. Locate SLV motor and run seat full rearward to show IB and OB spindles.
2. Apply even amount of grease to brush.
3. Spread grease along the entire LV spindle.
4. Once grease is spread over IB and OB spindle function length adjuster back and forth 3x to distribute grease evenly along the spindle.
5. Run seat full forward to show rear IB and OB of spindles and repeat above process.
